Service Bulletin No: 32-030

**LANDING GEAR - EXTENSION AND RETRACTION
ELECTRO-MECHANICAL ACTUATOR CORROSION PROTECTION****1. Planning Information****A. Effectivity**

DOCUMENT:	Inspection of Actuator, Nose Landing Gear and Actuator, Main Landing Gear
NUMBER:	SB21-0001
ISSUE STATUS:	03
ISSUE DATE:	25/August/2022
FILENAME:	SB21-0001_03.docx

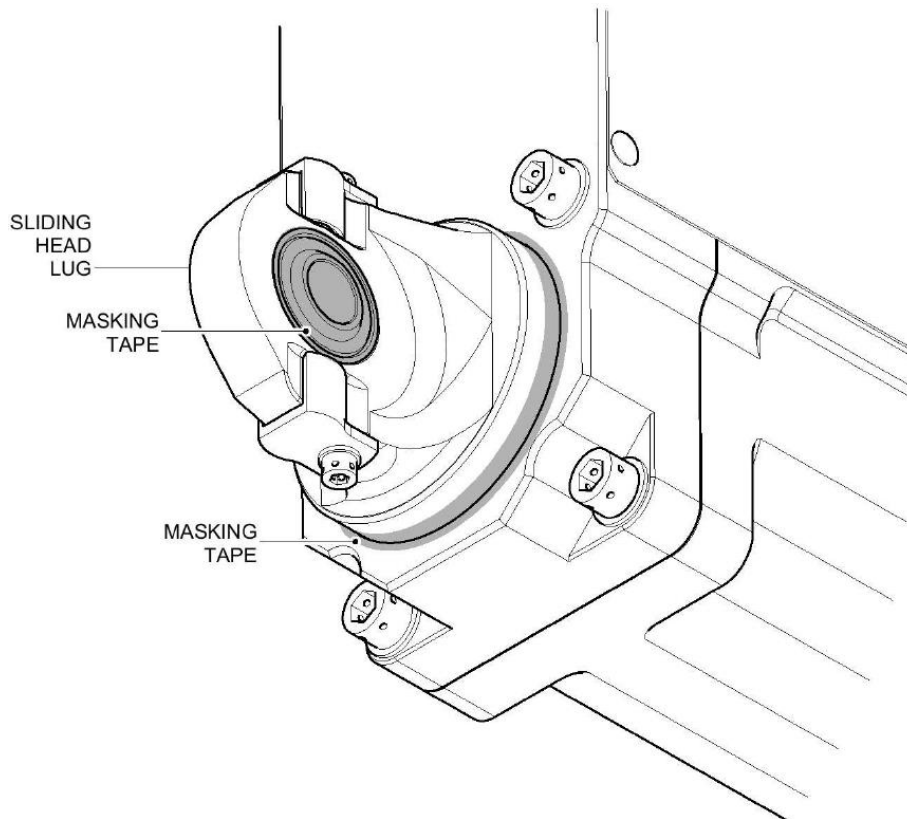
Figure 1

Mask the Actuator Lugs

(4) Remove the adhesive tape (Mat. No. 12), refer to Figure 1.

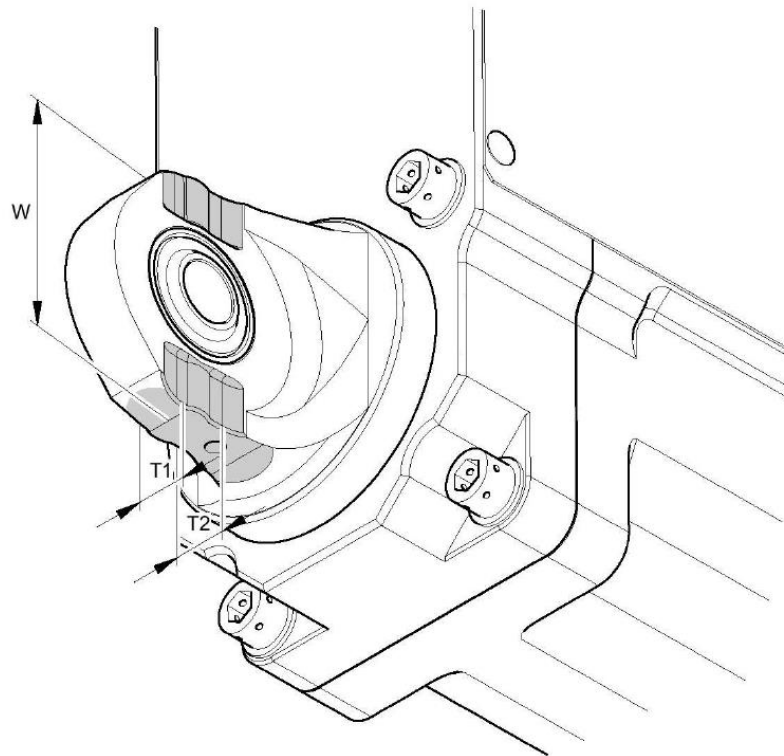
Figure 2

Measure the Actuator Lugs

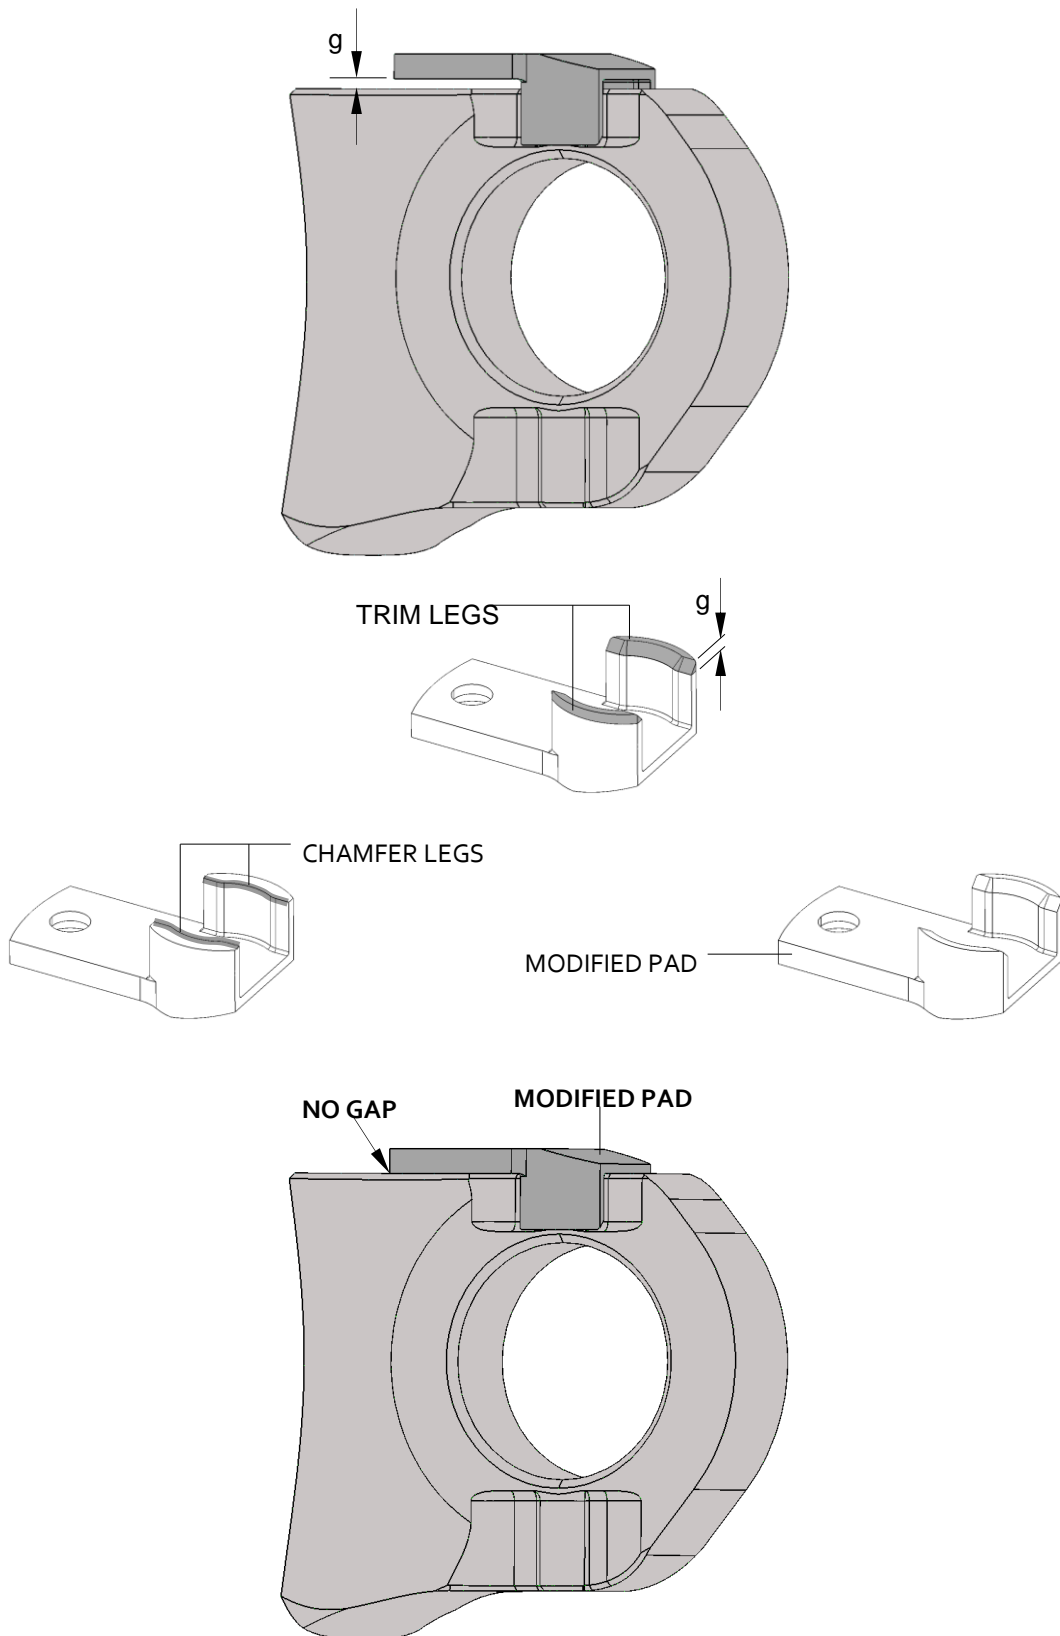
Figure 3

Modify the Anti-Rotation Pad

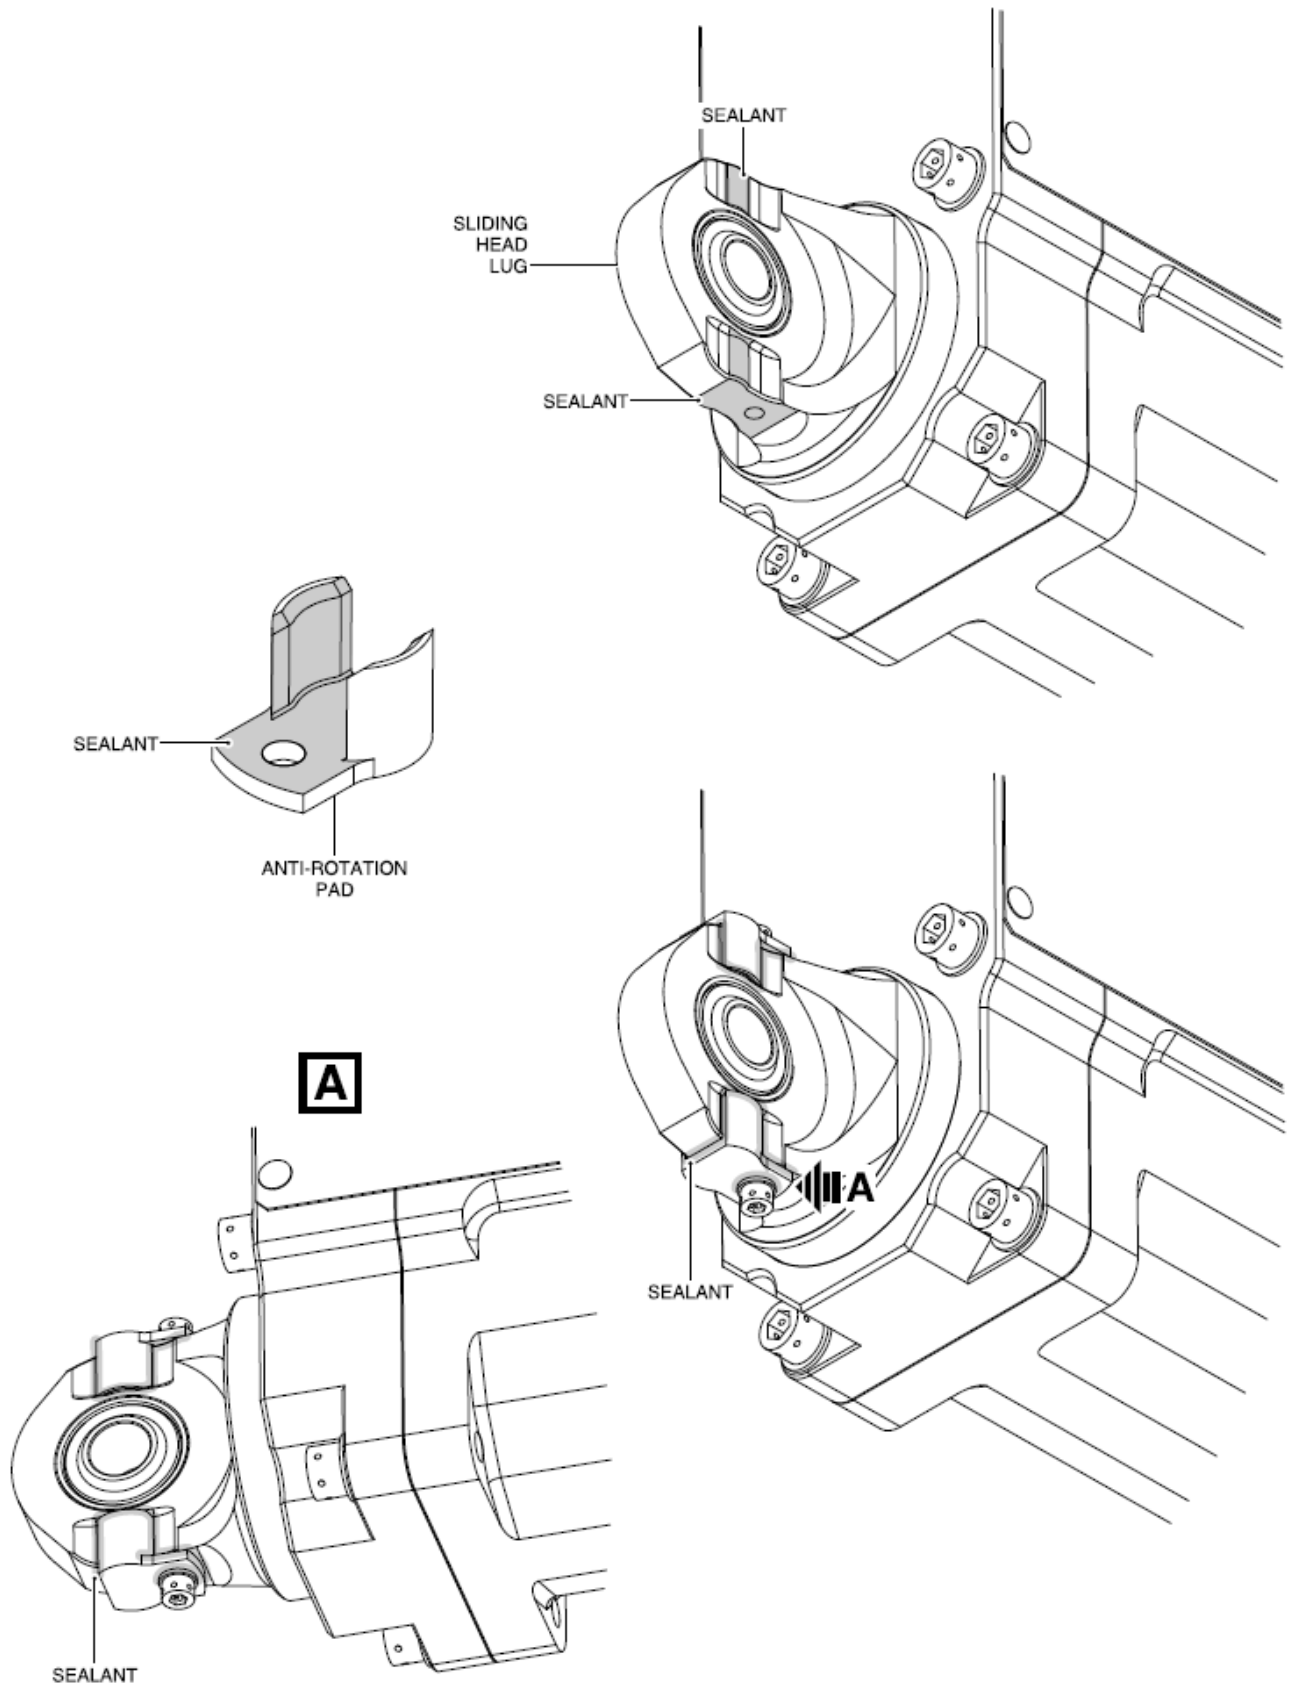
Figure 4

Apply Sealant to the Anti-Rotation Pads

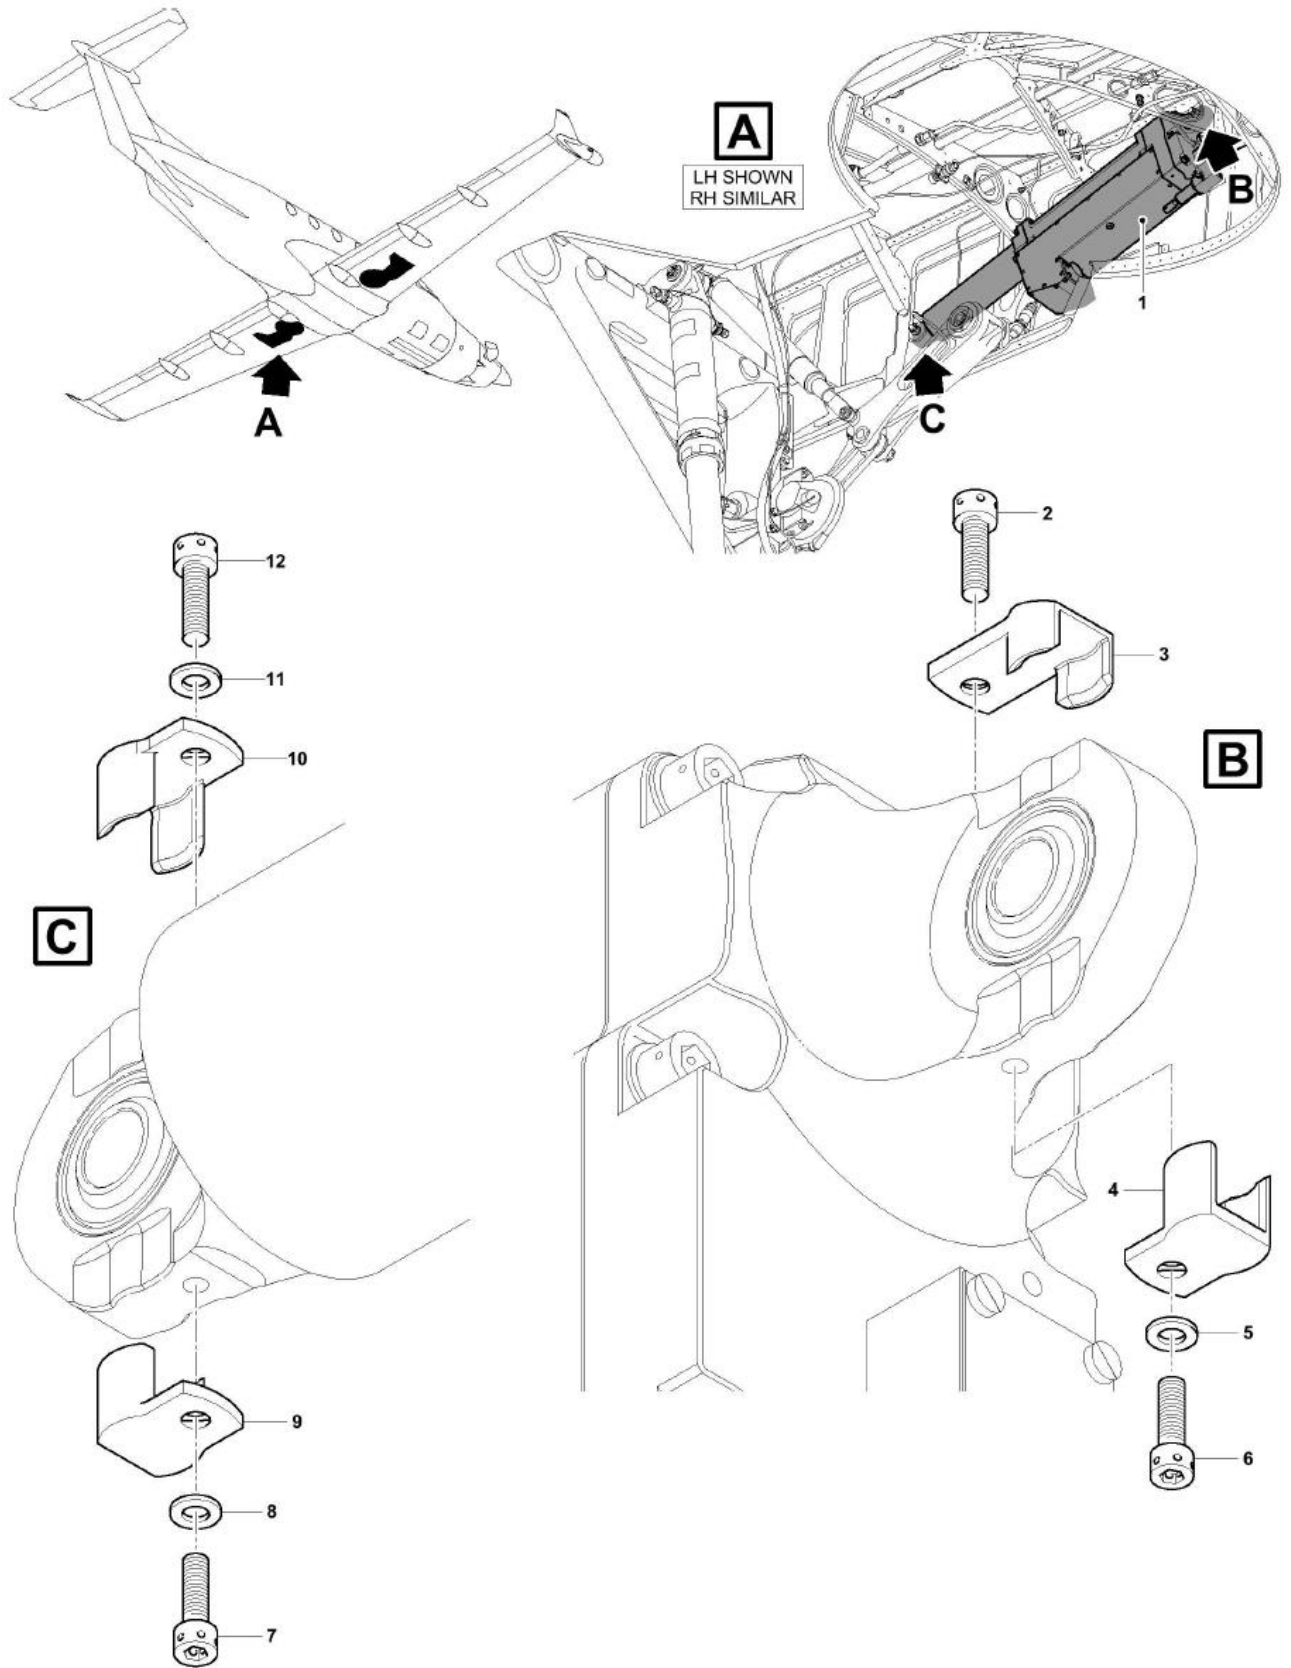
Figure 5

Main Landing Gear Actuator Anti-Rotation Pads

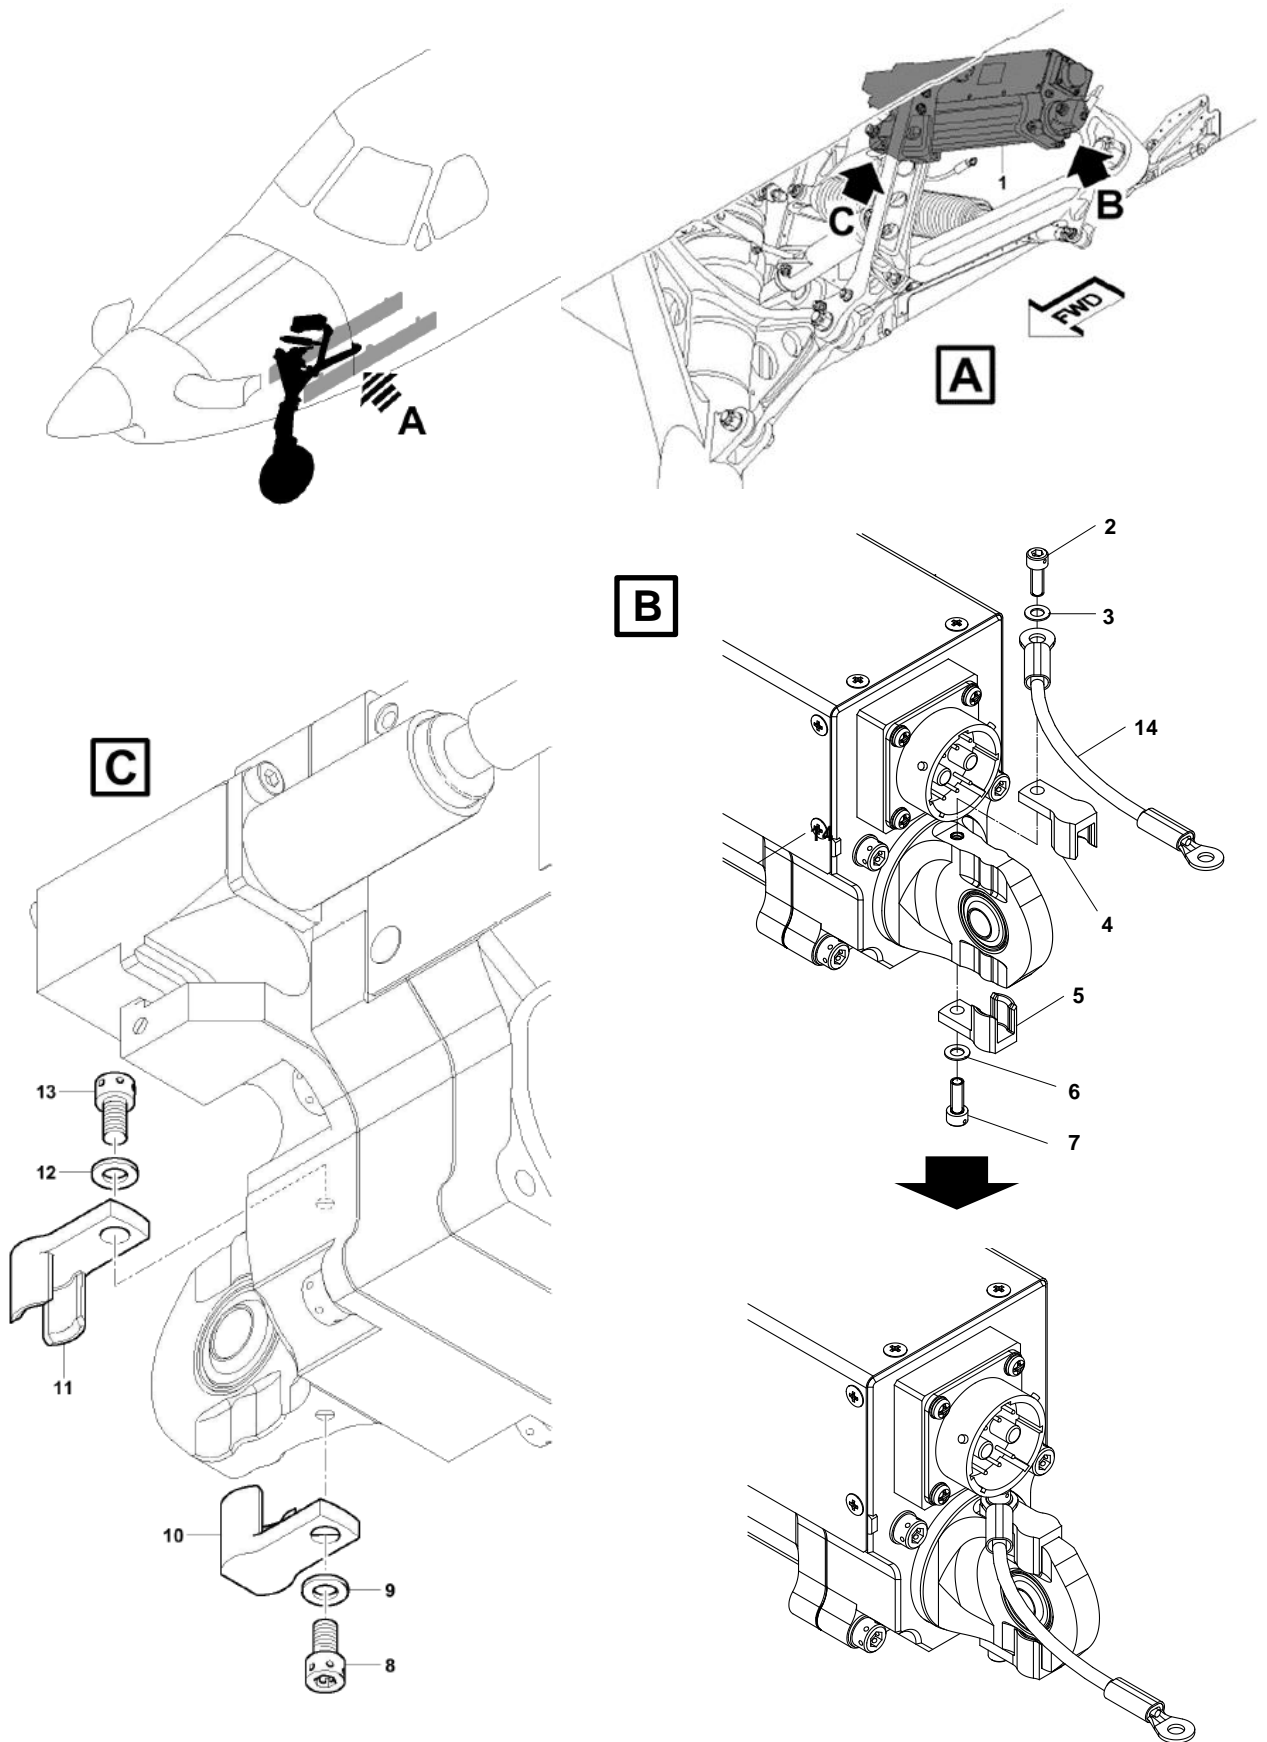
Figure 6

Nose Landing Gear Actuator Anti-Rotation Pads & Bonding Strap

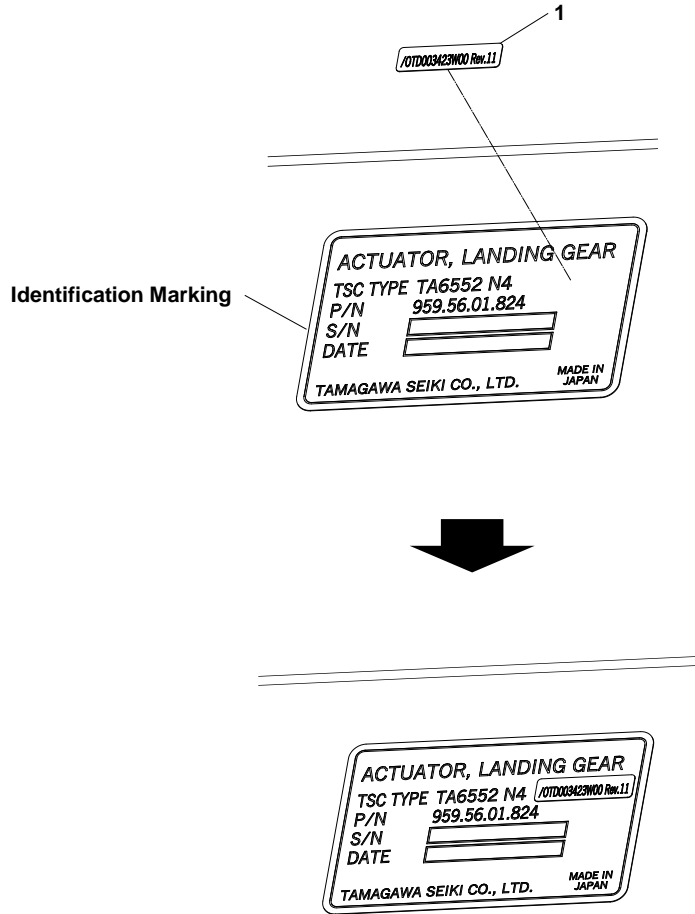
Figure 7

Landing Gear Actuator Revision ID Marking

- a. Use a Lint free cleaning cloth (Mat. No. 06) moist with isopropyl alcohol (Mat. No. 01) and clean the surface of the identification marking where the revision ID marking (1) is to be applied.
- b. Remove the backing paper from the revision ID marking (1). Press the revision ID marking (1) tightly onto the cleaned surface of the identification marking.
