Service Bulletin No: 21-007

ATA Chapter: 21

**ENVIRONMENTAL CONTROL - COMPRESSION  
INSPECTION OF THE RH P3 PIPE ASSEMBLY FOR CRACKING****1. Planning Information****A. Effectivity**

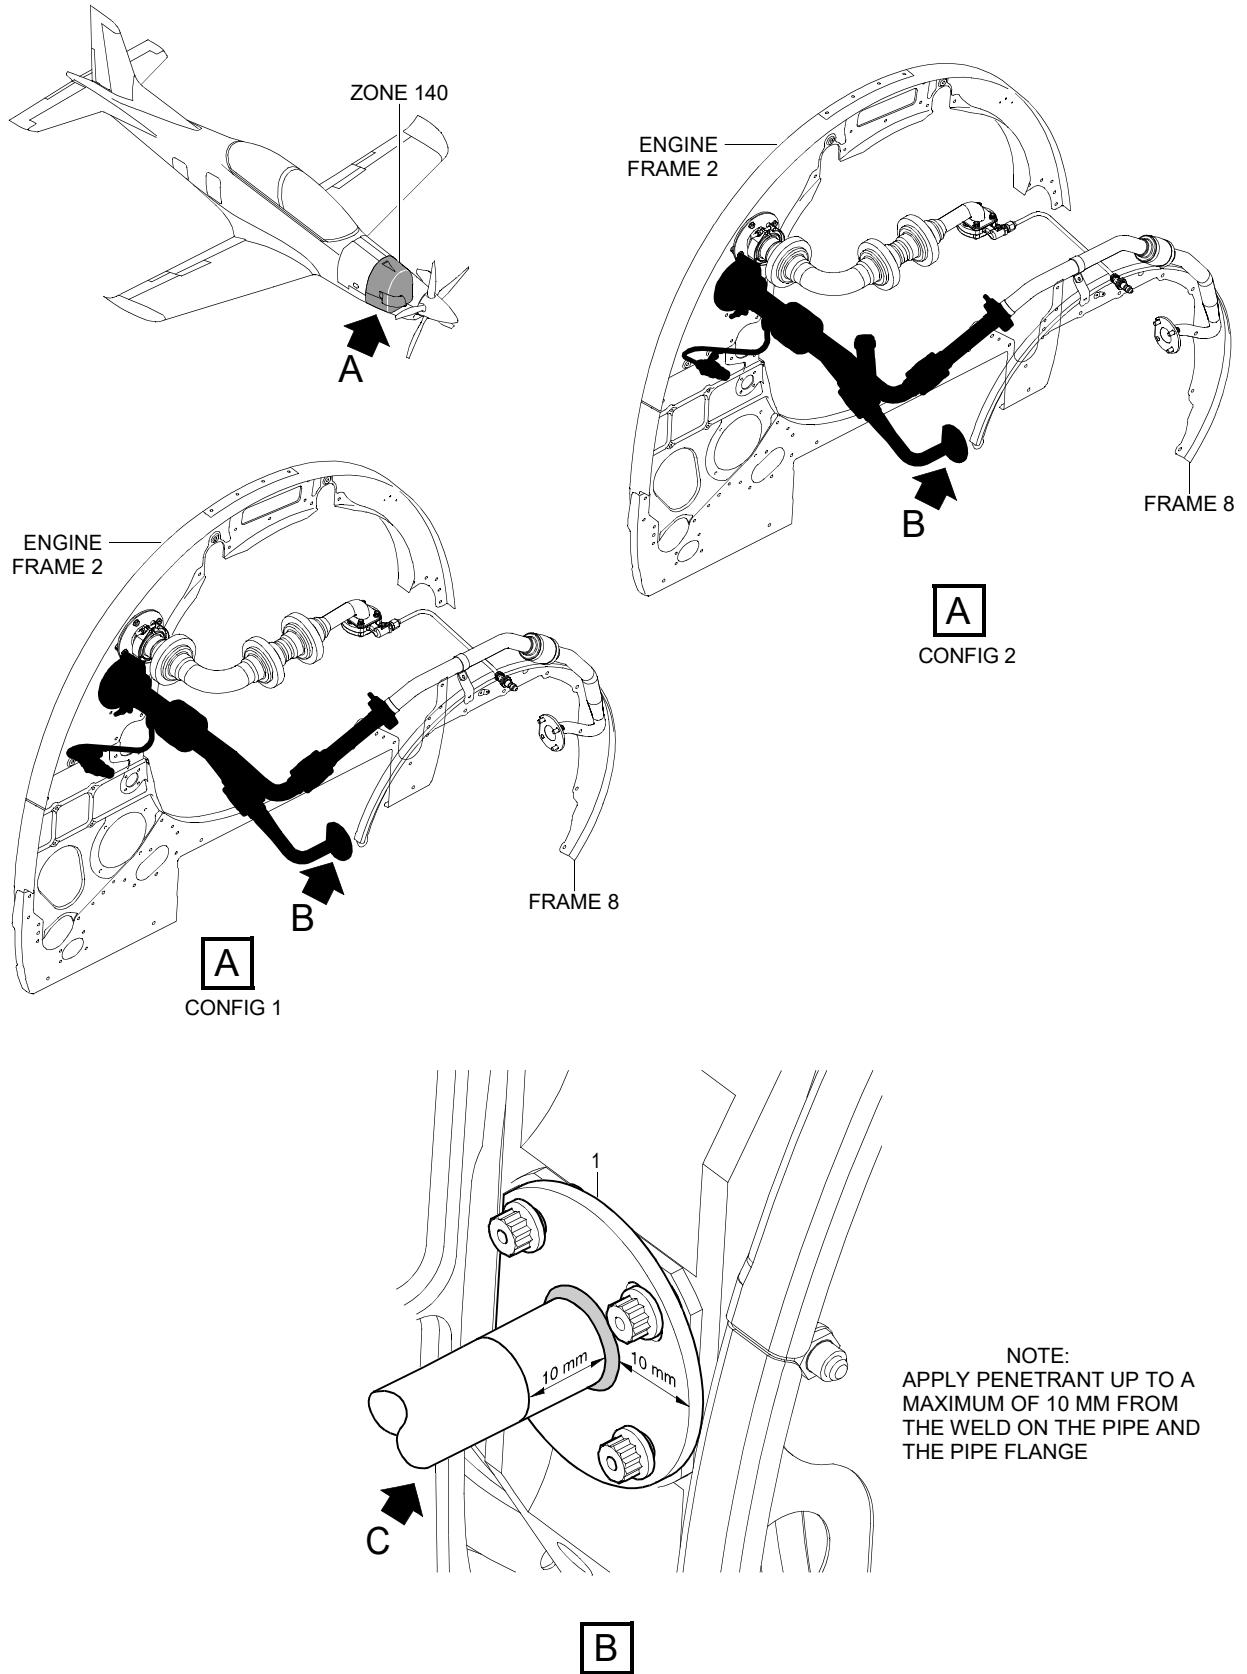
Inspection of the RH P3 pipe assembly  
Figure 1 (Sheet 1 of 2)

There has been an in-service incident of the RH P3 pipe assembly failing at the engine attachment point. A failure of the P3 pipe assembly would lead to a reduction in available engine power.

- (1) Do the inspection of the RH P3 pipe assembly (1).
  - (a) Do the penetrant NDT inspection in the area of the weld at the pipe/flange interface where the RH P3 pipe assembly (1) is attached to the engine, refer to SRM 51-20-07-00A-351A-A.

A one time penetrant Non Destructive Test (NDT) inspection of the RH P3 pipe assembly is done for cracks around the pipe/flange interface where the duct is attached to the engine.

- (b) Use Sheet 2 of Fig. 1 and make an inspection report as follows:
  - Give the date of the inspection
  - Give the aircraft details
  - Give the RH P3 pipe assembly details: Config. 1 (P/N 959.90.21.143) or Config. 2 (P/N 959.90.21.156) and serial number
  - Show the location(s) and dimensions of the crack(s) found (if applicable)
  - Add any additional comments, use the 'clock-face' indicator numerals to give more detail of the location of any cracks if necessary.
- (c) Send the inspection report with the results of the penetrant NDT inspection to PILATUS.
- (d) If you do not find cracks, continue with this Service Bulletin from Step 3.C, if you do find cracks contact PILATUS.
