Service Bulletin No: 57-016
Modification No: INSPECTION

**WINGS - CENTER WING
INSPECTION OF THE LOWER WING SKIN UNDER THE LOWER WING FAIRING**

PC-21 Aircraft MSN 101 thru MSN 337.

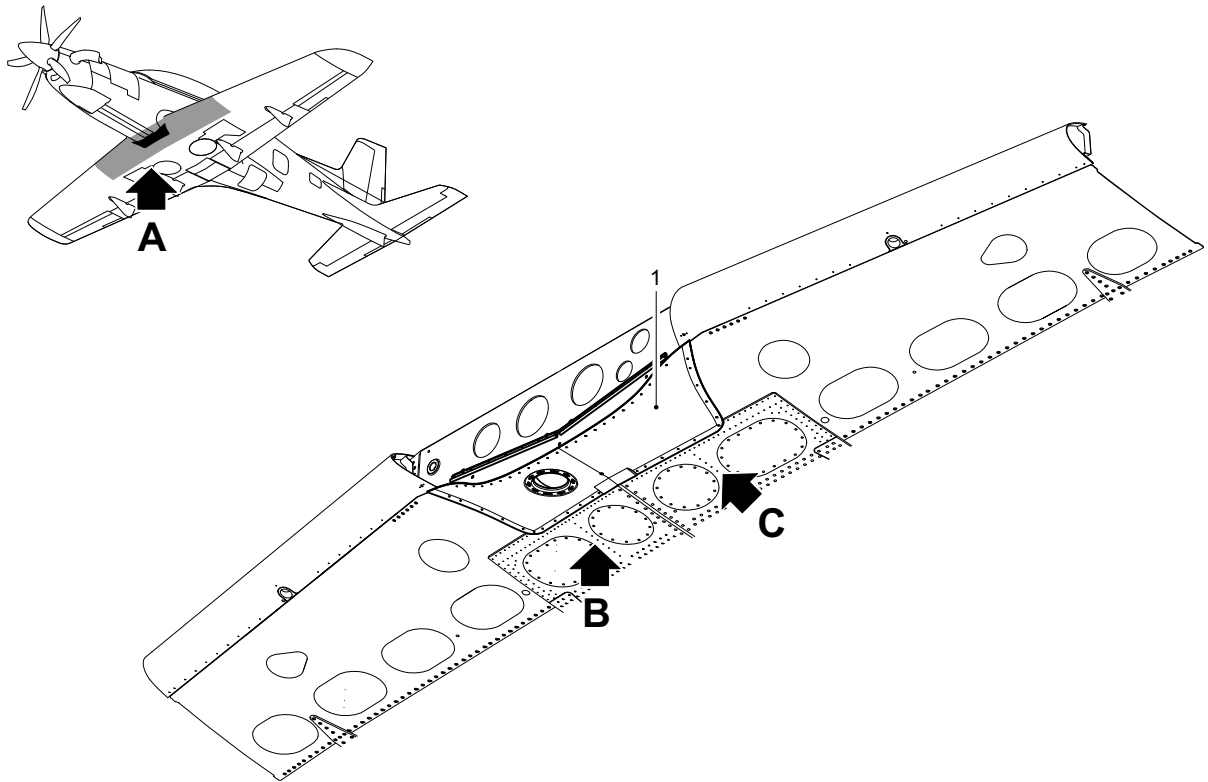
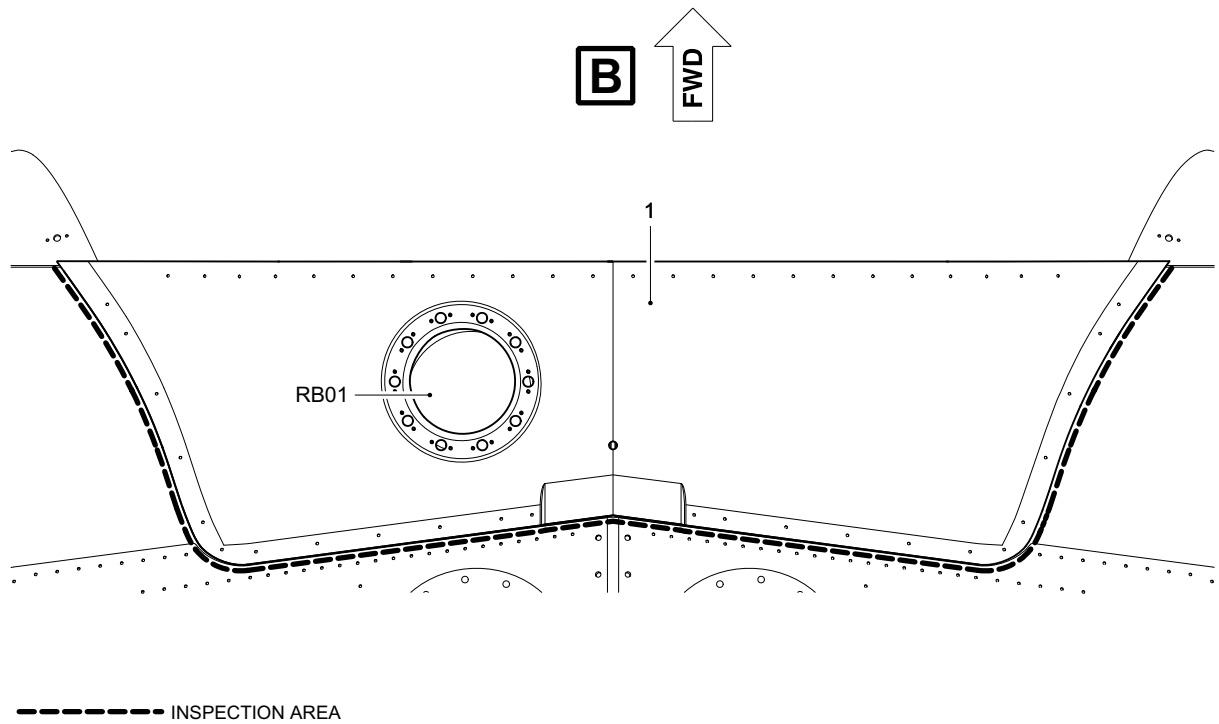
Inspection of Lower Wing Skin
Figure 1 (Sheet 1 of 8)

There have been reports of corrosion found on the lower wing skin under the carbon fibre fairing between the main spar and the front spar at the center of the wing.

- (a) Inspect along the outer edges of the lower wing fairing (1) for signs of corrosion.

NOTE: Signs of corrosion are indicated by bubbling of the paint under and around the edge of the fairing.

- (1) Do the initial visual inspection (Ref. Sheet 1, Detail B).

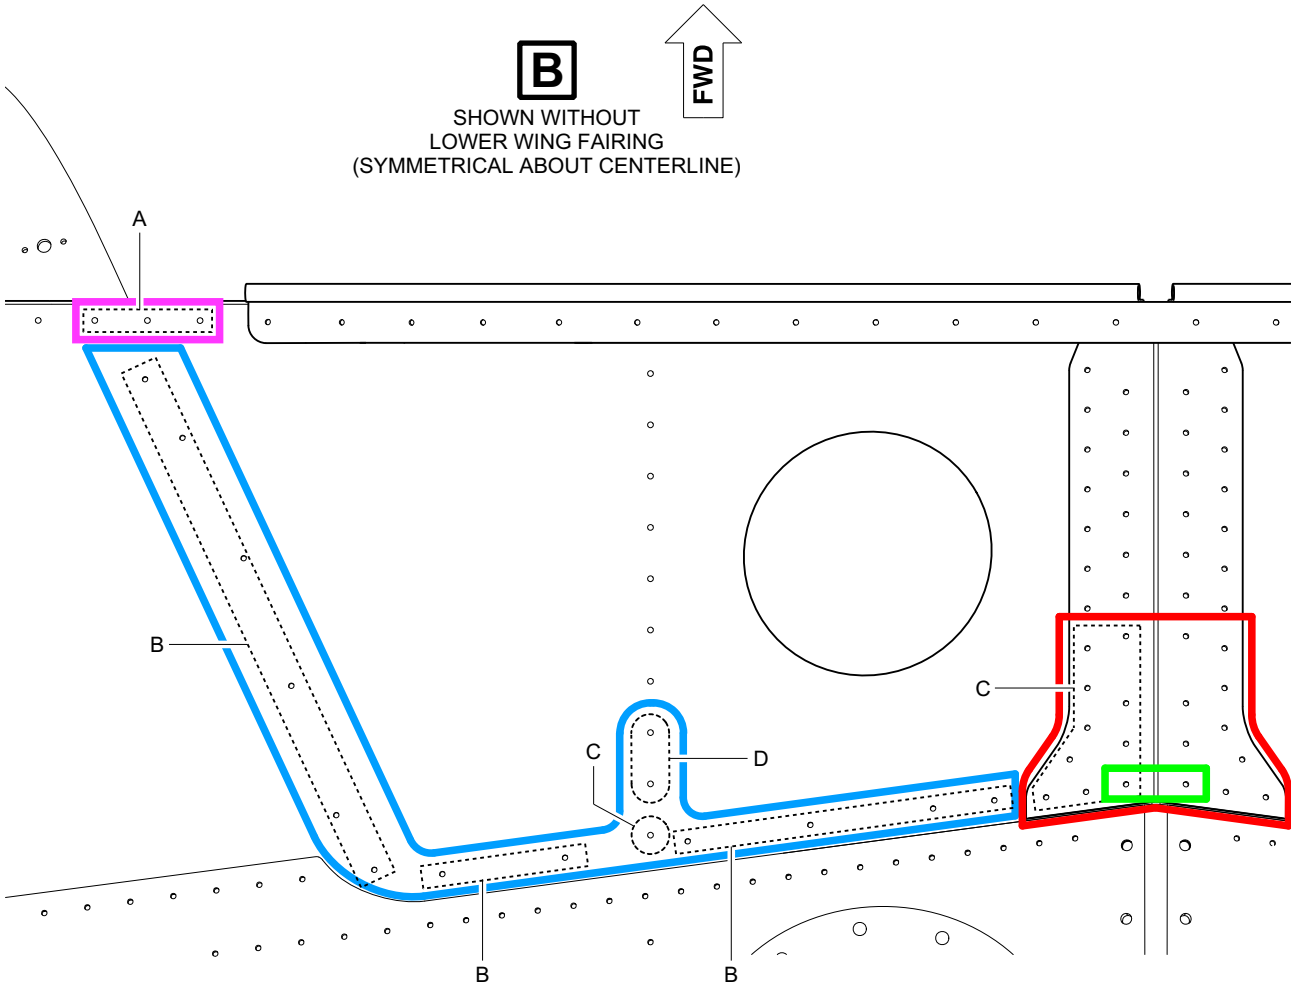
Inspection of Lower Wing Skin
Figure 1 (Sheet 4 of 8)

WING SKIN TO FRONT SPAR BLEND LIMIT ASSESSMENT AREA

WING SKIN BLEND LIMIT ASSESSMENT AREA

CENTERLINE STRAP BLEND LIMIT ASSESSMENT AREA

CENTERLINE STRAP BLEND LIMIT ASSESSMENT AREA (CENTER AFT)

- (a) De-fuel the aircraft, refer to AMM 12-10-00-00A-221A-A.
- (b) Lift the aircraft on jacks, refer to AMM 07-10-01-00A-541A-A.
- (c) Do a blend repair to the corrosion on the wing skin and the centreline strap (2), refer to SRM 51-70-01-00A-663A-A.

- (d) Remove the rivets as required to do the blend repair.
- (e) Use eddy current or ultrasonic inspection equipment to measure the remaining material depth in the areas you did the blend repair. The minimum material depths are as follows:

- Wing skin to front spar blend limit - 1,8 mm (0.071 in)
 - Wing skin area blend limit - 1,5 mm (0.059 in) depth
 - Centreline strap (2) blend limit - 1,5 mm (0.059 in) depthFor A/C MSN 101 thru MSN 313:

- Centreline strap (2) blend limit, centre aft - 1,8 mm (0.071 in)For A/C MSN 314 and Up:
 - Centreline strap (2) blend limit, centre aft - 1,9 mm (0.075 in).

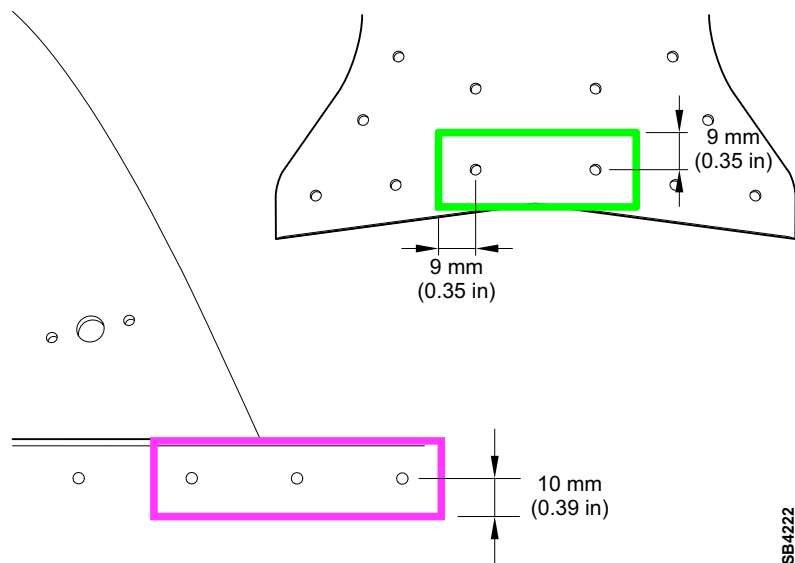
Inspection of Lower Wing Skin
Figure 1 (Sheet 5 of 8)

- (h) If there is still corrosion in the centreline strap (2) beyond the allowable oversized rivets, the strap is out of limits and must be replaced, continue to Para. 3.B.(4).

- Replace the centreline strap (2), continue to Para. 3.B.(4).
 - 3 If any of the wing skin areas are not within the blend limit, contact Pilatus Aircraft Ltd.

- Repair the lower wing fairing, continue to Para. 3.B.(8)
 - Do the close-up procedures, Para. 3.C.
- (4) Replace the centreline strap (2) (Ref. Sheet 5 and 6, Details C, D and E).

- (a) Remove a section of the support angle (3) for access (Ref. Detail E).

- 1 Use appropriate tools and remove a section of the support angle (3) in accordance with the dimensions given in Detail E.
 - 2 Remove the unwanted material and deburr all sharp edges from the support angle (3).

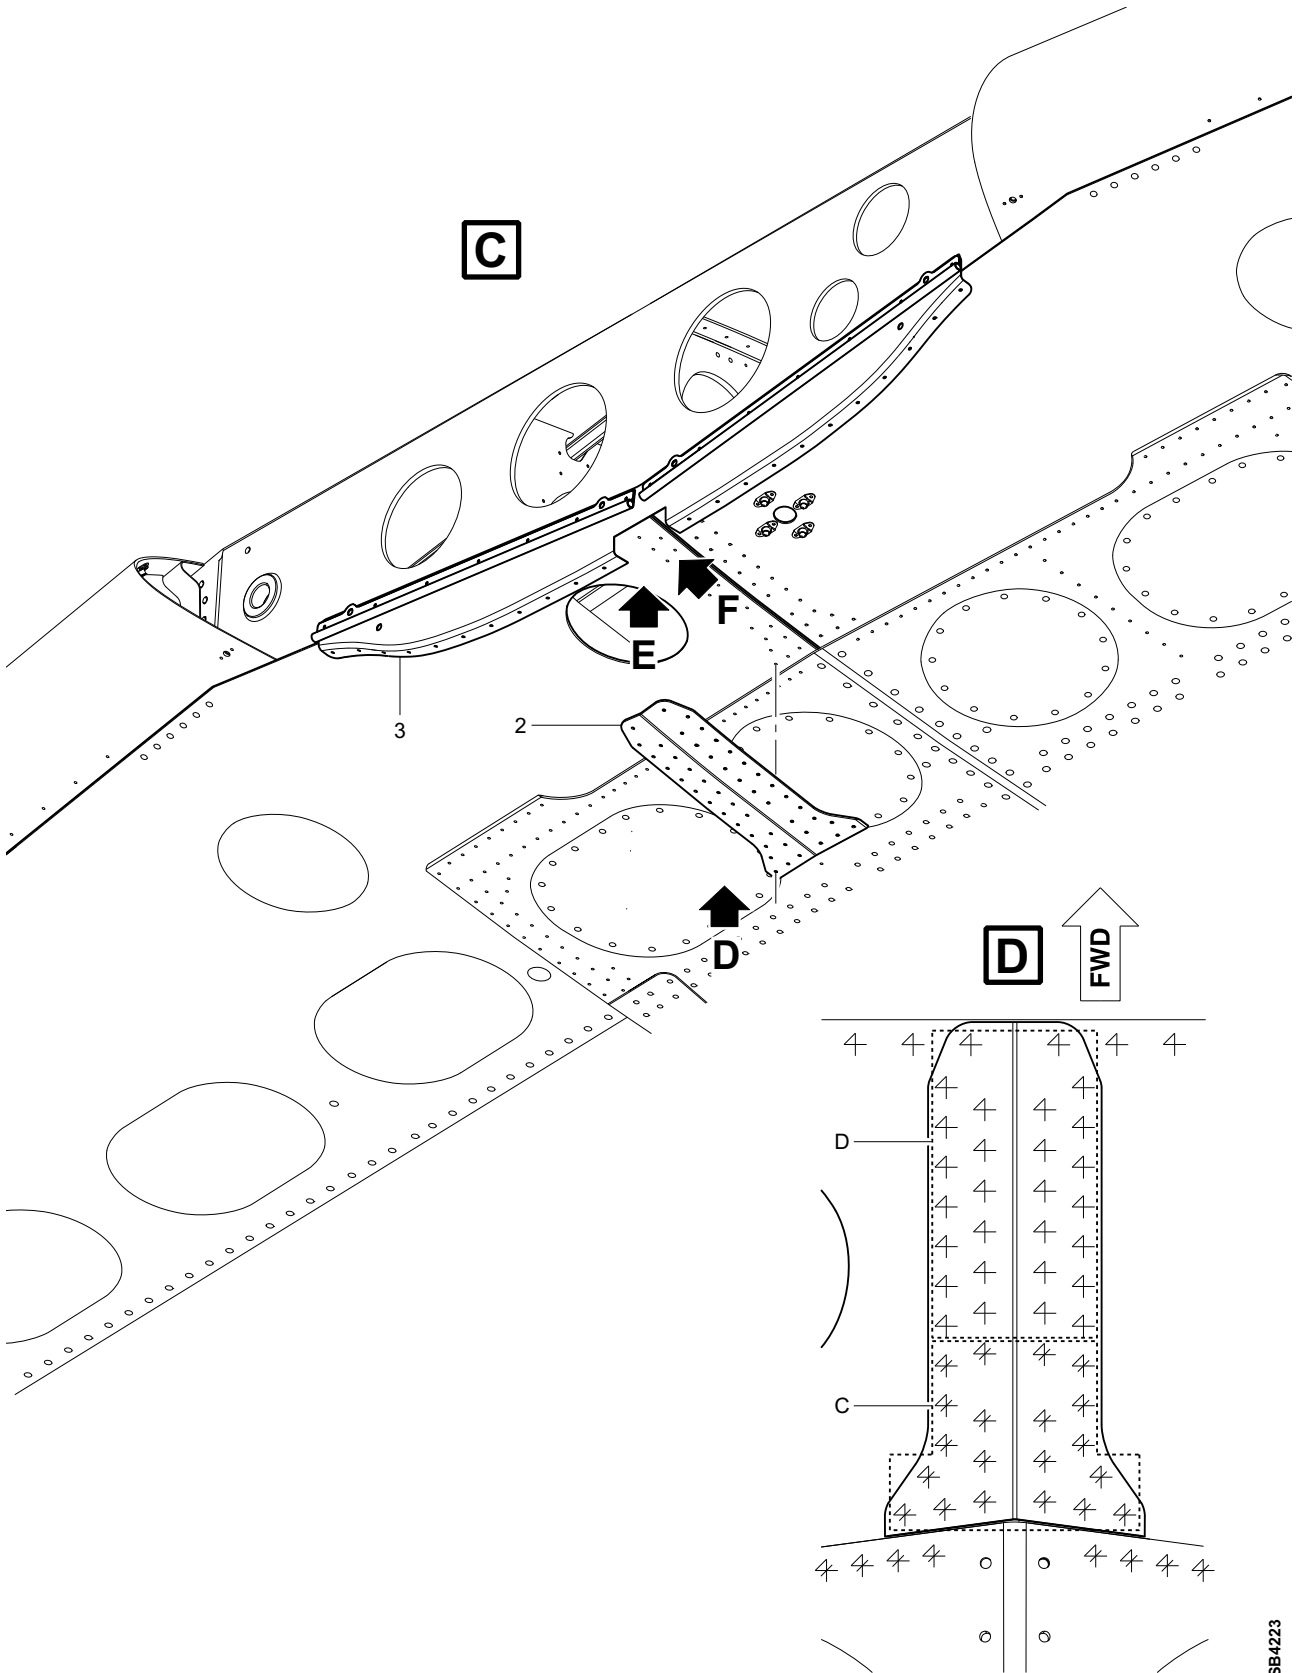
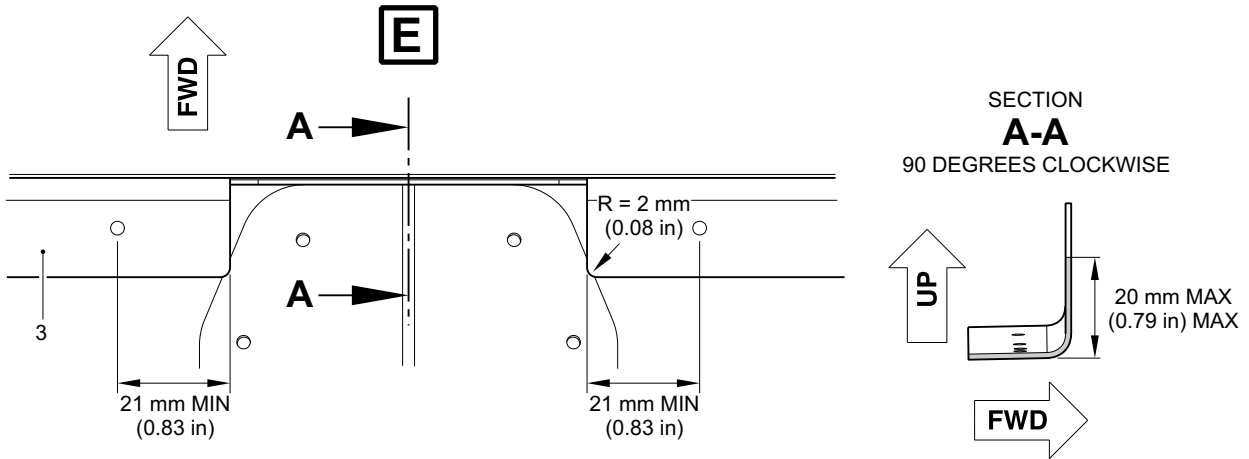
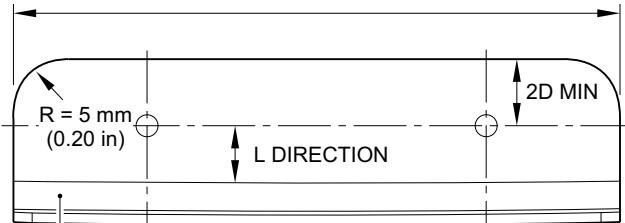
INFILL DIMENSIONS

CUT OUT DIMENSION MINUS BETWEEN 1 mm (0.04 in) AND 2 mm (0.08 in)

- (a) Use one of the items that follow to make the infill (5) to the dimensions given in Detail 'INFILL DIMENSIONS':
 - The metal from the cut-out you removed from the support angle in Para. 3.B.(4)(a)

- Make sure the infill (5) has the gaps given in detail 'INFILL DIMENSIONS' to the edge of the cut-out in the support angle.
- (c) Use a 10x magnification tool and a bright light source to do a visual inspection and make sure that there are no cracks on the outer bend radius.

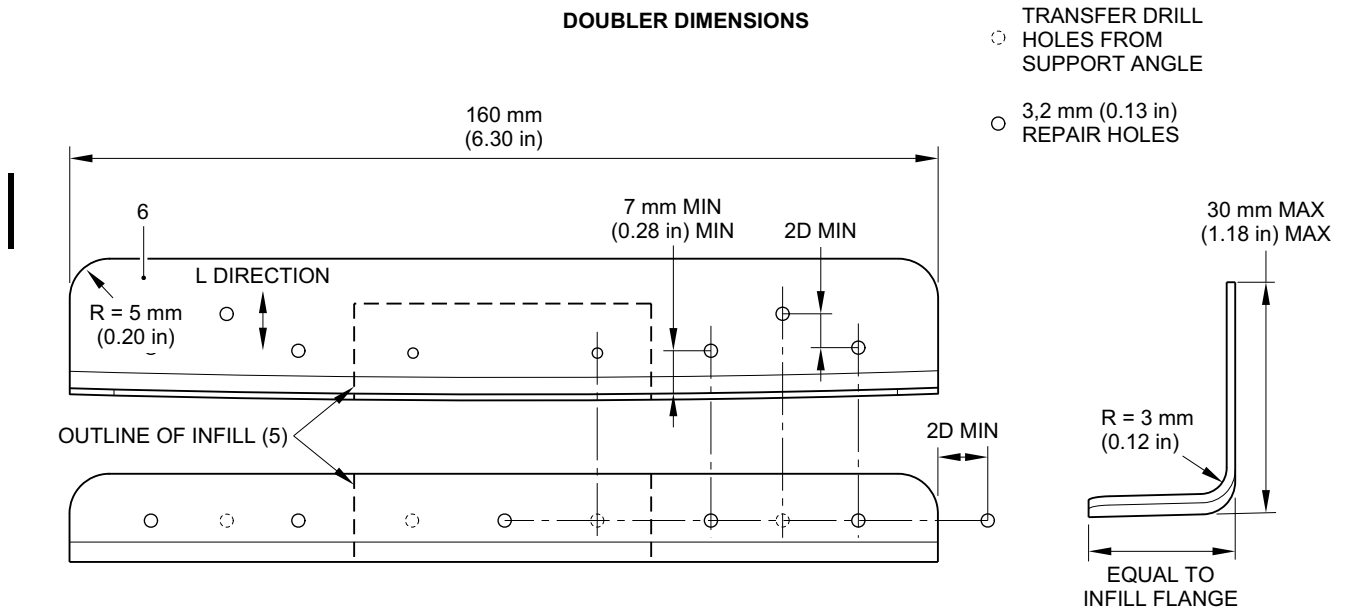
Inspection of Lower Wing Skin
Figure 1 (Sheet 7 of 8)

E SHOWN WITH DOUBLER (6) AND INFILL (5) ASSEMBLED ON SUPPORT PANEL (3)

- (o) Let the CCC solution dry.
- (p) Apply primer (Material No. P07-007) as necessary to the bare metal surfaces.
- (7) Install the repair items for the support angle (3) (Ref. Sheet 7, Detail E).

- (a) Apply a layer of interfay sealant (Material No. P08-106 or alternative) to the mating surfaces of these repair items:
- The support angle (3)
 - The infill (5)
 - The doubler (6).
- (b) Put the doubler (6) and the infill (5) in position on the support angle and hold in position with gripper pins (or equivalent) and clamps, as necessary.
- (c) Use interfay sealant (Material No. P08-106 or alternative) and install the rivets shown in Table 1:
- In rivet positions 'E'
 - The rivet (CR3223-4-02), P/N 939.19.86.102.
 - In rivet positions 'F'
 - The rivet (CR3224-4-02), P/N 939.31.86.301.

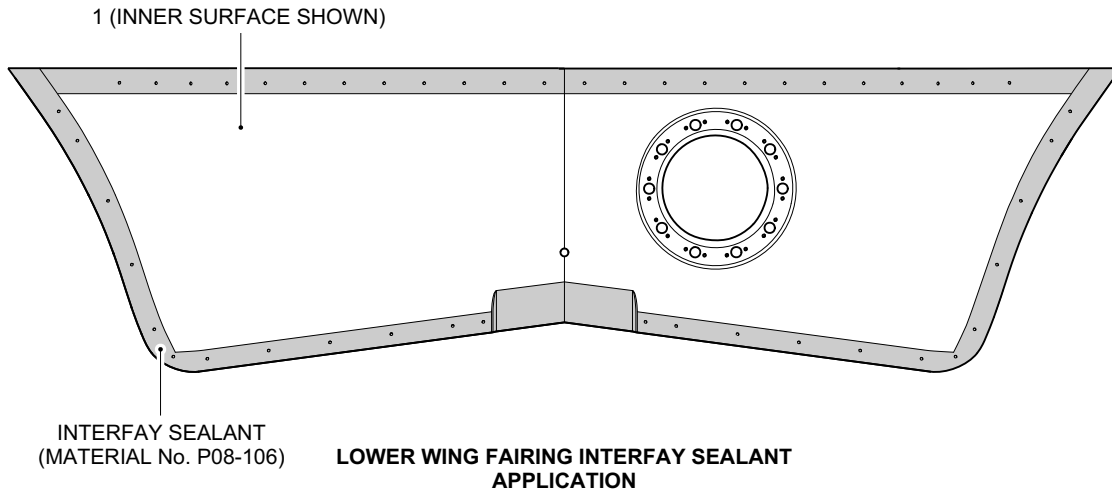
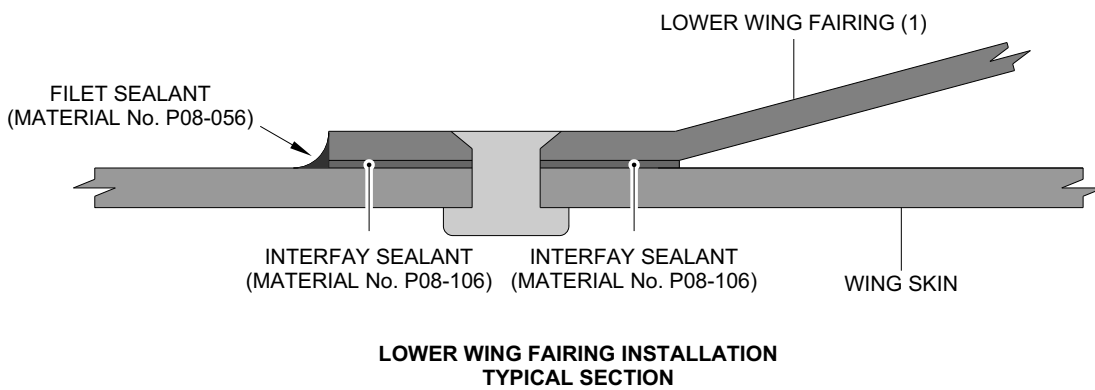
Inspection of Lower Wing Skin
Figure 1 (Sheet 8 of 8)

- (c) Apply CCC solution (Material No. P07-001) as necessary to holes in the lower-forward wing skin.
- (d) Do a visual inspection of the lower wing fairing (1) in the wing skin/support angle (3) interface areas for:
 - Ply damage
 - Raised folds in the material
 - Debris that has adhered to the surface.

NOTE: If you find damage, the lower wing fairing (1) (P/N 557.20.21.215) can be replaced, alternatively, do a repair. If you replace the lower wing fairing (1), make sure you restore the surface finish of the inner surfaces of the fairing (Ref. Para. (8)(f)).

- (d) Use sealant (Material No. P08-056) and apply a fillet seal around the edges of the infill (5) and the doubler (6).
- (e) Apply topcoat, snow white (Material No. P07-031) to these repair items:
- The support angle (3)
 - The infill (5)
 - The doubler (6).
- (f) Let the topcoat dry.
- (8) Repair the lower wing fairing (1) (Ref. Sheet 8).

- (e) Do a repair to the lower wing fairing (1) if you find any damage, refer to SRM 51-70-03-00A-663A-A. Make sure that any raised folds in the surface have been removed.
- (f) Use these materials to restore the surface finish of the inner surfaces of the lower wing fairing (1), refer to SRM 51-70-15-00A-663A-A:
 - Barrier primer (Material No. P07-016)
 - Epoxy primer (Material No. P07-037)
 - Topcoat, snow white (Material No. P07-031)
 - Topcoat, clear (Material No. P07-038).
