Service Bulletin No: 24-002
Modification No: EC-12-0028

Ref No: 71
ATA Chapter: 24

ELECTRICAL POWER - GENERAL**DO AN INSPECTION AND ADD A PROTECTIVE SLEEVE TO THE LEFT AND RIGHT WIRE LOOMS IN THE FRONT COCKPIT ADJACENT TO FRAME 10****1. Planning Information****A. Effectivity**

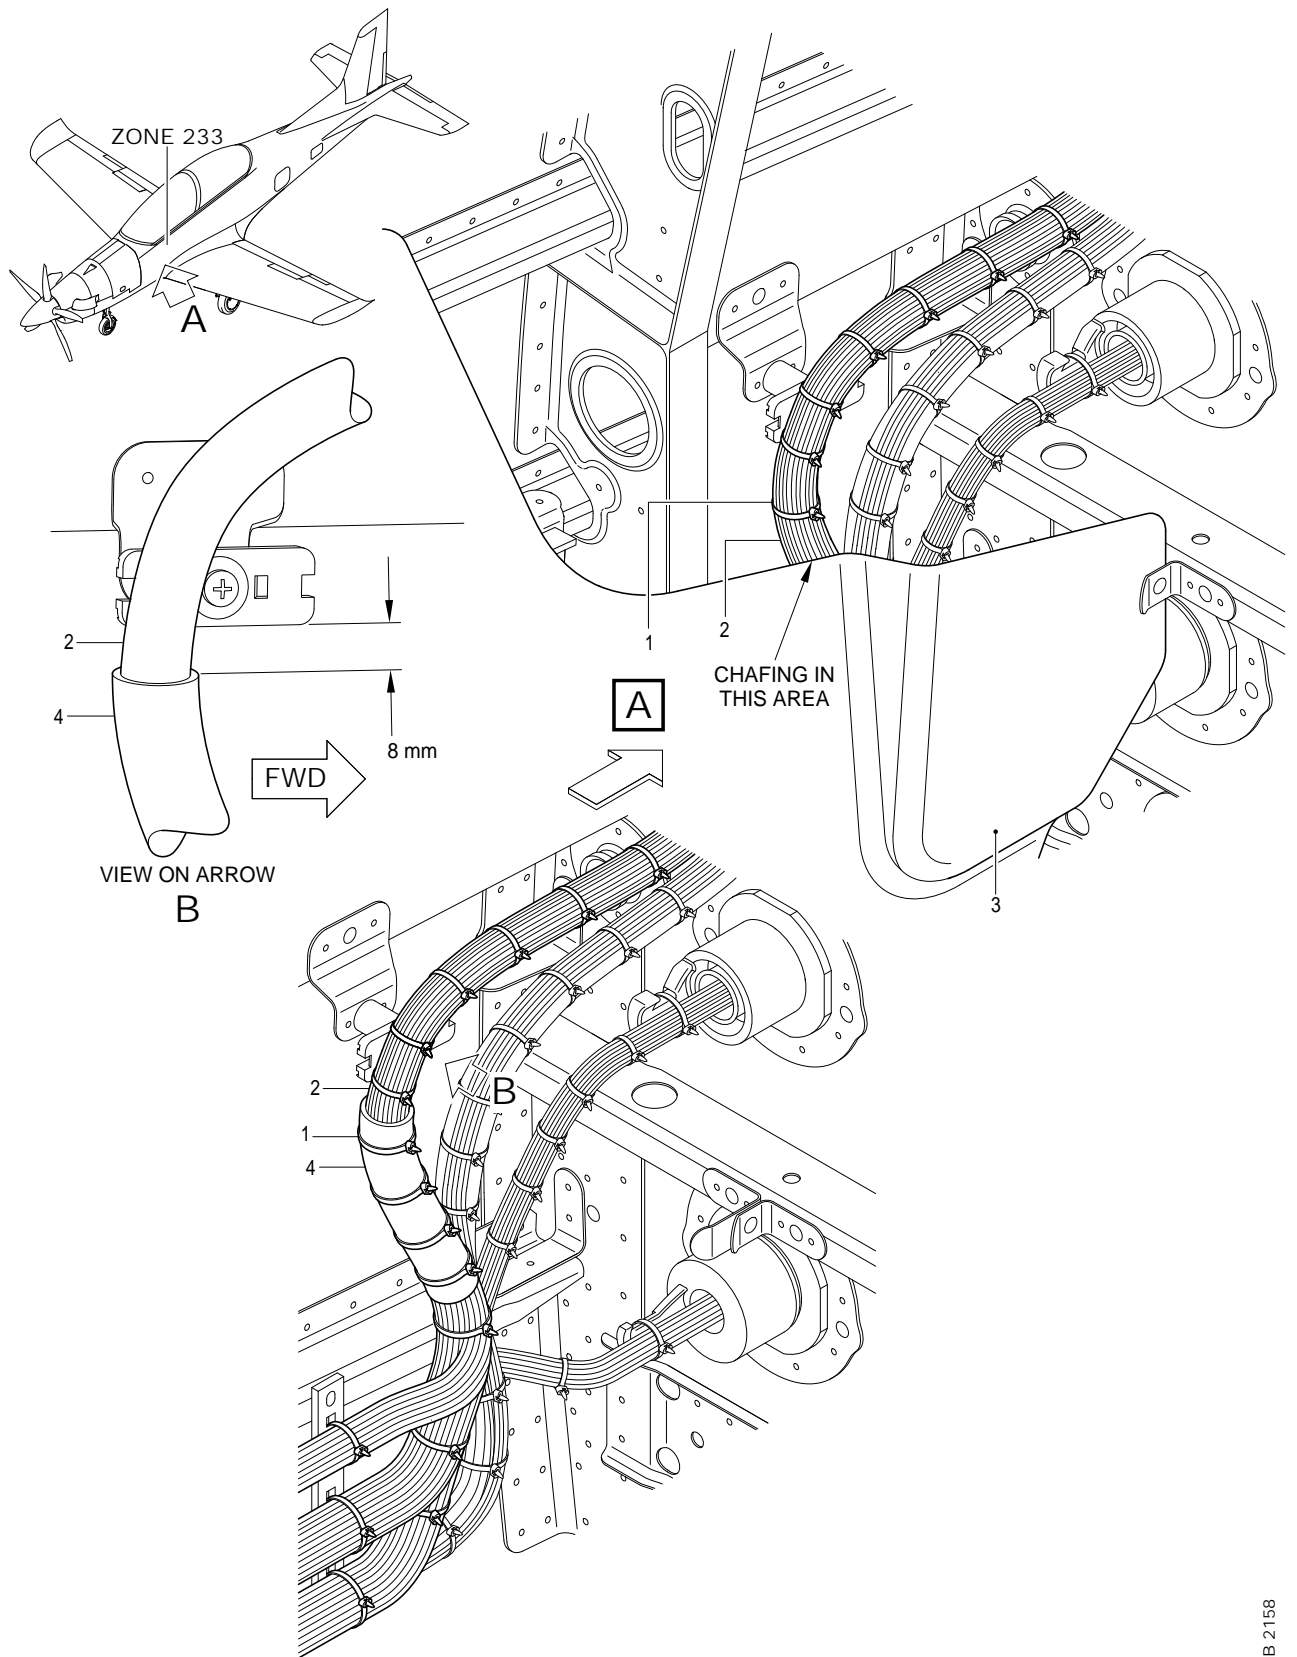
Inspection / Modification (Left Side)
Figure 1

Chafing has occurred between the wiring loom and the left hand side panel in the front cockpit.

Investigation has shown that, although there is sufficient clearance between loom and panel on new build aircraft, it can be reduced when the side panels are removed and installed during maintenance.

- (1) For the left side (Ref. Fig. 1)

- (a) Measure the clearance between the lower left forward panel (3) and the cable loom (2).
- (b) Tell Pilatus the actual clearance.
- (c) Remove the lower left forward panel (3).
- (d) Locate the cable loom (2) located adjacent to FR10 (Ref Detail A).
- (e) Remove the cable ties (1), as necessary, to free the wires in the affected area.
- (f) Inspect the wires on the outside of the loom (2) for signs of chafing.
- (g) Report all wires that show signs of chafing to Pilatus. If possible, give the wire number and the position of the chafing. Take photographs if possible. Wait for instructions from Pilatus before you return the aircraft to service.

- (1) For the left side (Ref. Fig. 1):
 - (a) Open the protection sleeve (4) (P/N 524.60.21.248) and put it in position around the cable loom (2) (Refer to Detail B). Make sure there are no cable ties beneath the protection sleeve (4) (P/N 524.60.21.248).
 - (b) Wrap the protection sleeve (4) (P/N 524.60.21.248) around the wires in the cable loom (2) and keep it in position with the cable ties (1) (Material No. P09-005, Material No. P09-008, and / or Material No. P09-014).
 - (c) Make sure the ends of the cable ties (1) (Material No. P09-005, Material No. P09-008, and / or Material No. P09-014) cannot cause damage to the adjacent wires and cables.

- (d) Install the lower left forward panel (3).
- (2) Do Paragraph 3.C.(1) to the right side (Ref. Fig. 2).

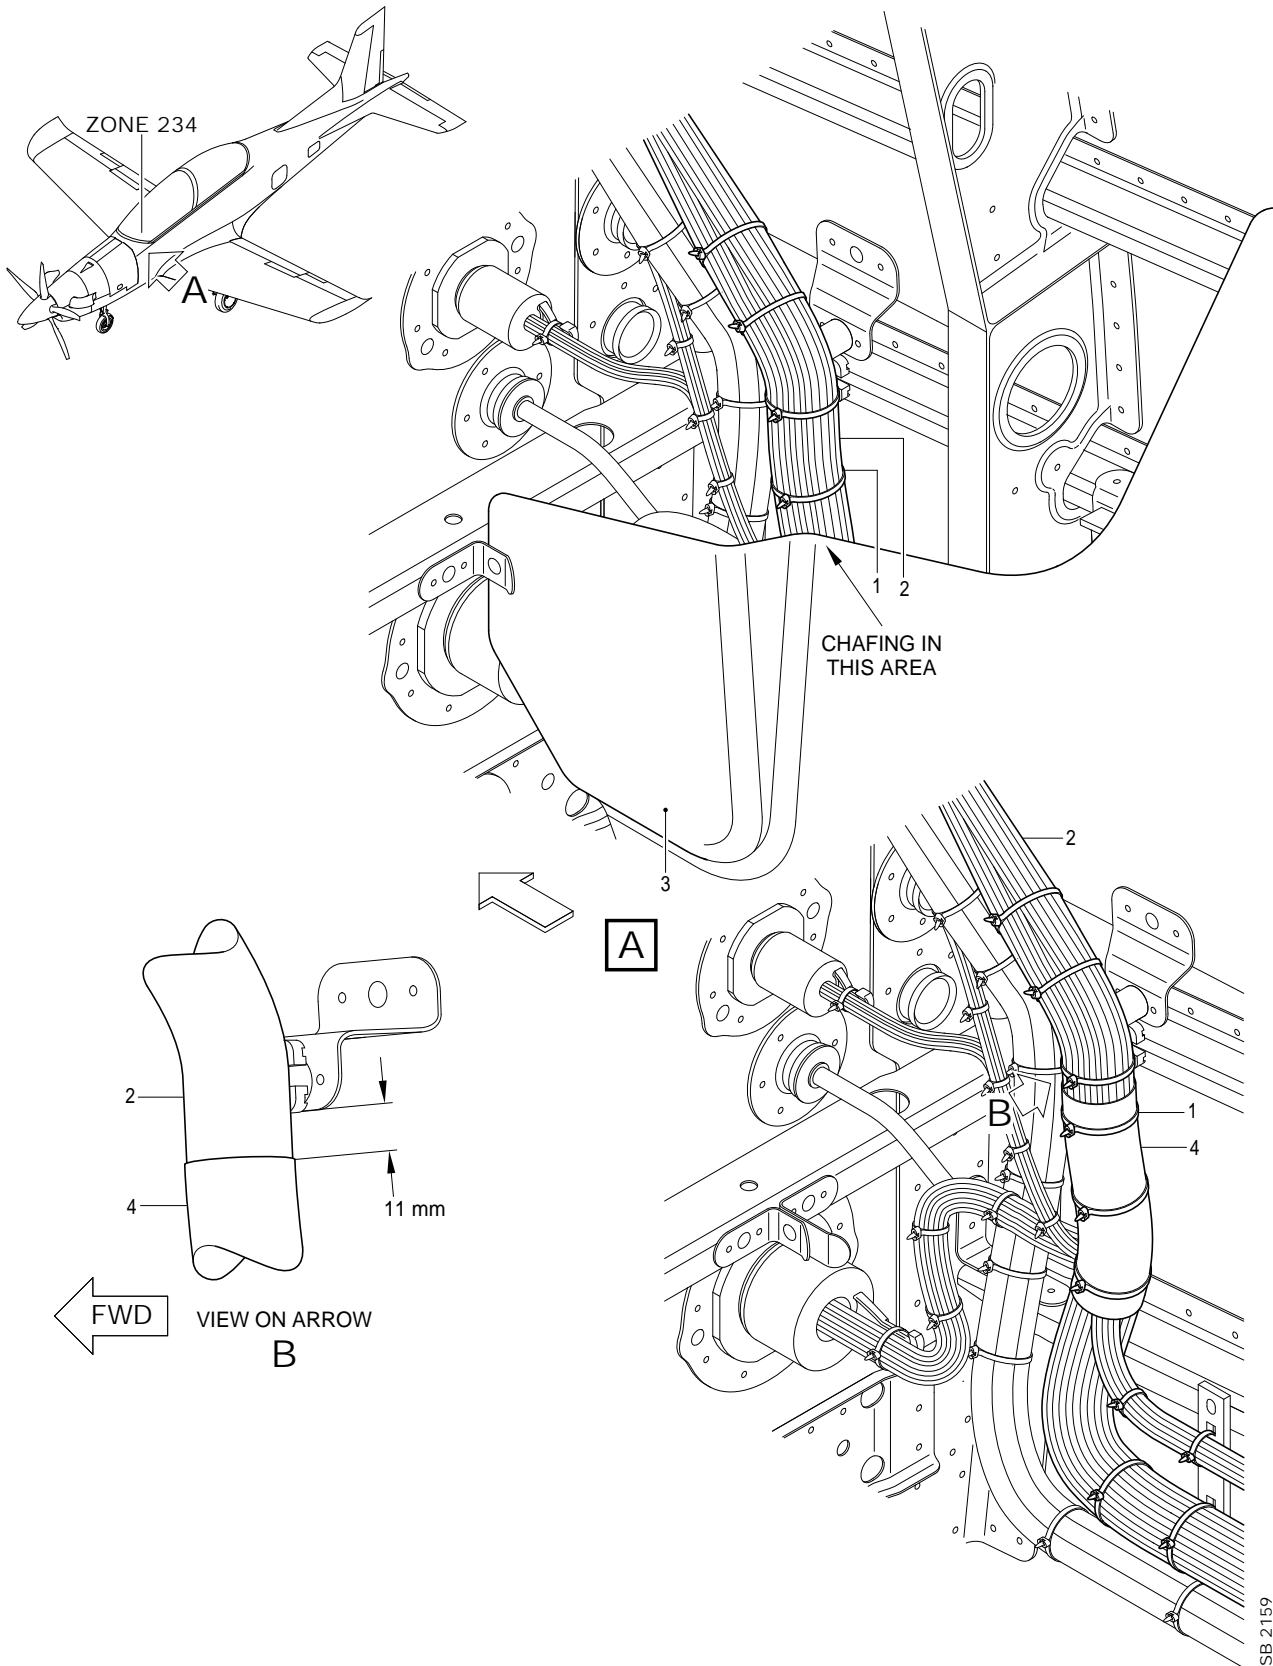
Inspection / Modification (Right Side)
Figure 2

- (2) For the right side (Ref. Fig. 2)

- (a) Measure the clearance between the lower left forward panel (3) and the cable loom (2).
- (b) Tell Pilatus the actual clearance.

- (c) Remove the lower right forward panel (3).
- (d) Locate the cable looms (2) located adjacent to FR10 (Ref Detail A).
- (e) Remove the cable ties (1), as necessary, to free the wires in the affected area.
- (f) Inspect the wires on the outside of the loom (2) for signs of chafing.
- (g) Report all wires that show signs of chafing to Pilatus. If possible, give the wire number and the position of the chafing. Take photographs if possible. Wait for instructions from Pilatus before you return the aircraft to service.
