Service Bulletin No: 27-009

ATA Chapter: 27

**FLIGHT CONTROLS - FLAPS
INSPECT THE LEFT AND RIGHT, INNER AND OUTER, FLAP HINGE BRACKETS****1. Planning Information****A. Effectivity**

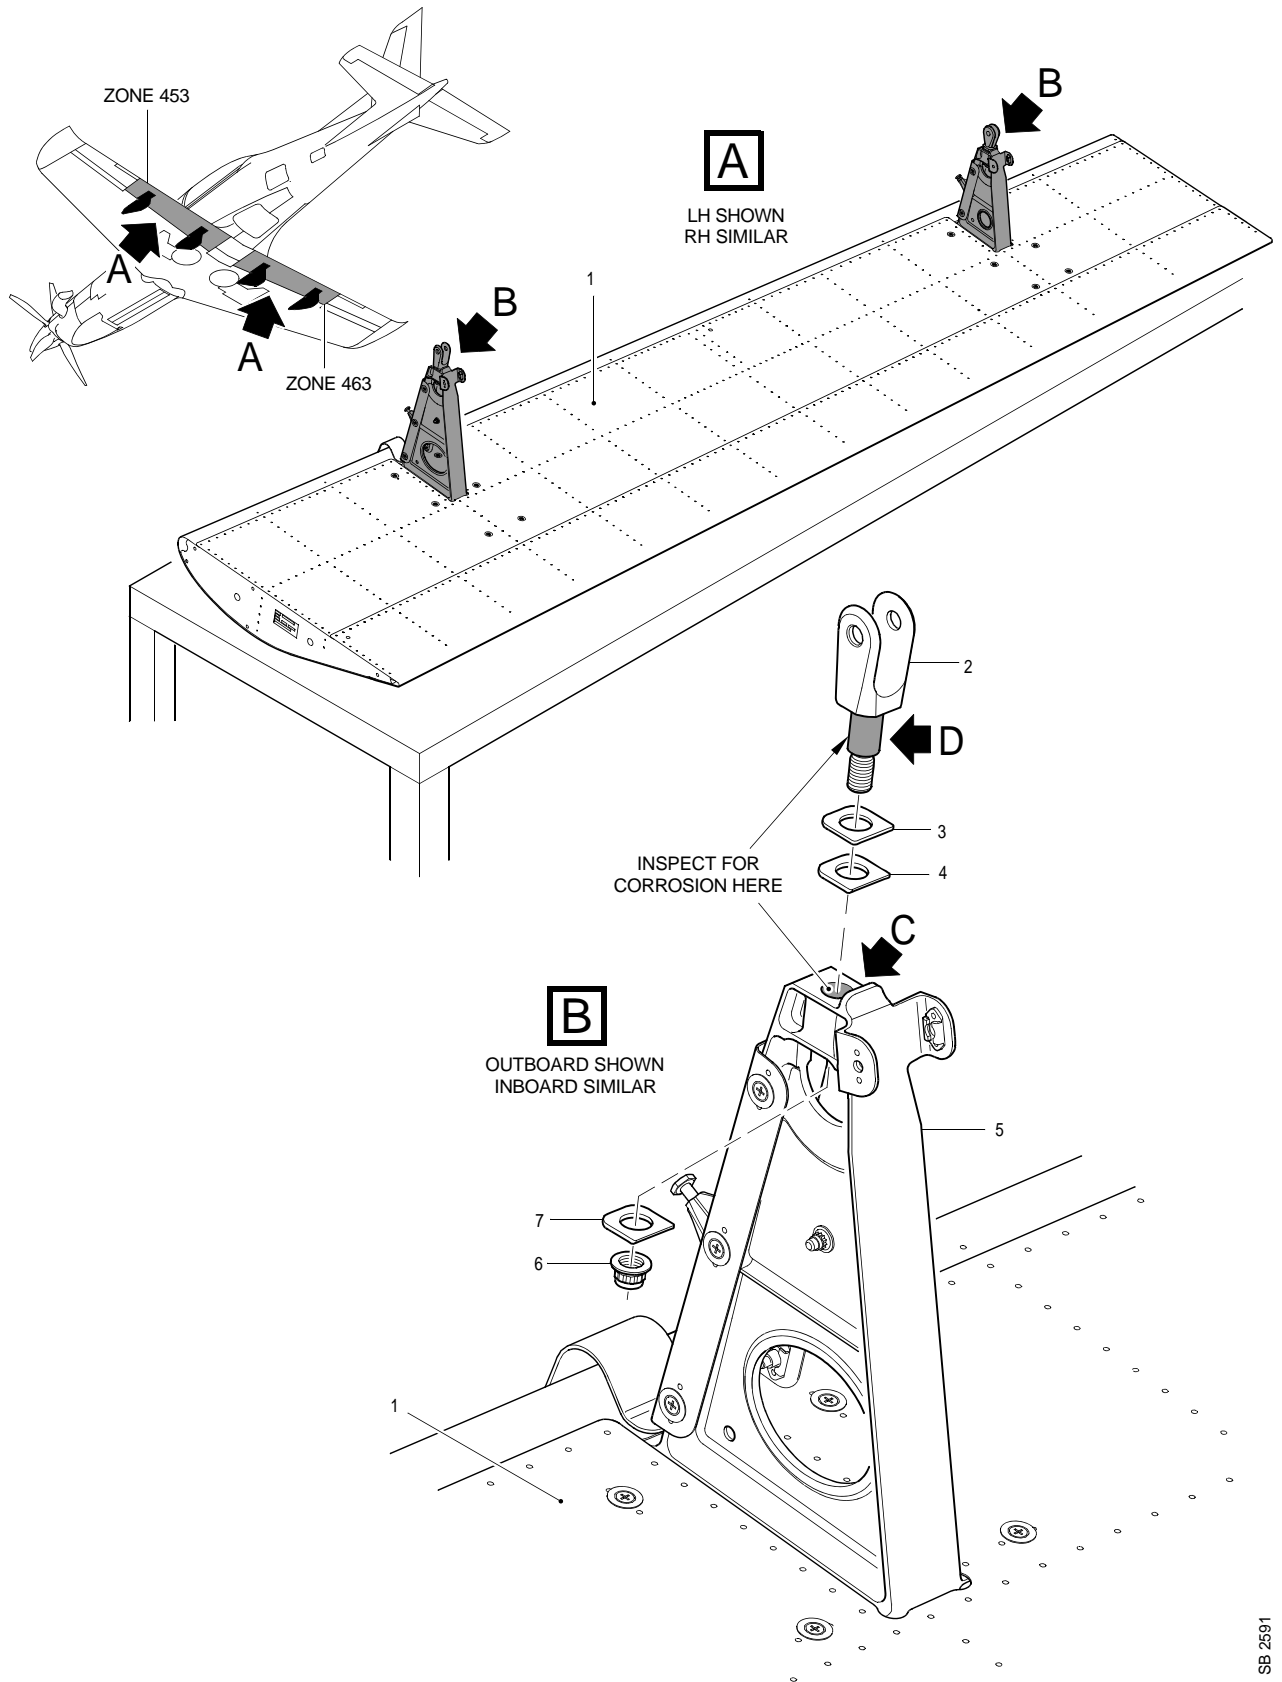
Inspection of the Flap Hinge Brackets
Figure 1, Sheet 1 of 2

Evidence of corrosion has been found in the flap hinge brackets.

- (e) Look for corrosion in the bore of the hinge bracket (5) and on the rod-end (2), as shown in Fig. 1 (Ref. SRM, 51-00-00-00A-284A-A).
- (2) Do Step 3.B.(1)(a) thru Step 3.B.(1)(e) again for:

- (a) Remove it (Ref. SRM, 51-20-01-00A-250A-A).
 - (b) After the corrosion has been removed:
 - 1 Measure the minimum diameter, in twelve positions, of the shank of the rod-end (2) as shown in Detail D and make a note of the dimensions in Table 1.

- a If the minimum diameter, at one of the twelve positions, is 12,699 mm or less, contact Pilatus Customer Technical Support (MCC), Fax: +41 (0) 41 619 67 73, Email: Techsupport@pilatus-aircraft.com.

- a If the maximum diameter, at one of the twelve positions, is 12.792 mm or more, contact Pilatus Customer Technical Support (MCC), Fax: +41 (0) 41 619 67 73, Email: Techsupport@pilatus-aircraft.com.
- b If the maximum diameter, at all of the twelve positions, is less than 12.792 mm, continue with this Service Bulletin from Step 3.B.(4).

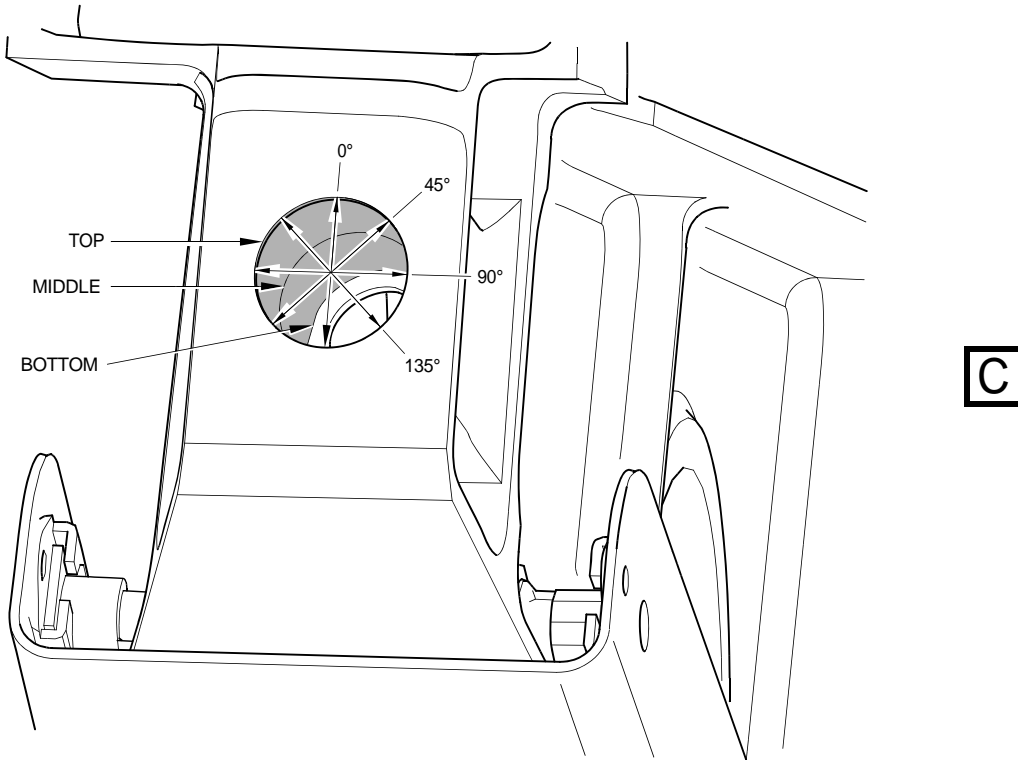
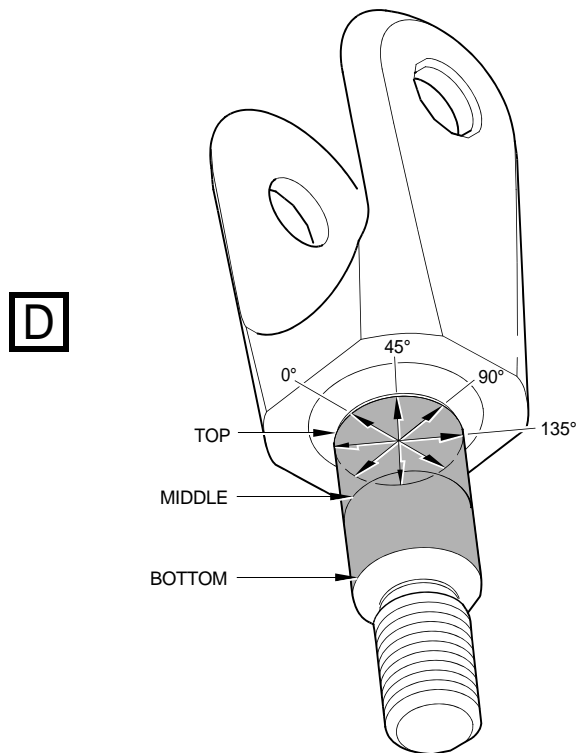
Inspection of the Flap Hinge Brackets
Figure 1, Sheet 2 of 2

- 2 Measure the maximum diameter, in twelve positions, of the bore of the hole in the inner flap-hinge bracket (5) as shown in Detail C and make a note of the dimensions in Table 2.
