Service Bulletin No: 71-005
Modification No: INSPECTION

POWER PLANT - GENERAL

DO A CHECK OF THE BATCH NO. OF THE SHOCK MOUNTING BOLTS AND REPLACE, IF NECESSARY

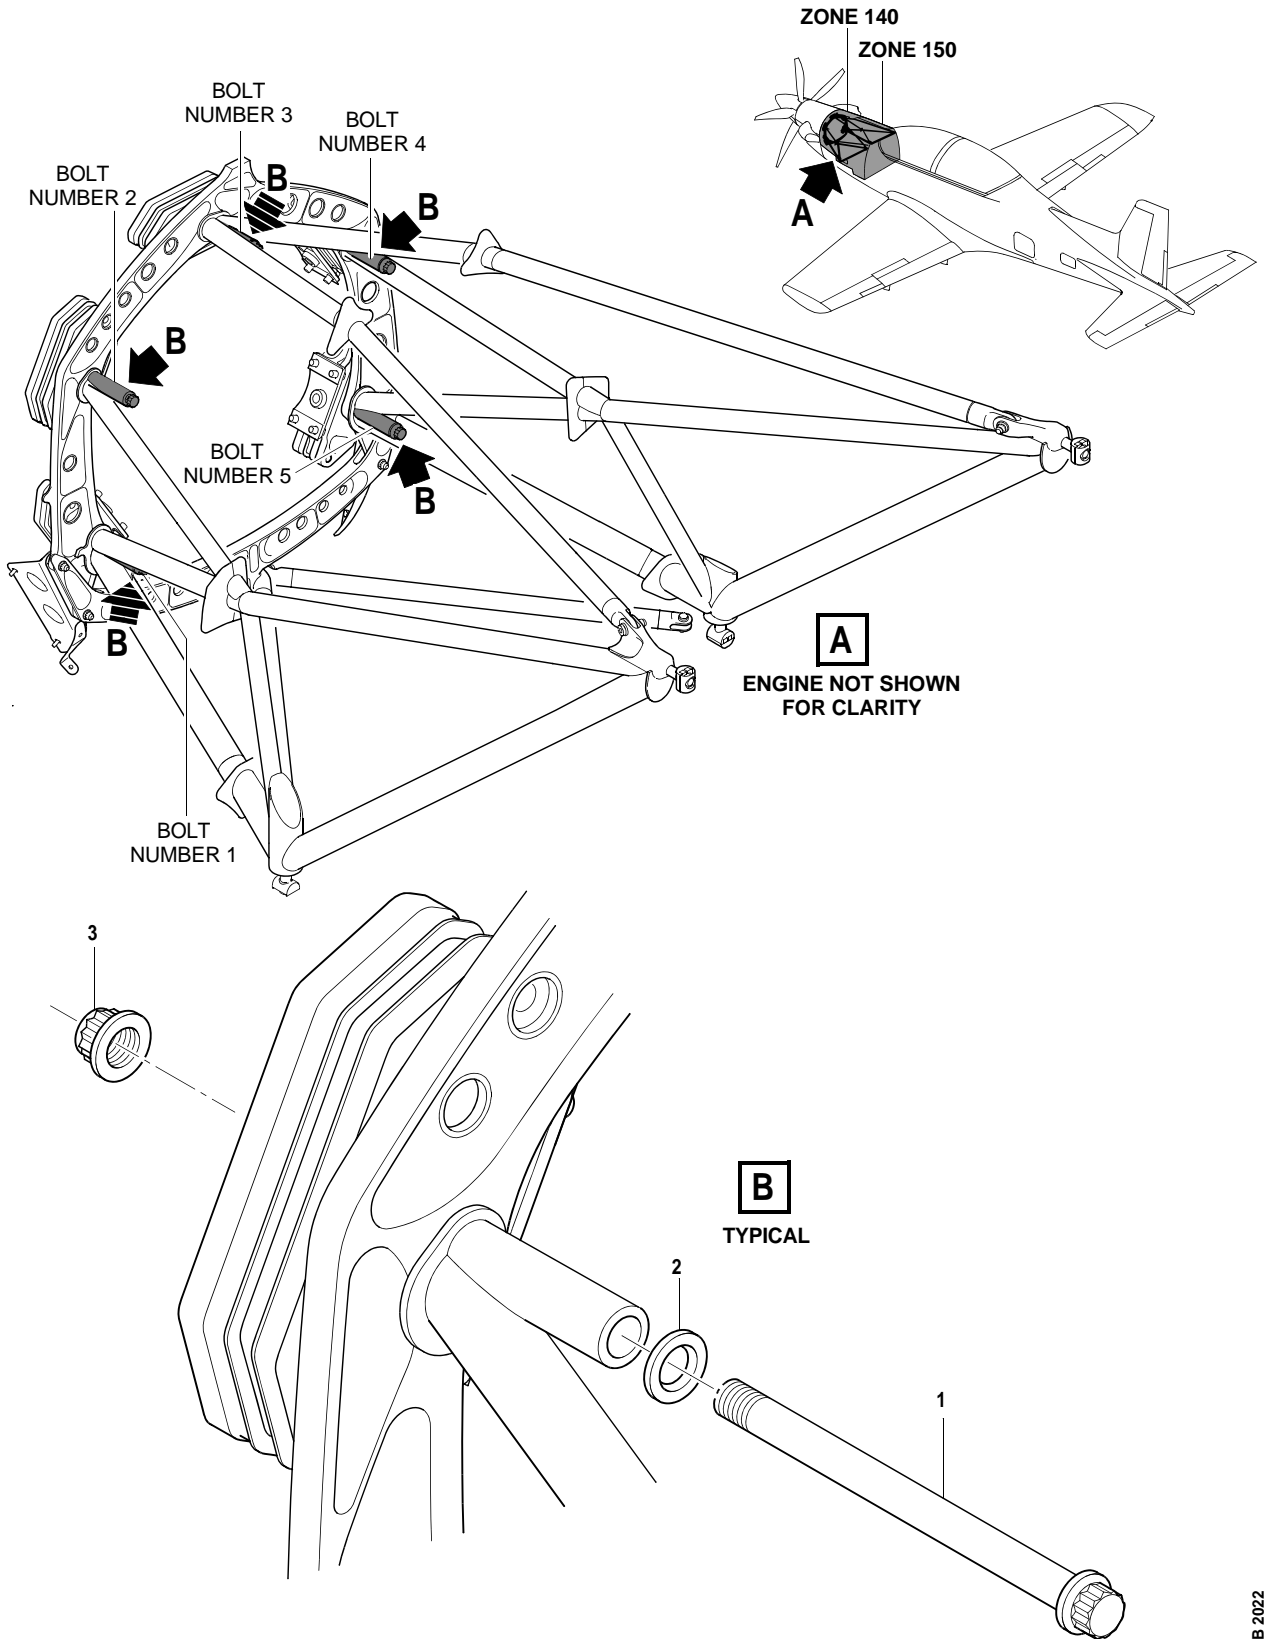
Replacement of the Shock Mount Bolts
Figure 1

An Operator has reported that during an unscheduled engine removal on one of his aircraft, one of the shock mount bolts (P/N 571.20.21.066) had lost the cadmium plating at some locations. The bolt has been traced to a certain batch and are manufactured with a vacuum plating process.

Look on the head of each of the five bolts (1).

- (1) If the batch number on the one or more bolts is 415196, continue with the Service Bulletin from Para. 3.C. for the bolts with a batch number of 415196.
- (2) If none of the bolts (1) have the batch number 415196, continue with the Service Bulletin from Para. 3.D(7).

Replace the shock mount bolts (P/N 571.20.21.066) with bolts from a known good batch.

- (12) Remove an affected bolt number:
 - (a) Remove the nut (3).
 - (b) Remove the bolt (1) and the washer (2).
 - (c) Discard the nut (3) and the washer (2).

- (i) Install the new nut (3) (P/N 938.09.14.308) with your fingers as far as possible.
- (15) Do Para 3.C.(11) thru (14) for the remaining affected bolts but do not remove more than one bolt (1) at a time.

- (16) Torque the attachment nut:
- (a) Add the run-down torque you noted at Para 3.C.(12)(f) to 92.5 Nm (819 lb.in.).
 - (b) Torque the new nut (3) (P/N 938.09.14.308) to the torque calculated in Para. 3.C.(16)(a) \pm 2.5 Nm (22 lb.in.).
