**Service Bulletin No: 25-005****Ref No: 60****Modification No: EC-19-0147****ATA Chapter: 25****EQUIPMENT AND FURNISHINGS - STANDARD CABIN CONFIGURATION  
UPPER PANEL ASSEMBLY, EMERGENCY EXIT - REPLACEMENT OF THE GROMMETS****1. Planning information****A. Effectivity**

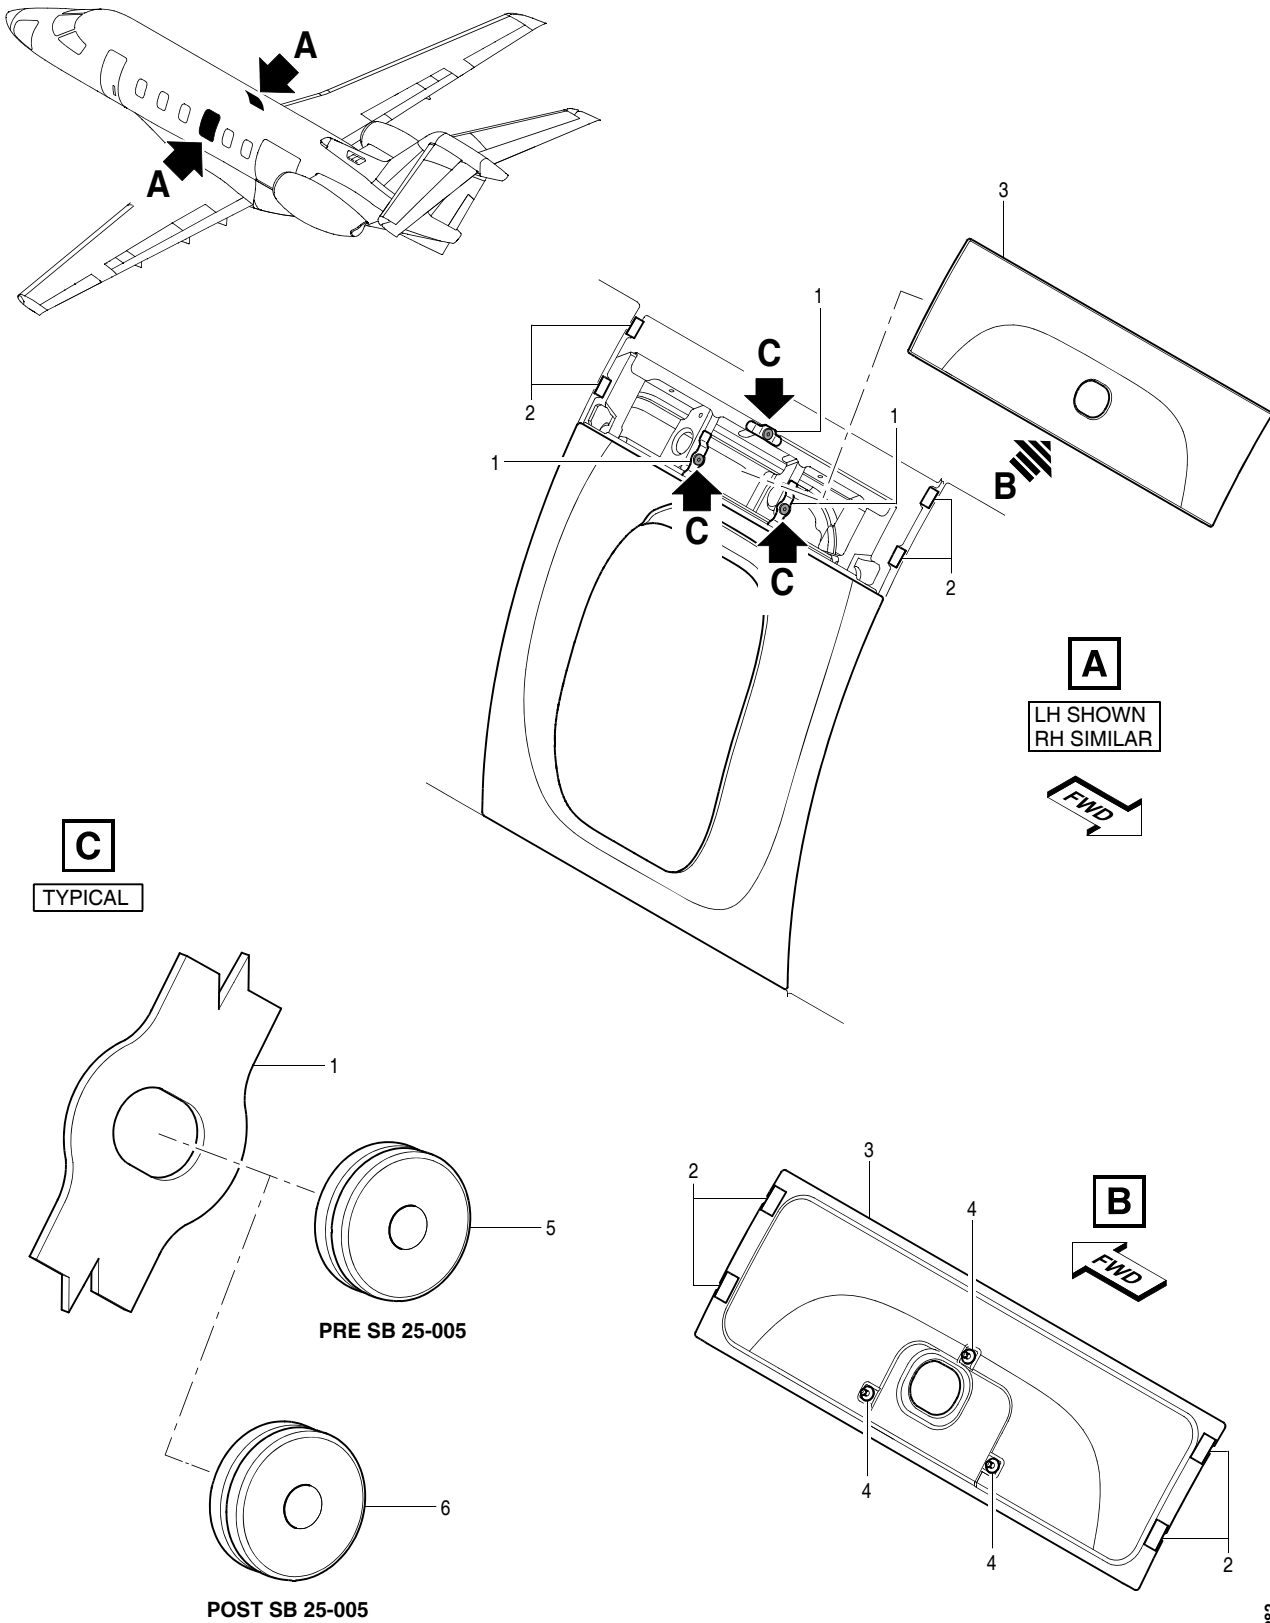
Replacement of the grommets  
Figure 1

A quality escape has been identified with the vinyl grommets that are used to hold the upper panel assembly in position on the LH and RH emergency exits. These grommets become rigid at low temperatures and make it difficult to remove the upper panel assembly.

- (1) Release the two hook-and-loop tape fasteners (2) at the fwd and aft side of the upper panel assembly (3).
- (2) Pull the upper panel assembly (3) to disengage the three panel pins (4) from the grommets (5).
- (3) Remove the upper panel assembly (3).
- (4) Remove and discard the three grommets (5) (P/N 944.87.32.001) from the upper panel brackets (1).
- (5) Install the three new grommets (6) (P/N 525.26.24.035) on the upper panel brackets (1).
- (6) Apply a thin layer of grease (Material No. P04-030) to the three panel pins (4).

- (7) Put the upper panel assembly (3) in position and engage the three panel pins (4) with the grommets (6).
- (8) Make sure that the two hook-and-loop tape fasteners (2) at the fwd and aft side of the upper panel assembly (3) are attached.
- (9) Do the above procedure again to replace the three grommets (5), for the upper panel assembly (3), on the other side of the aircraft.
