Pilatus Aircraft Ltd, Pilatusstrasse 1, 6371 Stans, Switzerland

Service Bulletin No: 27-009 Ref No: 221

## FLIGHT CONTROLS - YAW CONTROL RUDDER TRIM TAB, SHORT CONTROL RODS - THREADED BOLT REPLACEMENT

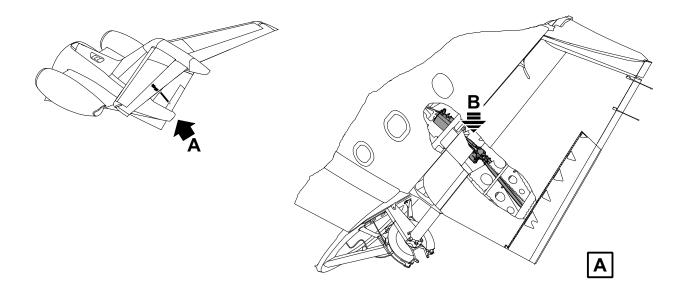
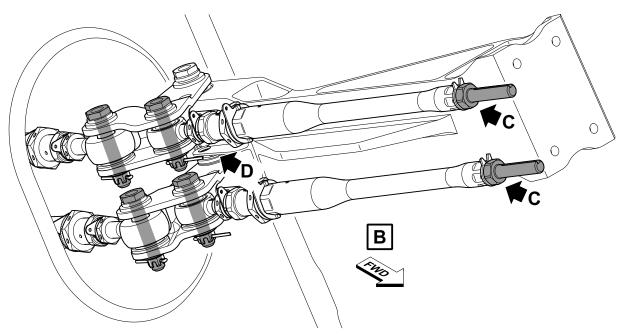
Rudder trim actuator control rods - Inspection Figure 1 (Sheet 1 of 2)

Pilatus has become aware that the titanium threaded bolts at the forward end of the short rudder trim tab actuating rods may be subject to oscillating loads due to aerodynamic forces acting on the trim tab. This condition, if not detected and corrected, could lead to bolt failure, possibly resulting in loss of the rudder control.

- (3) Do the rudder trim actuator remove procedure. Refer to AMM PC24-A-E27-20-0006-00A-520A-A and Figure 1.
  - **NOTE:** When you do the above referenced AMM procedure, make sure that the two rudder-trim-tab short control-rods (1) are removed (and kept) from the rudder trim actuator.

- (c) Do a visual inspection of the four bellcrank bolts (4), (5), (6), and (7) for damage and fretting.
  - (d) Return bellcrank bolts with damage to Pilatus Aircraft Ltd.

- (e) Record the position that bolts with damage were removed from.
  - (f) Record the visual inspection results on the Pilatus feedback sheet.
- (4) Remove the two threaded bolts (3) and the two lock washers (2) from the two rudder-trimtab short control-rods (1).

- (10) Install the two new threaded bolts (3) and the two new lock washers (P/N 938.83.12.001) (2) on the two rudder-trim-tab short control-rods (1) (that you kept).

- (11) Torque the two threaded bolts (3) to between 66 and 75 lbf in (7.5 and 8.5 Nm) plus the run-down torque.
- (12) Safety the threaded bolts (3) with the two lock washers (2).
