SERVICE BULLETIN

NO: 118

Inboard Fuel Tank Vent System

PILATUS AIRCRAFT LTD.

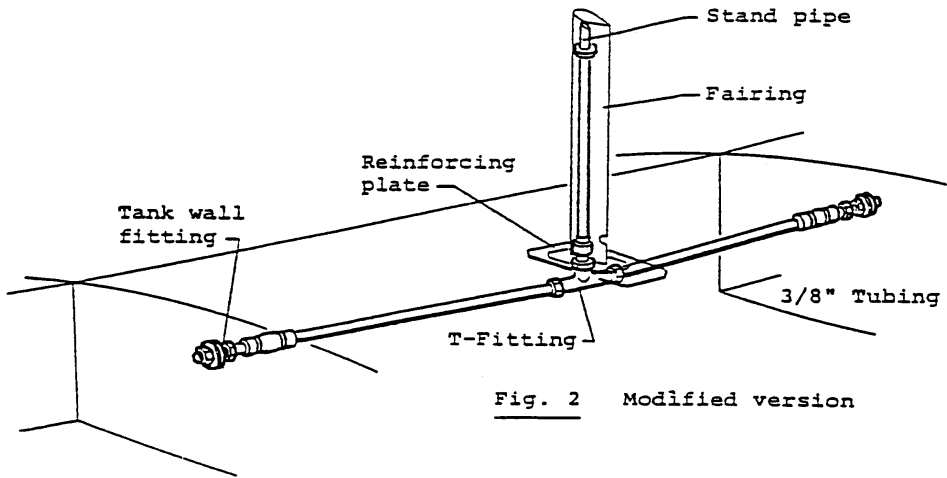
Fig. 2 Modified version

1.2 Reason: Introduction of an improved inboard fuel tank ventilating system, which is less susceptible to icing and provides symmetrical fuel feed in the event of clogged vent valves.
