SERVICE BULLETIN NO: 27-001

ATA CHAPTER: 27

FLIGHT CONTROLS - AILERON CONTROLS BELLCRANK ASSEMBLIES - INSPECTION AND REPLACEMENT OF BEARING HOUSINGS

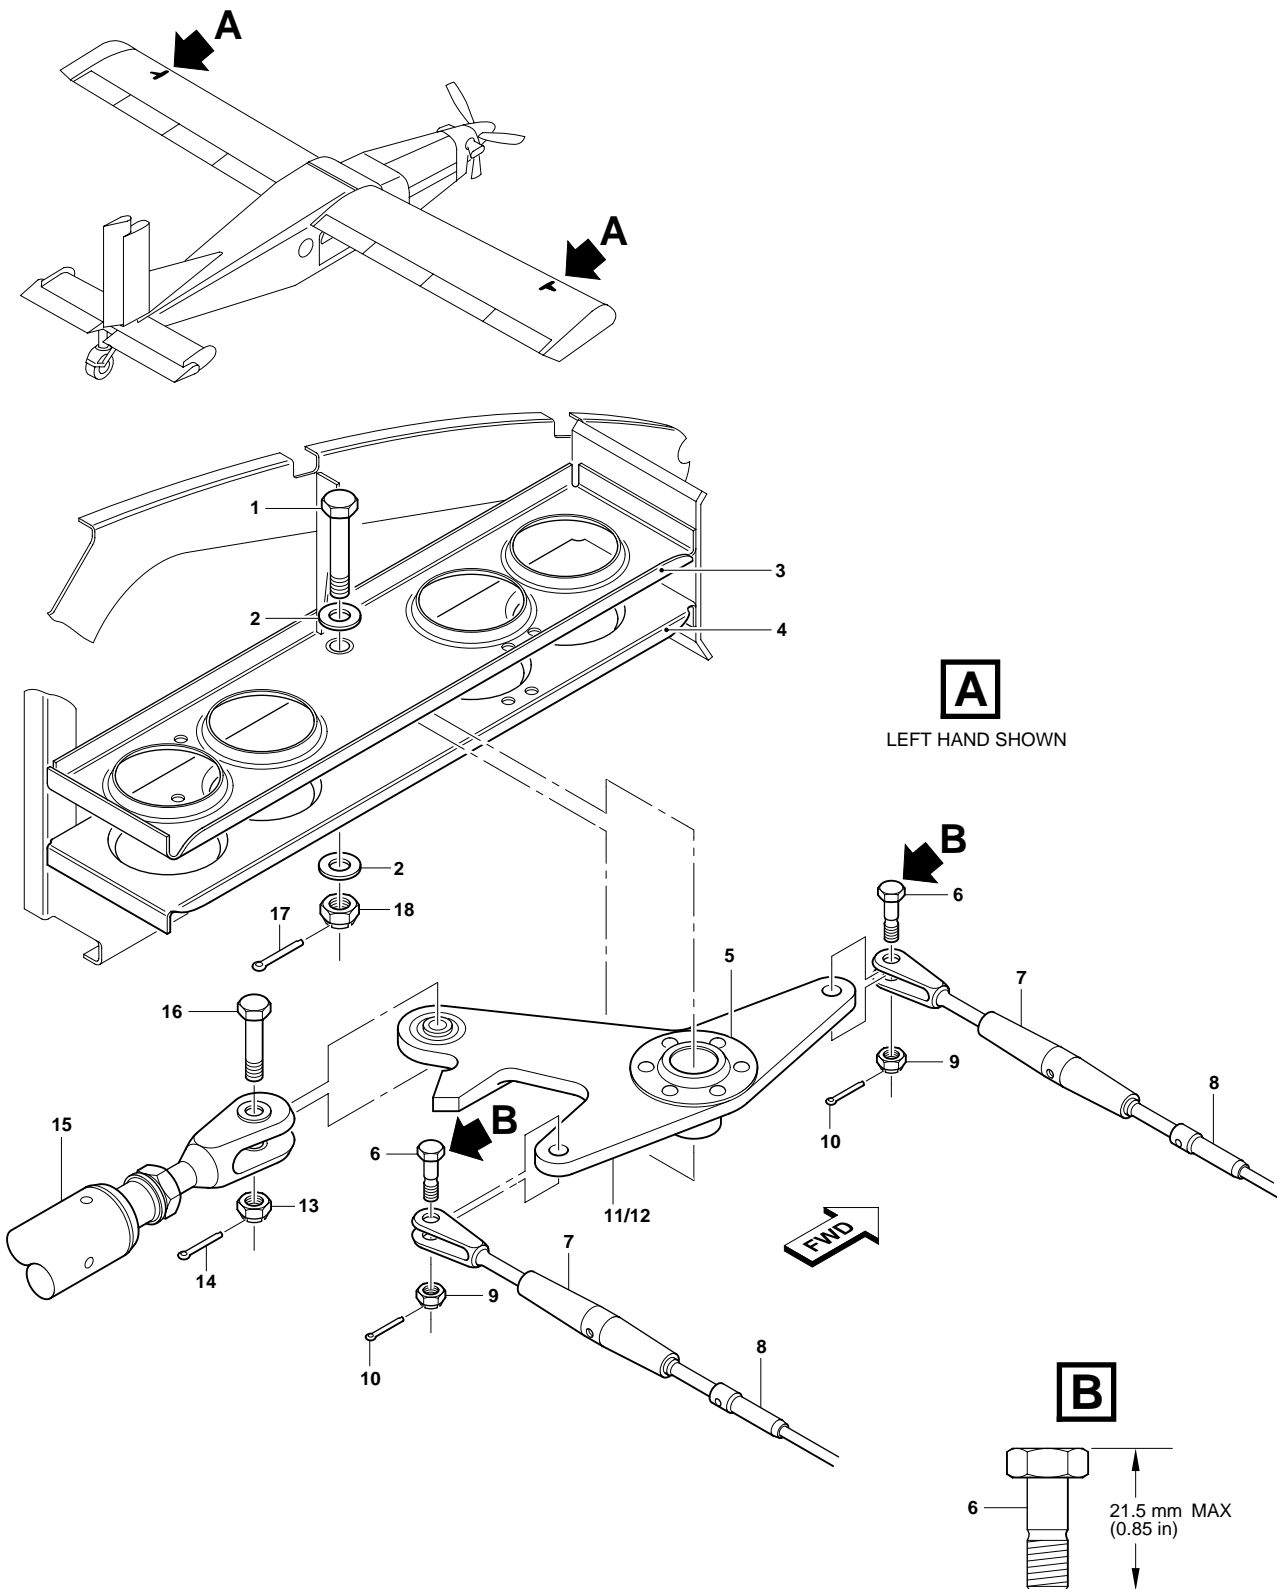
Wing Bellcrank and Housing Assemblies - Inspection and Replacement
Figure 1

- (1) Do an inspection of the wing bellcranks and related components (Ref. Fig. 1).
 - (a) Do an inspection of the housings (5) for wear, damage and signs of axial movement of the bearings in the housings. Worn or damaged bearings are not permitted. Axial movement of serviceable bearings in the housings is permitted (Ref. Para D).
 - (b) Do an inspection of the bolts (6) for signs of rub damage on the heads. No damage is permitted.
 - (c) Do a check of the bolts (6) for correct length. Discard bolts that have a total length of more than 21,5 mm (0.85 in.).

NOTE: It is not sufficient to do a check of the bolt part numbers. This is because it is possible for bolts of different lengths to have the same identification.
 - (d) Do an inspection of the support plate (3) for signs of rub damage caused by the bolts (6). Apply to PILATUS for repair instructions if you find damage.
- (2) Do an inspection of the housing (8, Fig. 2) for wear, damage and signs of axial movement of the bearing in the housing. A worn or damaged bearing is not permitted. Apply to PILATUS for a repair procedure if you find signs of axial movement of a bearing in the housing.

- (1) Loosen the control cables of the left aileron (Ref. Fig. 1).
 - (a) Remove and discard the lock wire from the turnbuckles (7).
 - (b) Turn the turnbuckles (7) until the control cables (8) are loose.
- (2) Remove the left aileron bellcrank.
 - (a) Remove and discard the cotter pins (10), (14) and (17).
 - (b) Remove the nuts (9) and bolts (6) to disconnect the fork ends of the turnbuckles (7) from the bellcrank (11).
 - (c) Remove the nut (13) and bolt (16) to disconnect the fork end of the control rod (15) from the bellcrank (11).
 - (d) Remove the nut (18), bolt (1) and washers (2) to disconnect the bellcrank (11) from the support plates (3) and (4).
- (3) Do Step (1), (a) & (b) and Step (2), (a) thru (d) again to remove the right aileron bellcrank (12).

- (1) Install the left aileron bellcrank (Ref. Fig. 1).
 - (a) Obey the manufacturers instructions and apply a thin layer of the grease (Item No. P04-002) on the applicable surfaces of the bolts (2), (6) and (15).

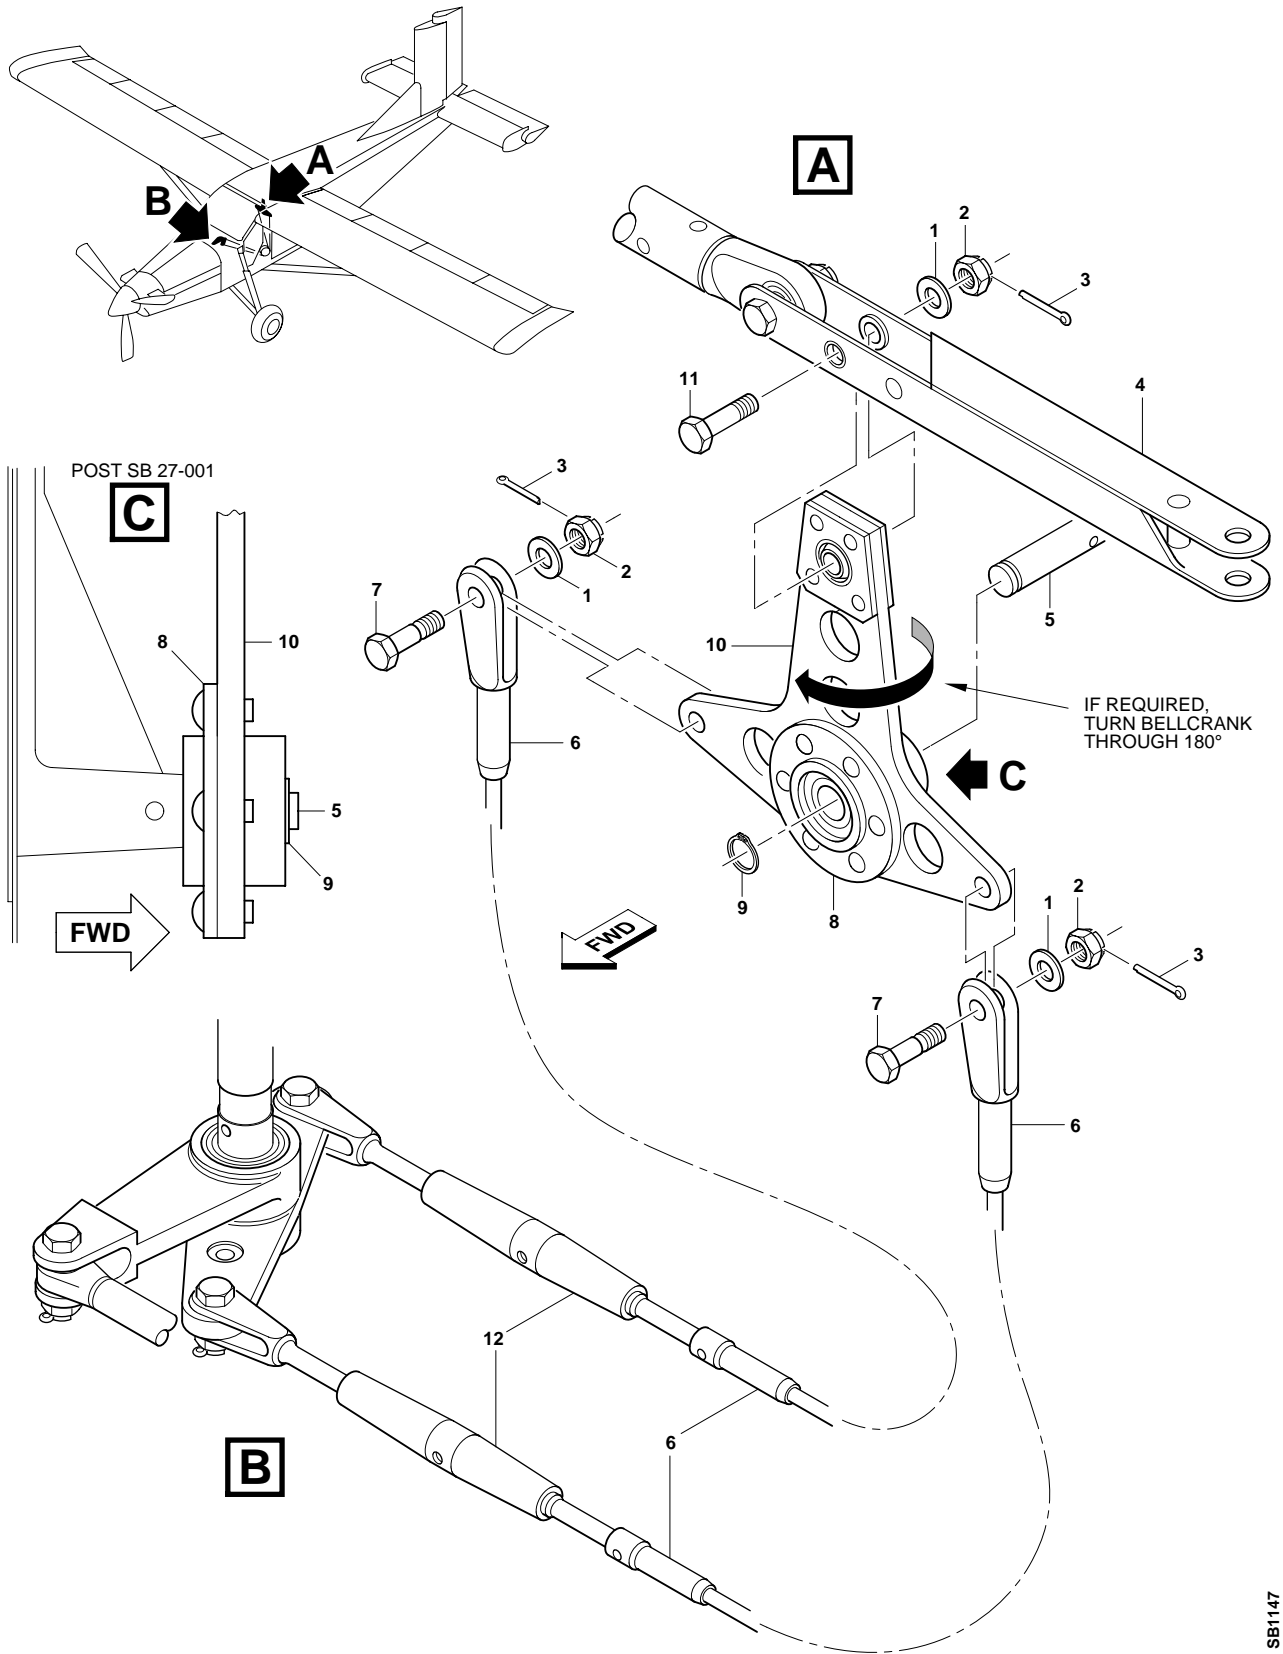
Fuselage Bellcrank and Housing Assembly - Inspection and Installation
 Figure 2

- (6) Do an inspection of the bellcrank (10, Fig. 2) for correct installation. The bellcrank is installed correctly if the surface with the flange of the housing (8) is to the rear.

NOTE: It is possible for the bellcrank (10) to be installed with the surface (which has the flange of the housing (8)) to the front or to the rear.

- (4) Remove the bellcrank from the fuselage (Ref. Fig. 2). This step is only applicable if the surface of the bellcrank which has the flange of the housing (8) is installed to the front (Ref. Para A, Step (5)).
 - (a) Remove and discard the lock wire from the turnbuckles (12).
 - (b) Turn the turnbuckles (12) until the control cables (6) are loose.
 - (c) Remove and discard the cotter pins (3).
 - (d) Remove the nuts (2), washers (1) and bolts (7) to disconnect the fork ends of the control cables (6) from the bellcrank (10).
 - (e) Remove the nut (2), washer (1) and bolt (11) to disconnect the bellcrank (10) from the push rod assembly (4).
 - (f) Remove the circlip (9) from the bearing tube (5).
 - (g) Turn the bellcrank (10) until the top is clear of the push rod assembly (4). Pull the bellcrank to remove it from the bearing tube (5).

- (b) Put the bellcrank (10) in position on the bearing tube (5). When you do this turn the bellcrank around through 180° on its pivot axis. Do this to make sure that its position on the bearing tube is opposite (180°) to its initial position.

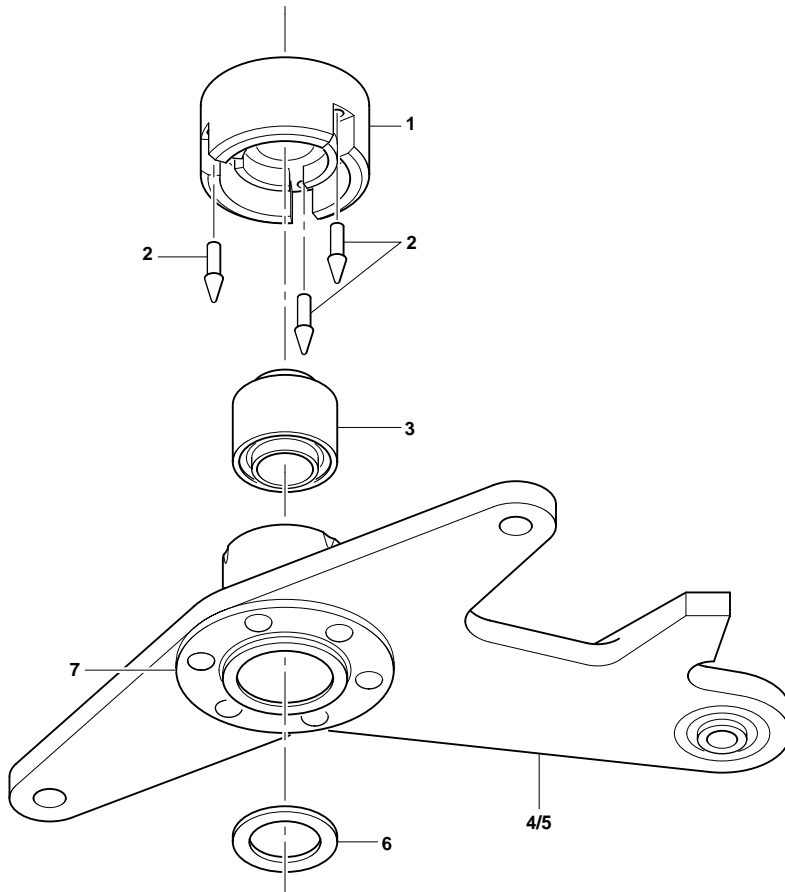
Bellcrank Assemblies (Wing) - Staking and Locking of the Bearings
Figure 3

This procedure is applicable to all (wing) bellcrank assemblies (4) and (5) with or without axial movement of the bearings in the housings (Ref. Para C, Step (1), (a)).

- (1) Make sure the three pins (2) are removed from the die (1).
- (2) Put a washer (6) and the left bellcrank (4) in position on a bearing press (or equivalent) as shown. Make sure the washer is concentrically aligned with the end of the bearing (3).
- (3) Put the die (1) in position on the remaining end of the bearing (3).

- (4) Operate the bearing press to push the bearing (3) fully into the housing (7).
- (5) Remove the die (1).
- (6) Put the three pins (2) in position in the die (1).

- (7) Put the die (1) in position on the open end of the housing (7).
- (8) Operate the bearing press until the die (1) stops against the bearing. Do this to bend the rim of the housing (7) at three places and thus, lock the bearing (3) in position.

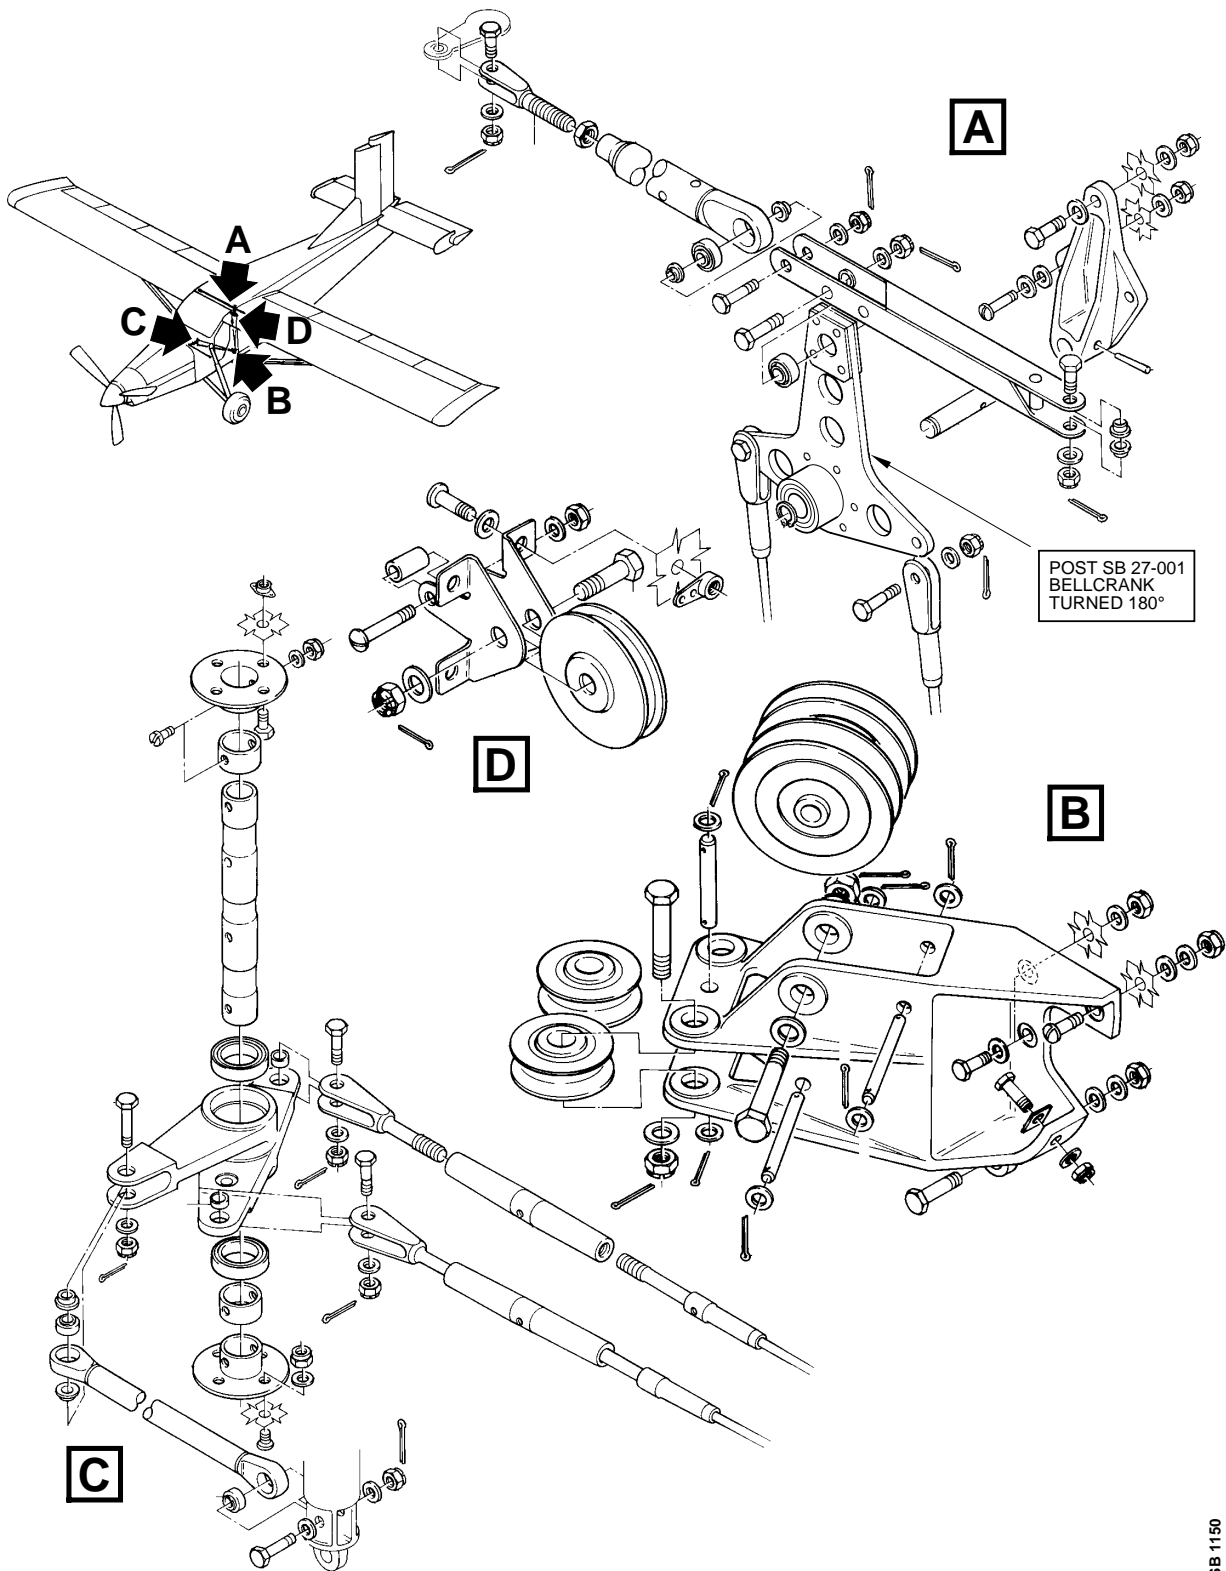
Aileron Control Instl, Fuselage
Figure 01 (Unannotated)

SB 27-001 requires the fuselage bellcrank to be turned 180°. It is therefore necessary to show the change to the existing figure for the bellcrank installation.
