SERVICE BULLETIN NO: 57-002

WINGS - OUTER WING INTEGRAL FUEL-TANK RIB ASSEMBLIES - INSPECTION AND REPAIR

All PC-6 Series aircraft to MSN 939 inclusive.

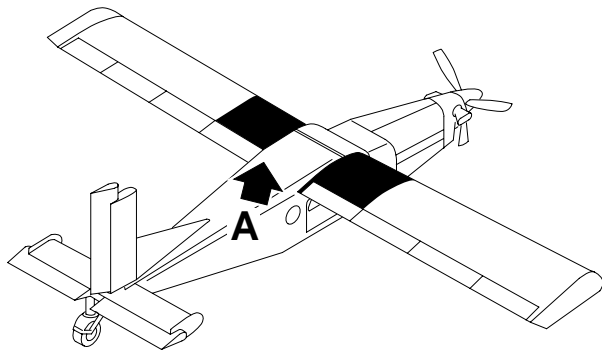
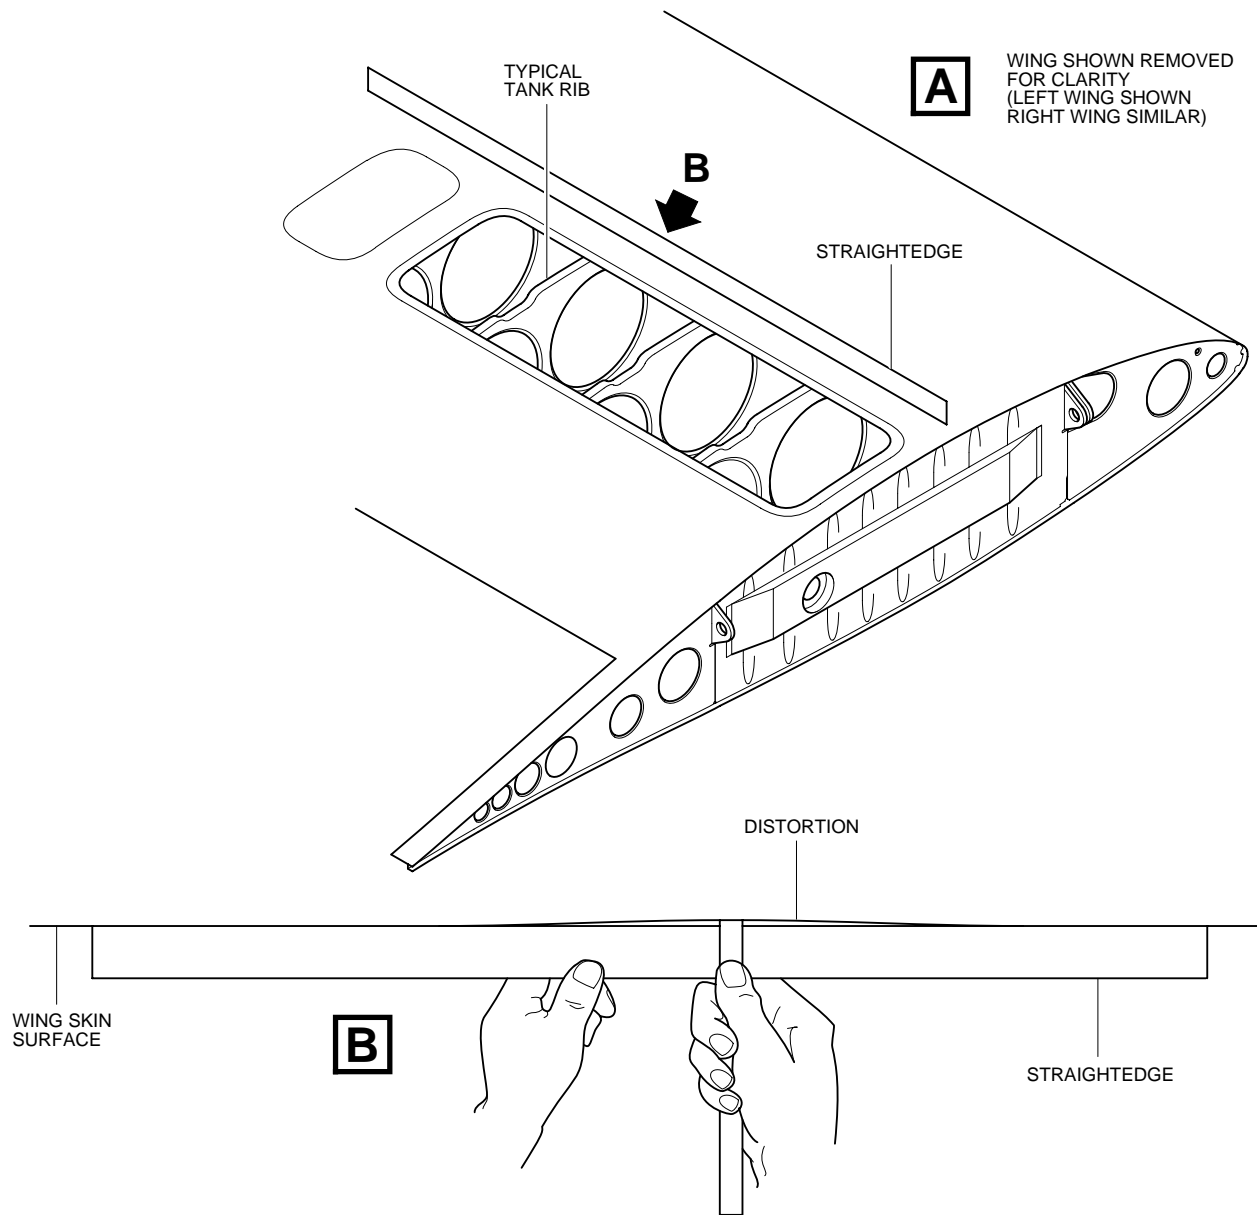
Ribs in Integral Tank and Related Structure - Inspection
Figure 1 (Sheet 1 of 2)

Crack damage has occurred in the ribs in the inboard integral fuel tanks in the left and right wings of PC-6 aircraft.

Distortion of the wing structure in the areas of the inboard fuel tanks. This can occur when there are pressure differentials between the ambient air pressure and that of the fuel tanks. The effect of a pressure differential is to compress the wing in the area of the fuel tank and cause distortion of the related structure.

- (1) Use a source of bright light and a X 10 magnifier to do an inspection for cracks in the ribs of the integral fuel tanks in the wings. Refer to the table below (Typical Tank Rib - Crack Damage) to identify repairable and none repairable crack damage.

Horizontal and Vertical Crack Combinations	Remarks
One, two or three horizontal cracks (A, B or C) with No vertical cracks	Repairable (Ref. Para D)
One horizontal crack (A, B or C) with One vertical crack (D or E)	Repairable (Ref. Para D)
One horizontal crack (A, B or C) with Two or more vertical cracks (D or E)	Apply to PILATUS for repair instructions
All other combinations of horizontal and vertical cracks	Apply to PILATUS for repair instructions

- (1) If possible obey the instructions given in the ROM and do the applicable repair (or repairs) to the applicable rib/ribs and/or related structure (Ref ROM, Chap 2, Page Block 1 and Chap 4, Page Block 1).

If a rib flange or a lightning hole flange is cracked, obey the instructions given in FAA AC 43. 13-1B and do the applicable repair (or repairs).

- (2) Apply to PILATUS for repair instructions if it is not possible to obey the instructions given in the ROM or FAA AC 43. 13-1B.
