SERVICE BULLETIN NO: 27-002

ATA CHAPTER: 27

FLIGHT CONTROLS - FLAPS INSPECTION OF THE LEAF SPRINGS IN THE FLAP OPERATING MECHANISM FOR CRACKS

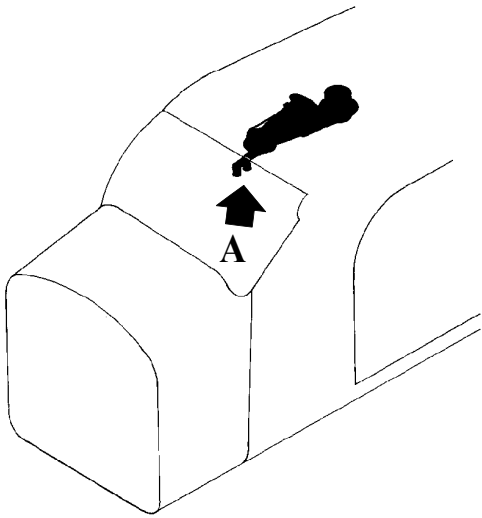
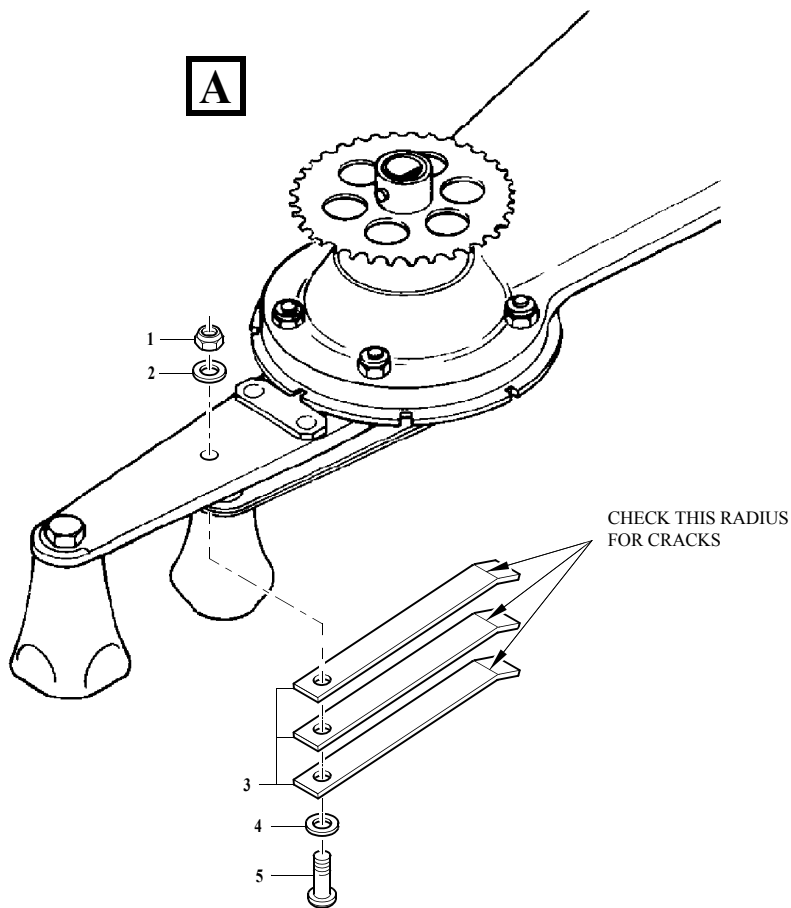
Wing Strut Fittings - Inspection
Figure 1

An Operator reported an un-commanded movement of the flap system. The un-commanded movement was because of cracked leaf springs P/N 6232.0175.01 installed in the overhead flap-operating mechanism of some PC-6 aircraft.

It is possible that the leaf springs P/N 6232.0175.01 were not manufactured correctly.

Before the next flight, and thereafter, every 25 flight hours, visually examine the radius of the leaf spring (3) for signs of cracks. Do this with a X10 magnifier and a source of bright light. No cracks are permitted. If you find a crack, you must replace the leaf spring before next flight.

- (1) Remove the nut (1), the washers (2) and (4) and the screw (5).
- (2) Remove the three leaf springs (3).

- (1) Put the three leaf springs (3) in position.
- (2) Install the screw (5), the washers (4) and (2) and the nut (1).
- (3) Remove all tools and materials. Make sure that the work areas are clean.

Visually examine the radius of all leaf springs (3) P/N 6232.0175.01 held as spare or in stock for signs of cracks. Do this with a X10 magnifier and a source of bright light. No cracks are permitted. If you find a crack, return the leaf spring to Pilatus for replacement.
