SERVICE BULLETIN NO: 53-002

FUSELAGE STOP NUTS - REPLACEMENT

PILATUS
PC-6
SERVICE BULLETIN

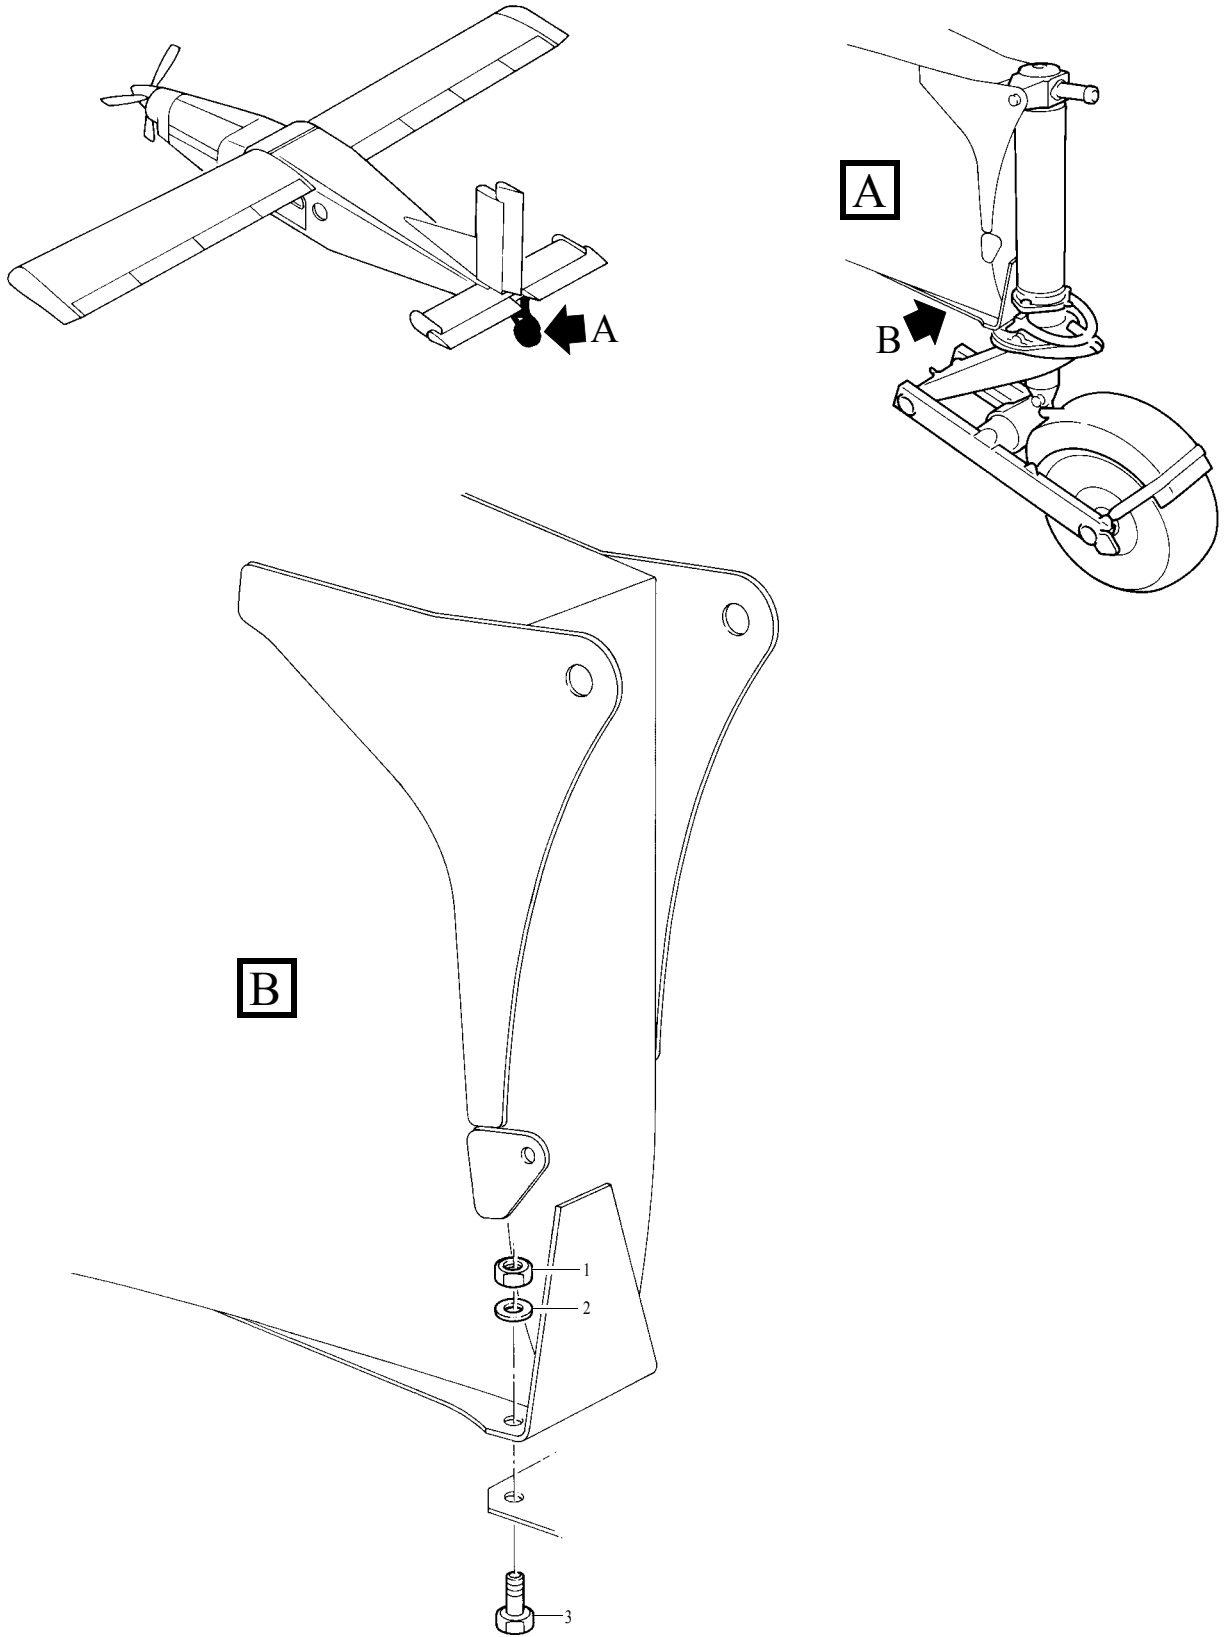
Tail Landing Gear - Nut Replacement
Figure 1

Operators have reported loose (all steel type) self-locking stop nuts (nuts) (938.07.65.105) in the fastener assemblies of the tail landing gear in some PC-6 aircraft. This problem could also occur in equivalent fastener assemblies at other locations in the aircraft.

B. Nut Replacement - Tail Landing Gear (Ref. Fig. 1)

CAUTION: DO NOT DISASSEMBLE THE TWO FASTENER ASSEMBLIES AT THE SAME TIME TO REPLACE THE NUTS. THIS CAN CAUSE DAMAGE.

- (1) Do an inspection to identify the nut (1). You must replace nuts (938.07.65.105) with nuts (938.07.31.124).
- (2) Replace the left nut (Ref. IPC, 32-71-01, Fig. 01). This step is only necessary if you found nuts (938.07.65.105) in Step (1).
 - (a) Lift the rear of the aircraft and put the tail stand in position (Ref. AMM, 07-10-00, Page Block 201).
 - (b) Disassemble and remove the nut (1) washer (2) and the bolt (3). Discard the nut.
 - (c) Install the bolt (3), washer (2) and new nut (1).
- (3) Do Step (2), (b) and (c) again to replace the right nut.
- (4) Remove the tail stand (Ref. AMM, 07-10-00, Page Block 201).

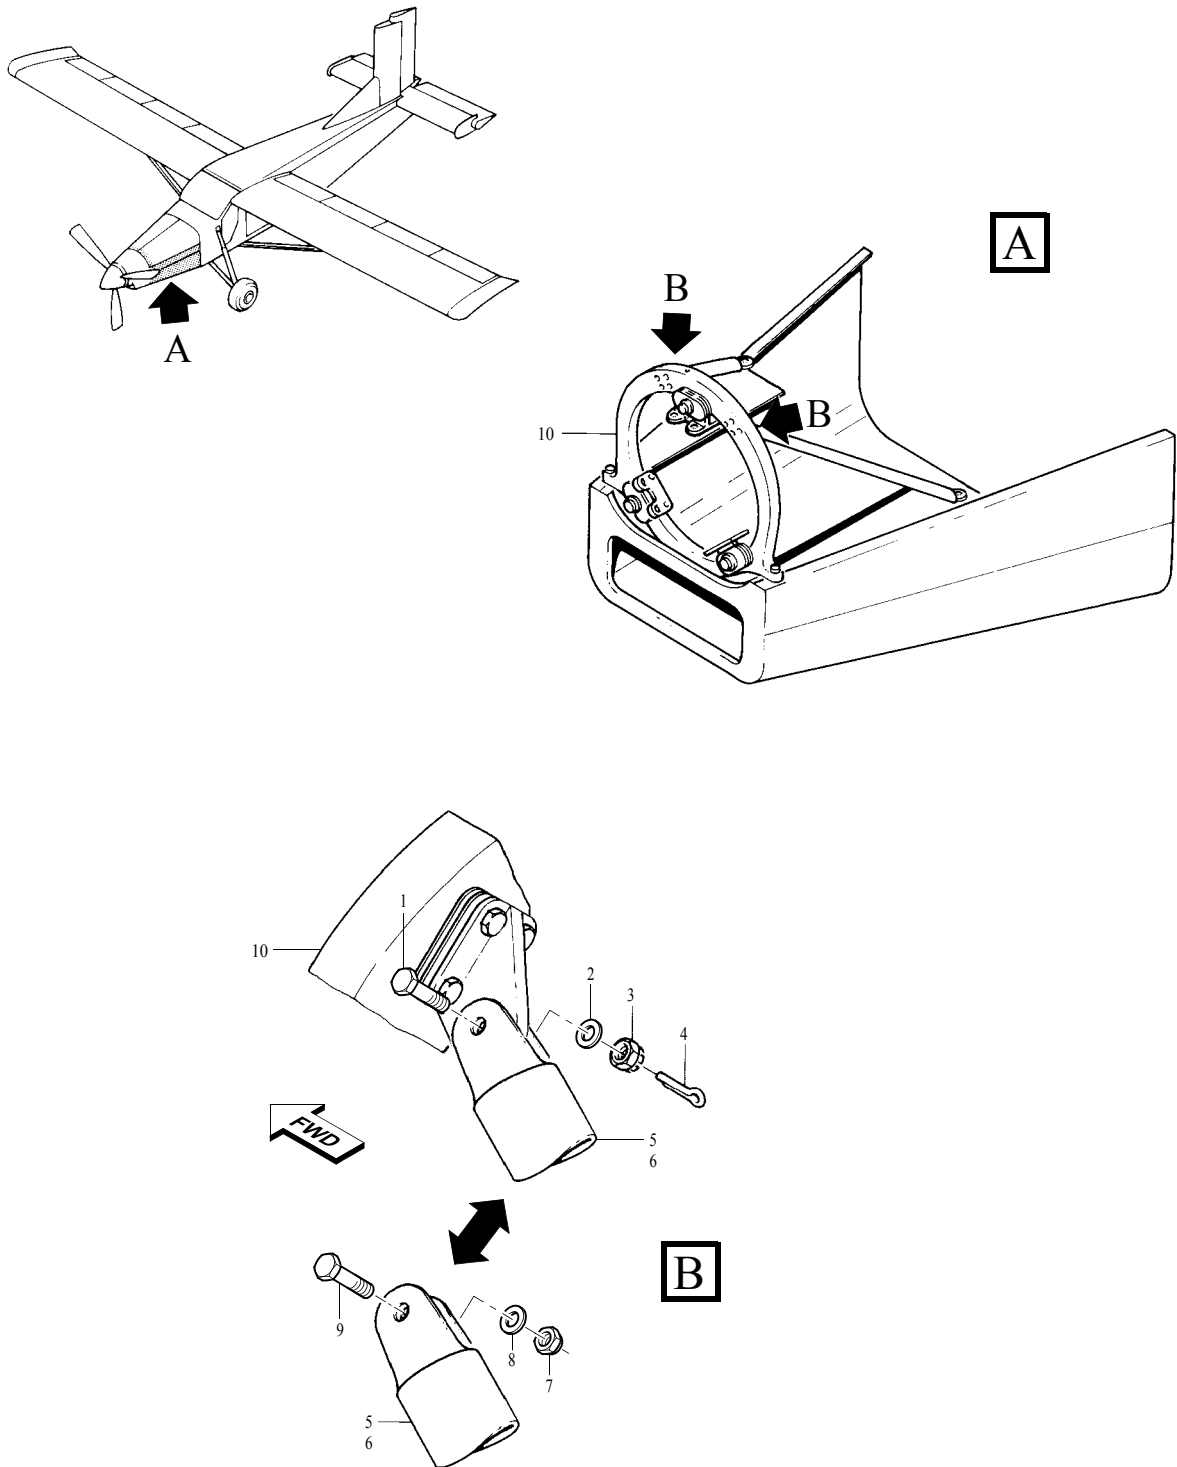
Engine Mountings - Fastener Assembly Replacement
Figure 7

- (1) Do an inspection to identify the nuts (in the fasteners assemblies) which attach the strut assemblies (5) and (6) to the engine mount assembly (10) (Ref. IPC, 71-21-01, Fig 01). Self locking nuts (938.07.65.105), (938.07.31.108) or (938.07.34.104) are not permitted.

H. Nut Replacement - Engine Mountings (Ref. Fig. 7)

Self locking nuts must be replaced with castellated nuts (938.08.47.105). It is recommended (but not necessary) that you also replace the related bolts (932.53.47.213) and washers (938.81.11.507) at the same time.

- (3) Replace the fastener assembly of the left strut assembly.
 - (a) Remove and discard the nut (7).
 - (b) Remove and discard the washer (8) and bolt (9) if you are going to replace them.

- (c) Temporarily install the new nut (3) on the bolt (9) or assemble the new nut with the new washer (2) and new bolt (1).
 - (d) Torque the nut (3) to between 10,5 and 12,5 Nm (95 and 110 lb in.).

- (e) Make a mark on the threaded part of the bolt (1) or (9) to show the location of the cotter pin hole. Do this between two of the castellation tangs on the nut (3).

- (f) Remove the nut (3), washer (2) or (8) and bolt (1) or (9).
 - (g) Make the cotter pin hole in the bolt (1) or (9) with a 1,7 mm (0.07 in.) diameter drill. Do this with a pillar drill (or equivalent) to make sure the cotter pin hole goes through the middle of the bolt shank. Make sure there are no sharp edges.

- (h) Install the bolt (1) or (9), washer (2) or (8) and nut (3).
 - (i) Torque the nut (3) to between 10,5 and 12,5 Nm (95 and 110 lb in.).
 - (j) Install the cotter pin (4) (Ref. AMM, 20-10-01, Page Block 201).

- (4) Do Step (3) again to replace fastener assembly of the right strut assembly.
- (5) Remove the engine support.
