METRIC RIVET ISSUE - FERRY FLIGHT CONDITION

The scope of this memo is to define the ferry flight condition and a pre-flight inspection.

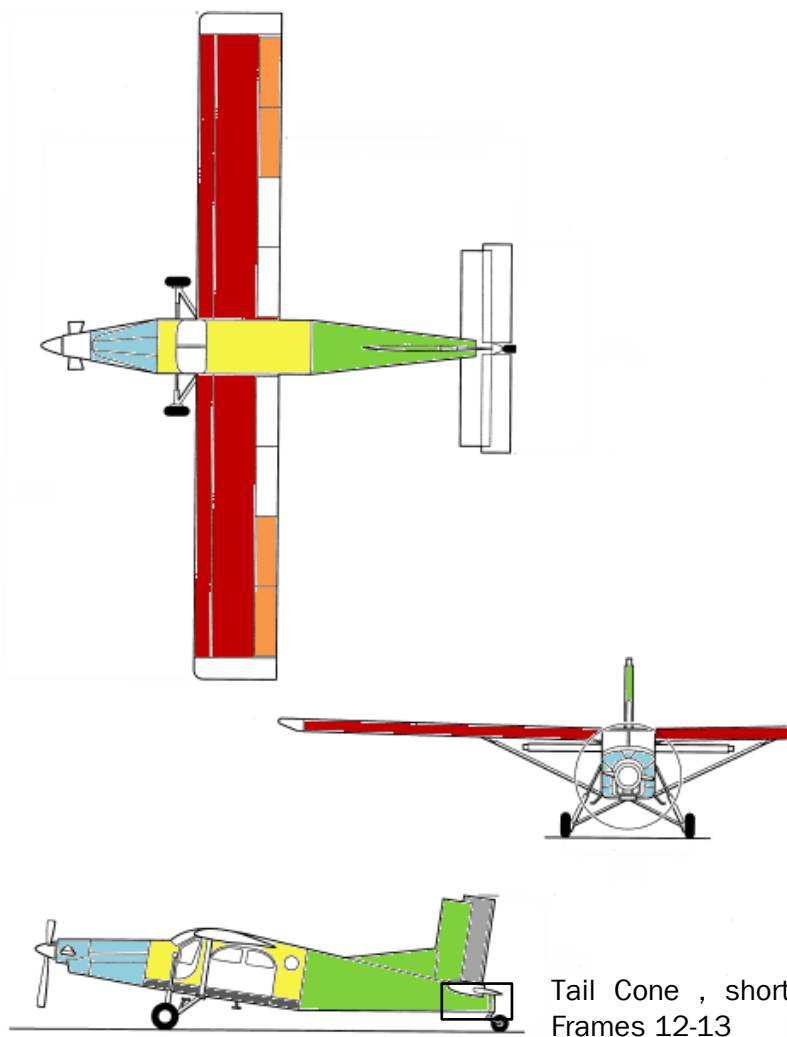
Figure 6-3 Affected Skins

Metric rivets with an ultimate shear allowable of about 50% were installed on several PC-6 assemblies on new production aircraft and some spare parts. The affected in-service PC-6 are MSN 735, 863, 909, 923, 948, 956, 958, 977, 978, 979, 980, 981, 982, 985 and 986.

The affected PC-6 are not affected to the same extent. Figure 6-3 and Table 7-1 provide an overview of the affected structural areas and serve as basis for the pre-flight inspection defined in the next chapter.

Perform a visual inspection of the aircraft skins as being identified as affected in the previous chapter. The inspection focus is on loose or missing rivets.
