SERVICE BULLETIN

SERVICE BULLETIN NO: 28-009

FUEL - DISTRIBUTION FUEL BOOSTER PUMP - DAMAGE TO WIRES DURING INSTALLATION

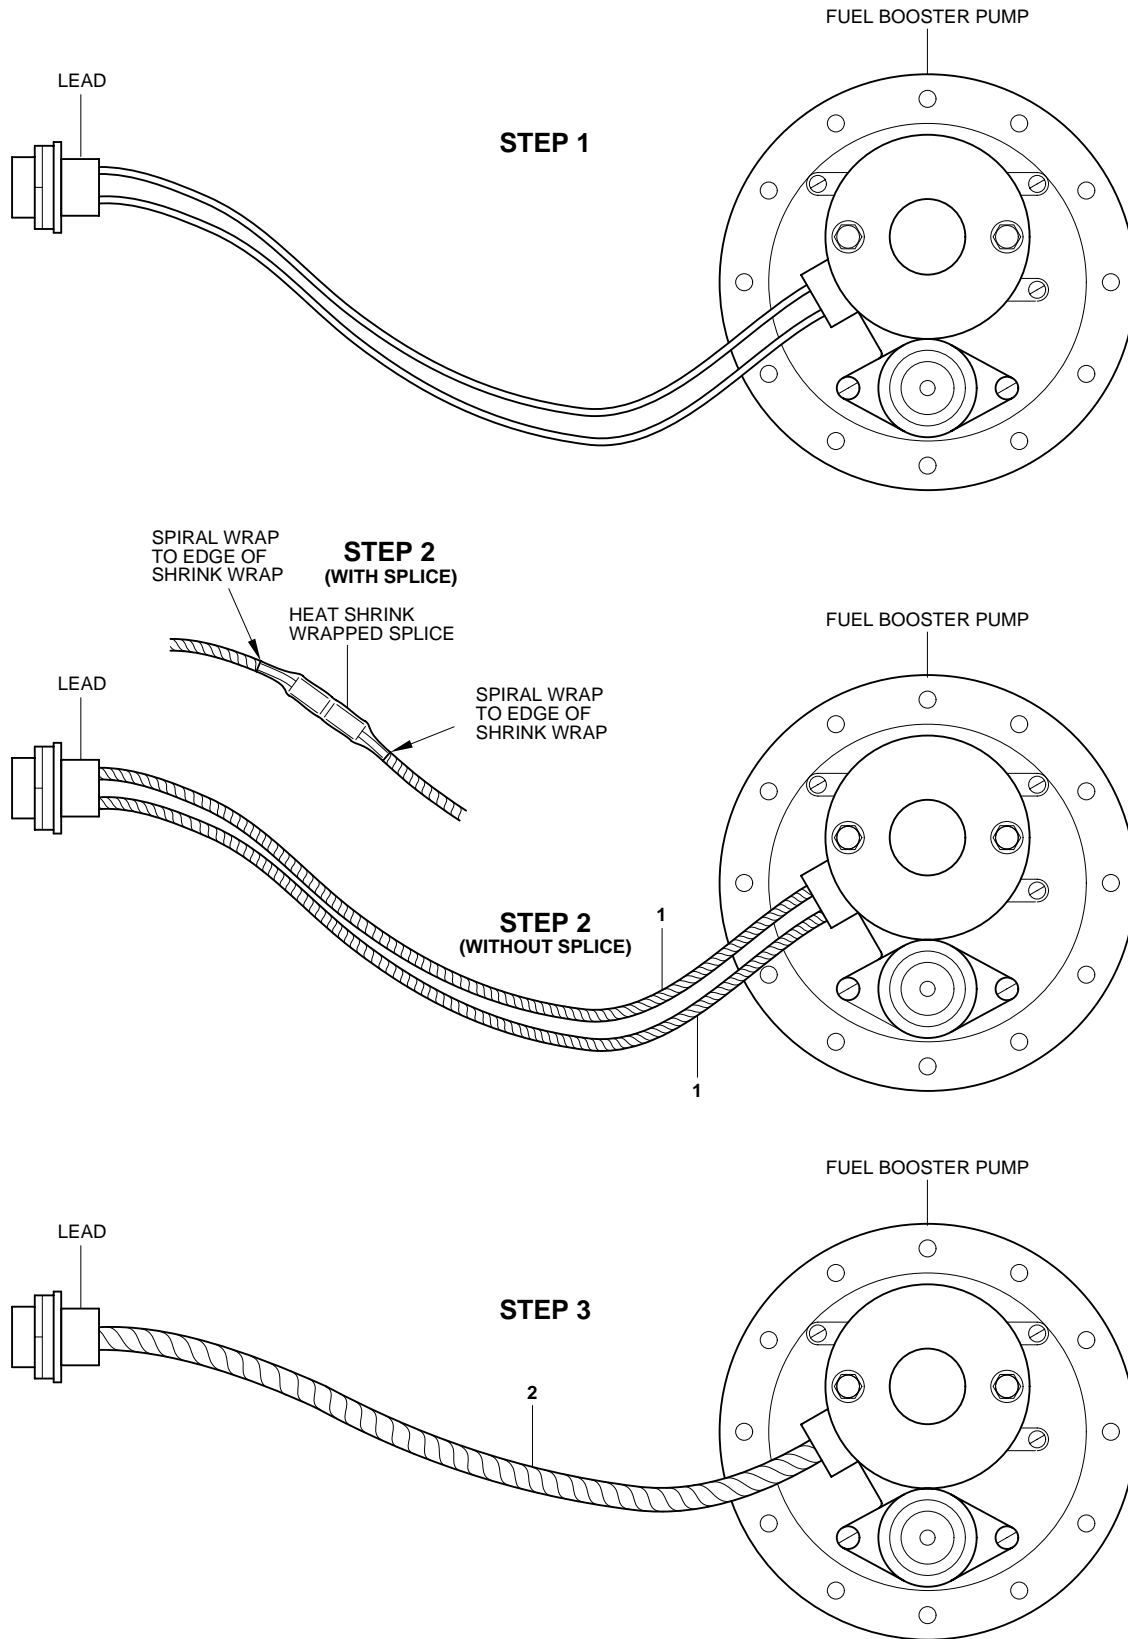
Lead Protection - Installation
Figure 1

It is possible the electrical power wires (leads) to the left and right fuel pumps are damaged. This damage could cause an electric arc from the leads in an air/fuel mixture which can make a dangerous condition.

The damage can occur to the leads during the installation of the pump. It is also possible that the leads could rub during the operation of the aircraft.

- (2) Install the spiral wrap on each wire:
 - (a) For a wire with no splice. Wind spiral wrap (1) around the full length of the wire. Twist the spiral wrap (1) to make sure there are no gaps and cut the spiral wrap (1).
 - (b) For a wire with a splice. Wind spiral wrap (1) around the wire between the edge of the shrink wrap and the end of the wire. Twist the spiral wrap (1) to make sure there are no gaps and cut the spiral wrap (1). Do this for each side of the splice.
- (3) Release the black wire and the white wire.
- (4) Wind the spiral wrap (2) around the full length of the black wire and the white wire. Twist the spiral wrap (2) to make sure there are no gaps and cut the spiral wrap (2).

- (3) Install the spiral wrap on each wire:
- (a) For a wire with no splice. Wind spiral wrap (1) around the full length of the wire. Twist the spiral wrap (1) to make sure there are no gaps and cut the spiral wrap (1).
- (b) For a wire with a splice. Wind spiral wrap (1) around the wire between the edge of the shrink wrap and the end of the wire. Twist the spiral wrap (1) to make sure there are no gaps and cut the spiral wrap (1). Do this for each side of the splice.
- (4) Release the black wire and the white wire.
- (5) Wind the spiral wrap (2) around the full length of the black wire and the white wire. Twist the spiral wrap (2) to make sure there are no gaps and cut the spiral wrap (2).
