Service Bulletin No: 53-013

ATA Chapter: 53

FUSELAGE - MAIN FRAMES**DO A CHECK OF THE MATERIAL SPECIFICATION OF THE FRAME 11 FITTINGS AND, IF NECESSARY, DO A CHECK FOR CRACKS****1. Planning Information****A. Effectivity**

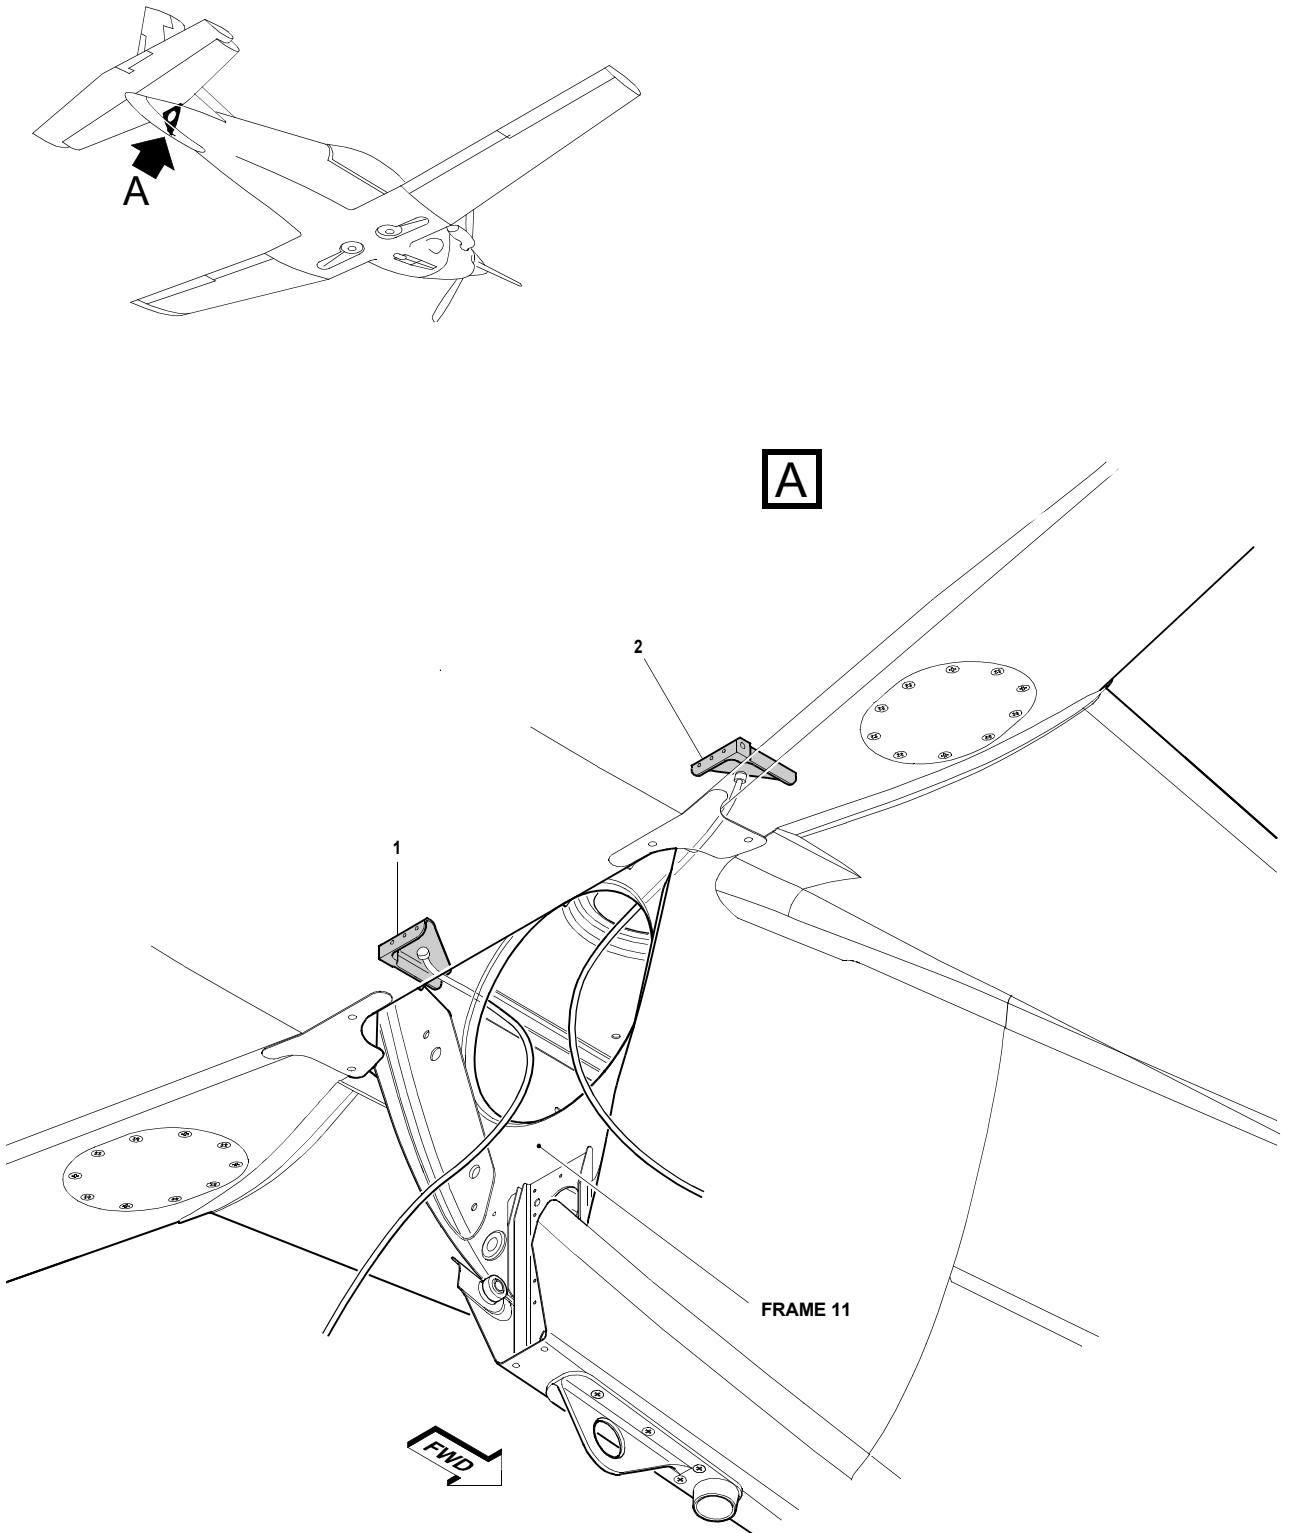
Check of the Material Specification
Figure 1

Initially the material specification of the parts was AA2024-T351.

- (1) For the left fitting (1) (P/N 112.35.07.489):
 - (a) Remove the dirt and grease from the test area with the absorbent paper (Material No. P02-031) made moist with the solvent (Material No. P01-010).

- (b) Put the eddy current probe in position on the left fitting (1) (P/N 112.35.07.489).

- (d) Compare the value recorded above with the values recorded in Step 3.A.(6) and determine if the fitting is manufactured from AA2024-T351 or AA2124-T851.
 - (e) Do Steps 3.B(1)(b) thru (d) again to make sure the result is the same.
 - (f) Make a note of the type of material that the left fitting (1) (P/N 112.35.07.489) is made from.
- (2) Do Step 3.B.(1) of this Service Bulletin again on the right fitting (2) (P/N 112.35.07.490).
 - (3) If you find a left or right fitting made from AA2024-T351, continue this Service Bulletin from Step 3.C.
 - (4) If the left and right fittings are made from AA2124-T851, continue this Service Bulletin from Step 3.D.

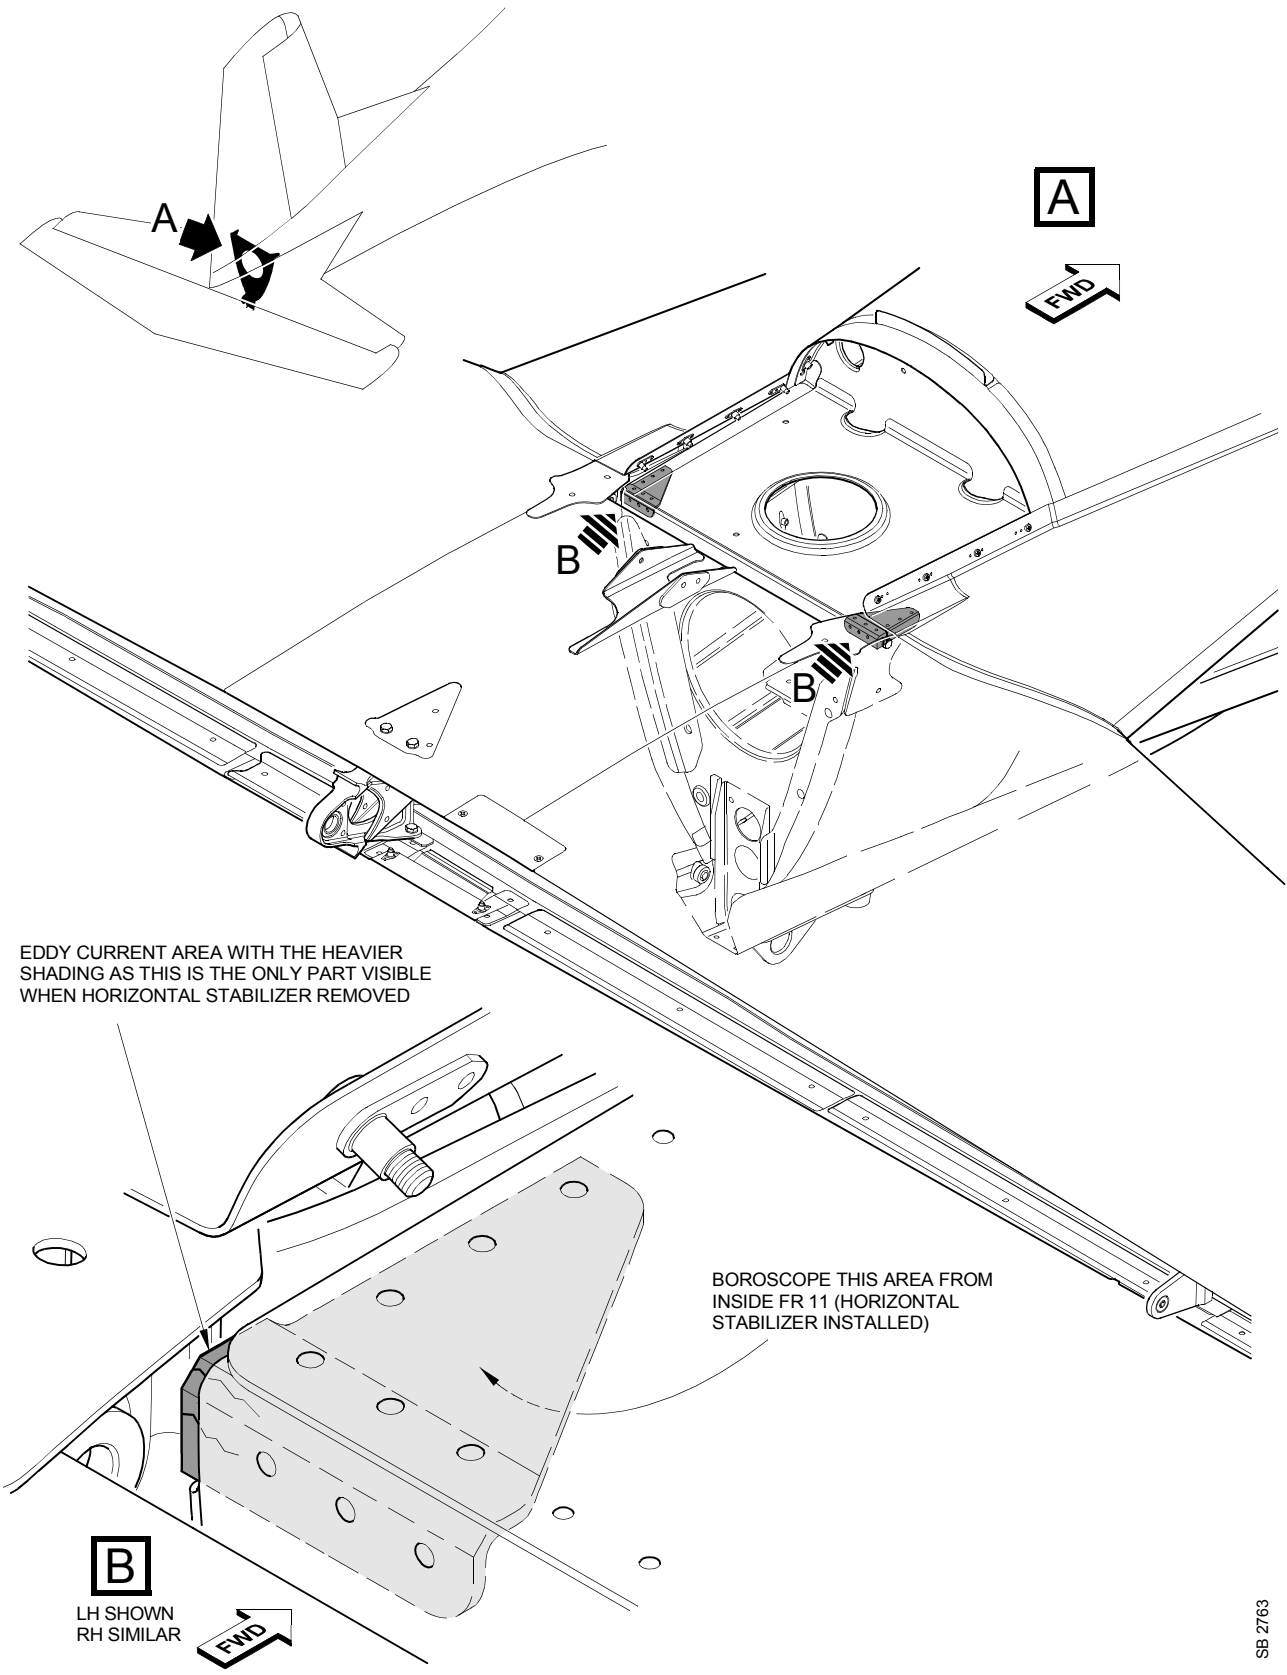
Fittings - Crack Inspection (If Necessary)
Figure 2

An operator reported Stress Corrosion Cracking (SCC) on the FR 11 left fitting P/N 112.35.07.489 and right fitting P/N 112.35.07.490 (known hereafter as "fittings").

- (1) Obey the manufacturer's instructions and use a borescope to examine the fitting from inside FR11 (looking AFT) for cracks (Ref. Fig. 2).

- (2) If you find cracks, you must replace the fitting before the next flight (Ref. Service Bulletin 53-014). Make a copy of the Inspection Report Form (Ref. Fig. 3).

- (c) Examine the area shown in Fig. 2 with the eddy current equipment.

- (4) If you find cracks, you must replace the fitting before the next flight (Ref. Service Bulletin 53-014). Make a copy of the Inspection Report Form (Ref. Fig. 3).
