**Service Bulletin No: 57-017****Ref No: 183****Modification No: Inspection****ATA Chapter: 57**

**WINGS - WING STRUCTURE****DO AN INSPECTION FOR CORROSION OF THE ANGLE BRACKETS INSTALLED ON THE LH AND RH WING MIDDLE RIB 23****1. Planning Information****A. Effectivity**

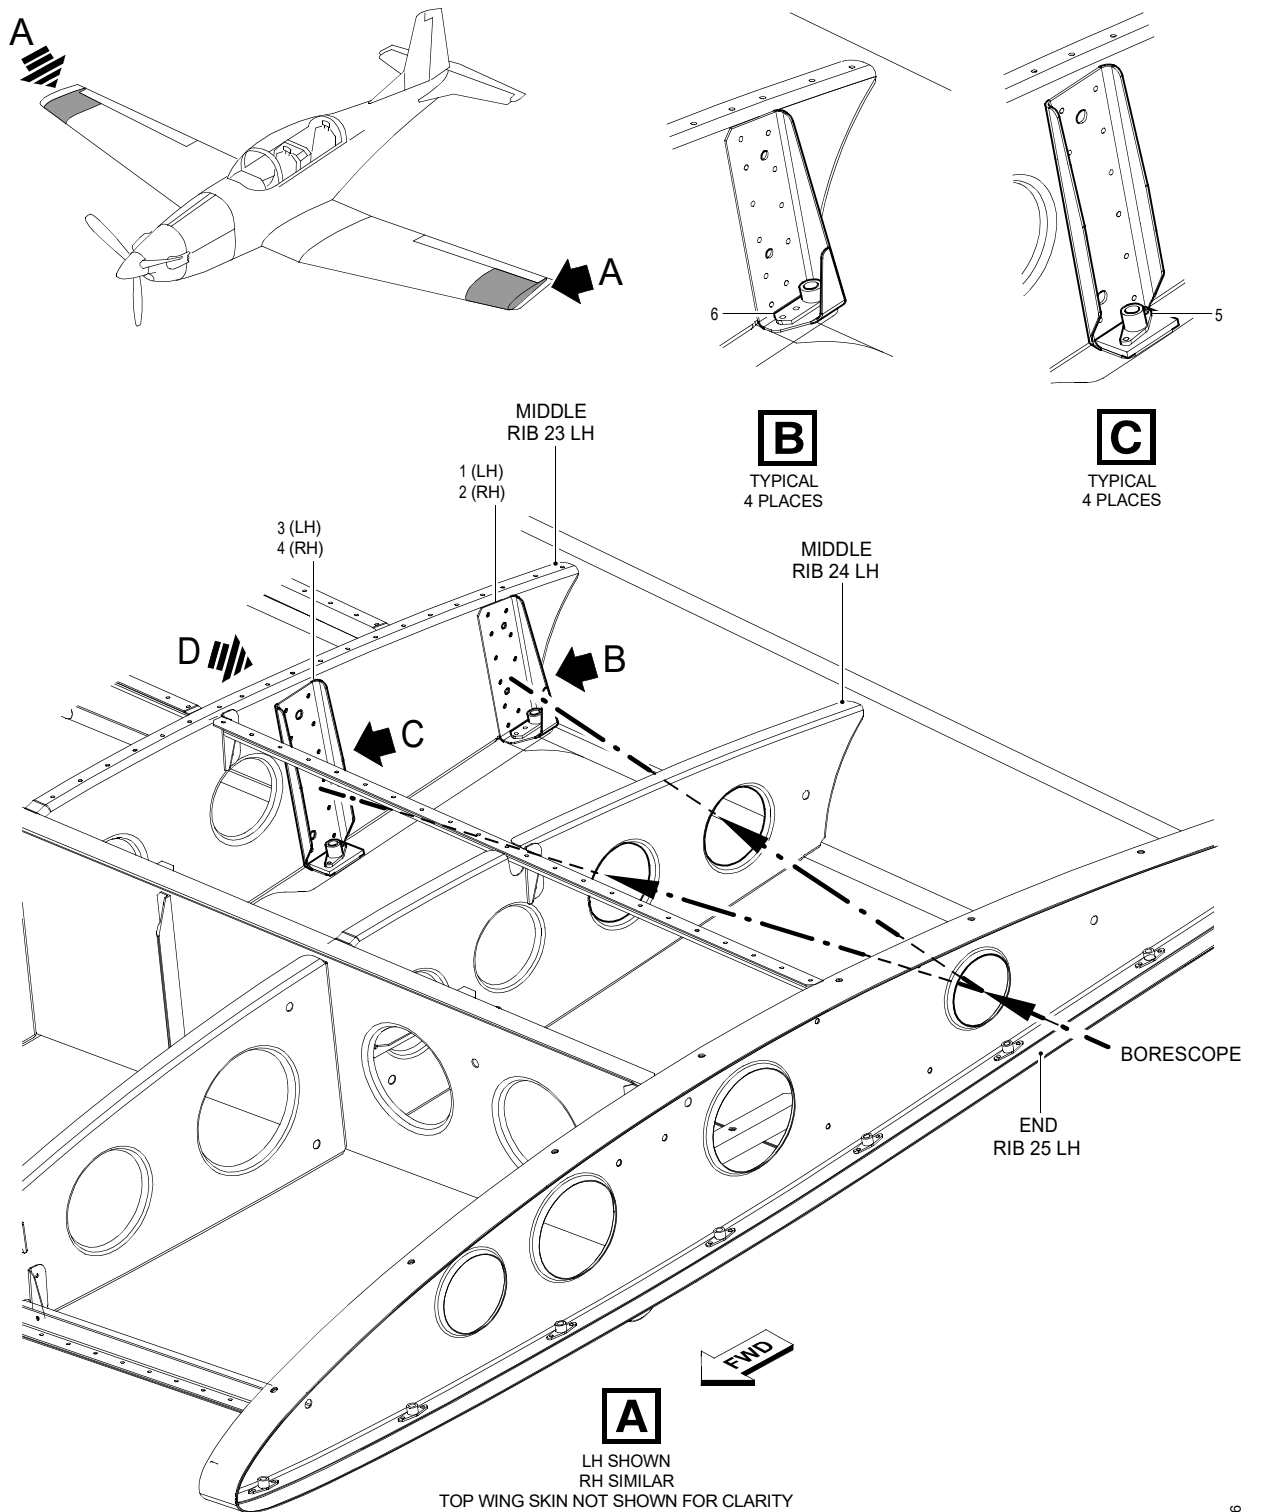
Boreoscope Inspection of the LH and RH Wing Middle Ribs 23  
Figure 1 (Sheet 1 of 2)

An operator has reported that during a scheduled inspection corrosion was found on the angle brackets installed on the LH and RH wing middle rib 23.

It is possible that the silver-plated anchor nuts have caused the corrosion after being installed without corrosion preventative during manufacture of the wing.

- (a) Do the borescope inspection of these outboard brackets through the aft lightening hole in the end rib 25 (Ref. Detail A):
  - Angle bracket LH (1)
  - Angle bracket RH (2)
  - Channel bracket LH (3)
  - Channel bracket RH (4).
- (b) Do the borescope inspection to these forward inboard brackets through the 2nd to aft lightening hole in the end rib 25 (Ref. Detail D):
  - Channel bracket LH (9)
  - Channel bracket RH (10).
