**Service Bulletin No: 24-009**  
**Modification No: INSPECTION**

**Ref No: 151**  
**ATA Chapter: 24**

**ELECTRICAL POWER - GENERAL**  
**INSPECTION FOR CHAFING ON AN ELECTRICAL HARNESS IN THE ENGINE COMPARTMENT**

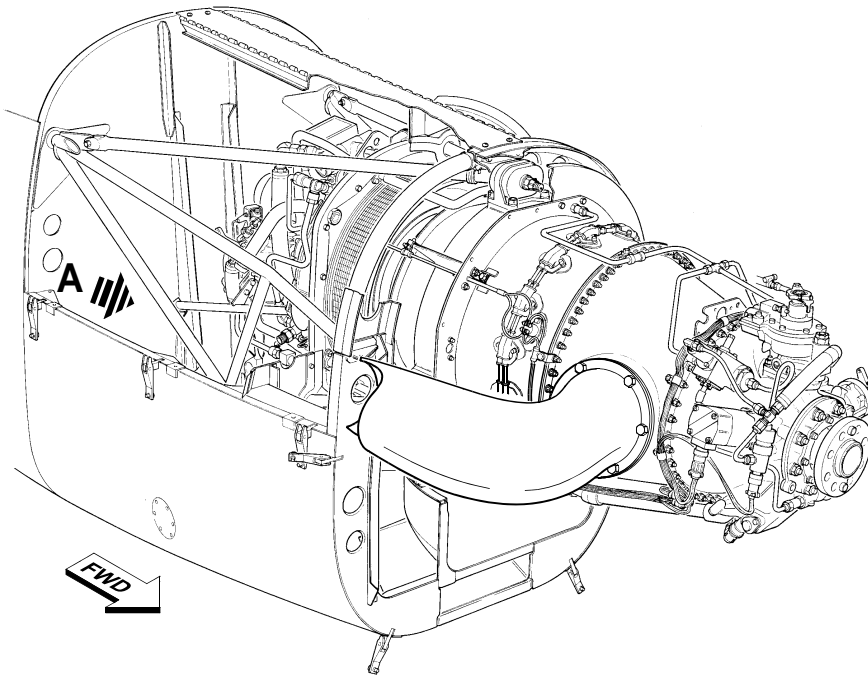
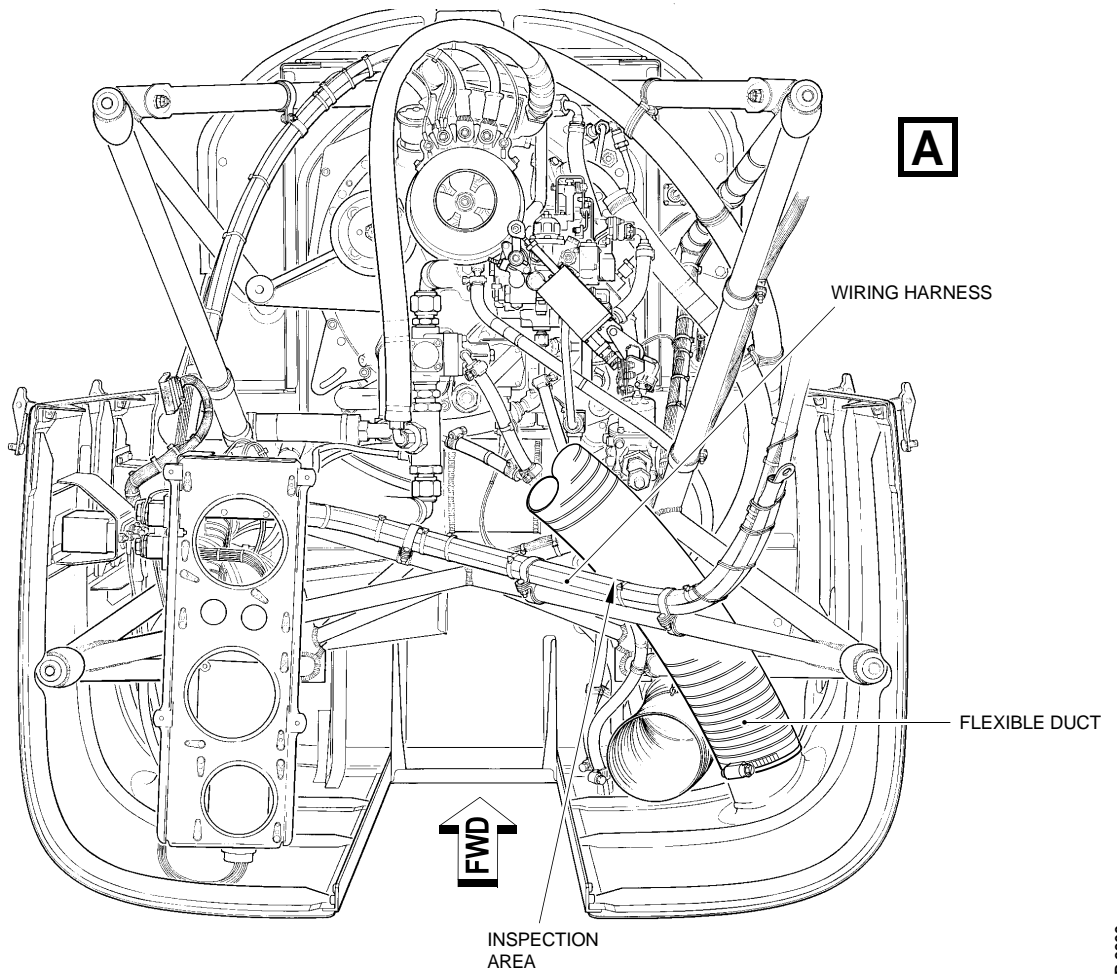
Inspection  
Figure 1

An operator has reported signs of chafing on a wiring harness attached to the engine mounting frame on the RH side of the engine compartment. If an electrical cable becomes chafed through the insulation, a short circuit could cause a fire in the engine compartment.

The RH flexible duct for the condenser unit can chafe against the wiring harness.

**B. Inspection (Ref. Fig. 1)**

- (3) Do a visual inspection of the flexible duct for chafing damage. If you find damage that makes the flexible duct unserviceable, remove and discard the flexible duct.
- (4) Use absorbent paper (Material No. P02-031) made moist with solvent (Material No. P01-011) to clean the harness in the area to be inspected.
- (5) Use a bright light source and mirror to do a visual inspection of the harness for chafing damage.
- (6) If you find chafing on the harness and you can see bare wires under the insulation you must replace the damaged electrical cable(s):
  - (a) Send details/photographs of the damaged cable(s) to this address to get replacement data:

- (1) Install the flexible duct and tighten the hose clamp(s).

**NOTE:** The flexible duct installation is shown in IPC 21-50-02, Fig. 02.
- (2) Use Koroseal binding (Material No. P09-004), as required, to secure the flexible duct to the engine mounting frame. Do this to prevent movement of the flexible duct which could cause chafing.
