SERVICE BULLETIN NO: 32-024

LANDING GEAR - MAIN GEAR INSPECTION OF THE MAIN-GEAR SUPPORT STRUT

PILATUS
PC-7
SERVICE BULLETIN

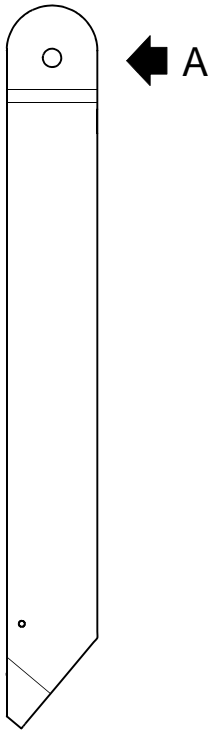
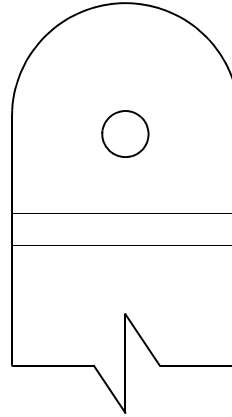
- (1) Do a visual examination of the left and right main-gear support struts installed on the aircraft:
 - If the main-gear support strut has rounded clevis lugs, it is made of material with an increased resistance to stress corrosion cracking. Continue the Service Bulletin from Step 3.E.
 - If the main-gear support strut has chamfered clevis lugs, it is made of material which has a lower resistance to stress corrosion cracking. Continue the Service Bulletin from Step 3.B.

ROUNDED CLEVIS LUGS
NO NDI NECESSARY

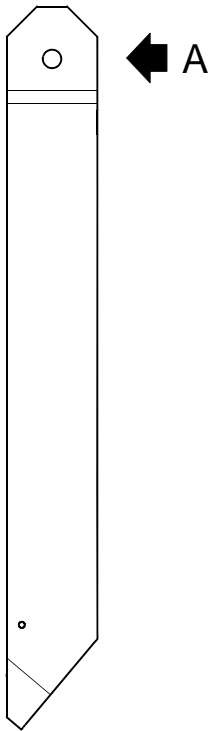
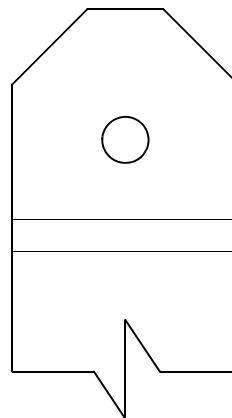
Type of Main-Gear Support Struts
Figure 1

Cracks have occurred in the main-gear support struts on some aircraft. All the main-gear support struts that had cracks were made from material AA2024-T351. This material has a lower resistance to stress corrosion cracking.

The cause of the cracks is stress corrosion.

CHAMFERED CLEVIS LUGS
NDI IS NECESSARY

- (a) Do a visual inspection of the main-gear support struts to check if they are made from AA2024-T351.
- (b) Do a Non-Destructive Inspection (NDI) procedure on the main-gear support struts which are made from AA2024-T351.

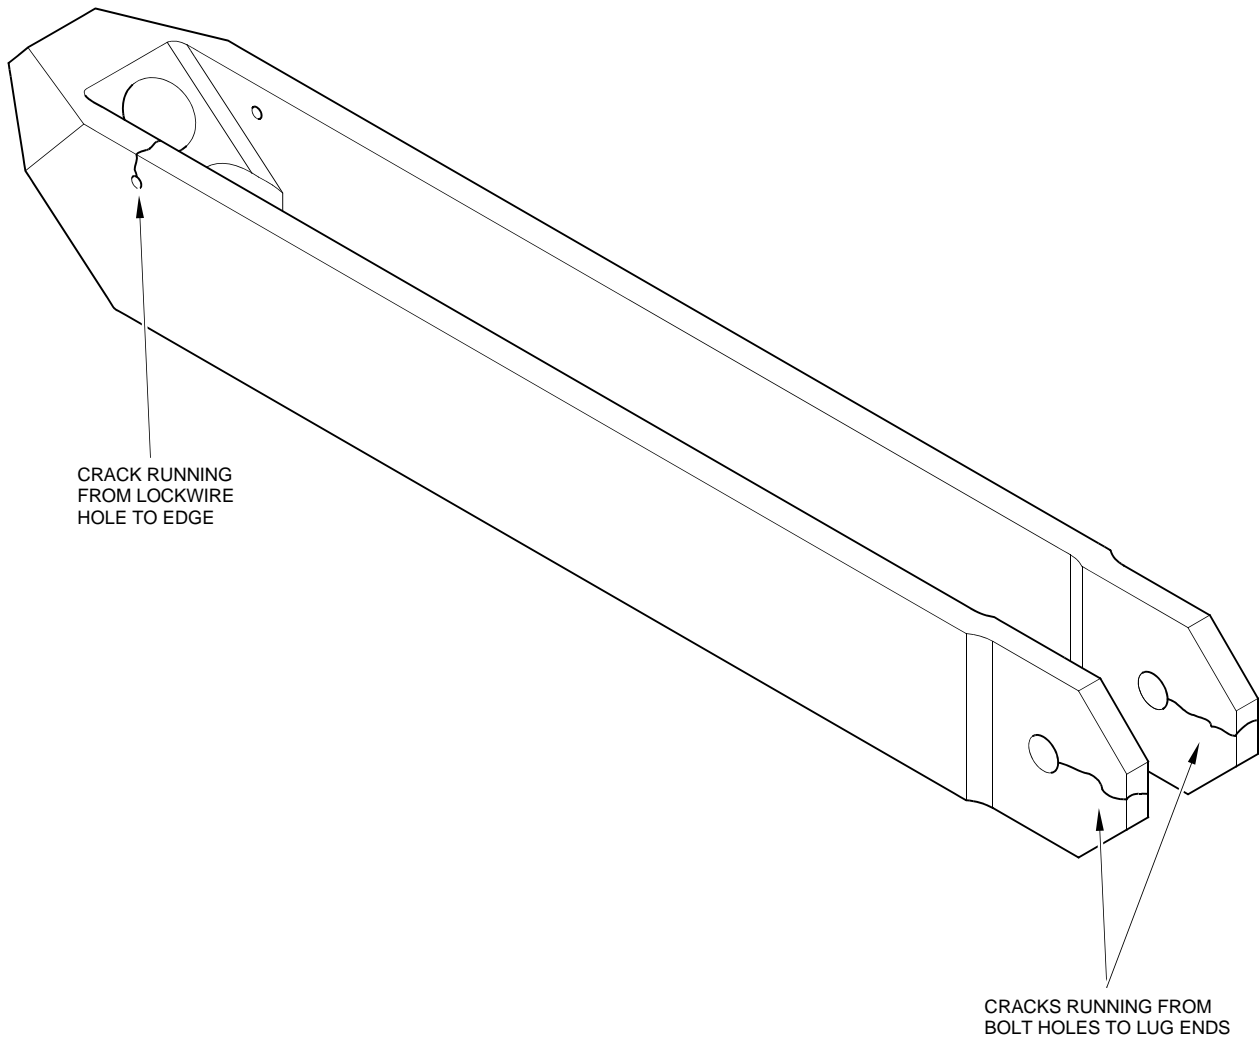
Position of Possible Cracks
Figure 3

- (4) Examine the area around the hole, for the bolt (4), on the aft surface with a 90° shielded probe.
- (5) Examine the area around the hole, for the bolt (4), on the forward surface with a 90° shielded probe.

- (6) Examine the area adjacent to the lockwire holes with the 90° shielded probe.
- (7) Do steps 3.C.(1) to 3.C.(6) for the right main-gear support strut.

PILATUS AIRCRAFT LTD,
CUSTOMER LIAISON MANAGER,
CH 6371 STANS
SWITZERLAND
Fax: +41 41 619 61 70
 - (b) Do Service Bulletin 32-025 to replace the main-gear support strut.
- (9) If you do not find cracks (Ref. Fig. 2):
 - (a) Put the bush (2) in position in the actuator (3).
 - (b) Put the actuator (3) in the correct position between the lugs of the left and/or right folding strut lever (1).
 - (c) Install the bolt (4), the washer (5) and the new nut (6) (P/N 938.07.68.506).
 - (d) Safety the bolt (7) to the main-gear support strut (8) with the lockwire (Mat. No. P02-001).
