SERVICE BULLETIN NO: PC7-A73-002

POWER CONTROL SUPPORTING STRUT ASSEMBLY - CRACKING

≡PILATUS≡
PC-7
SERVICE BULLETIN

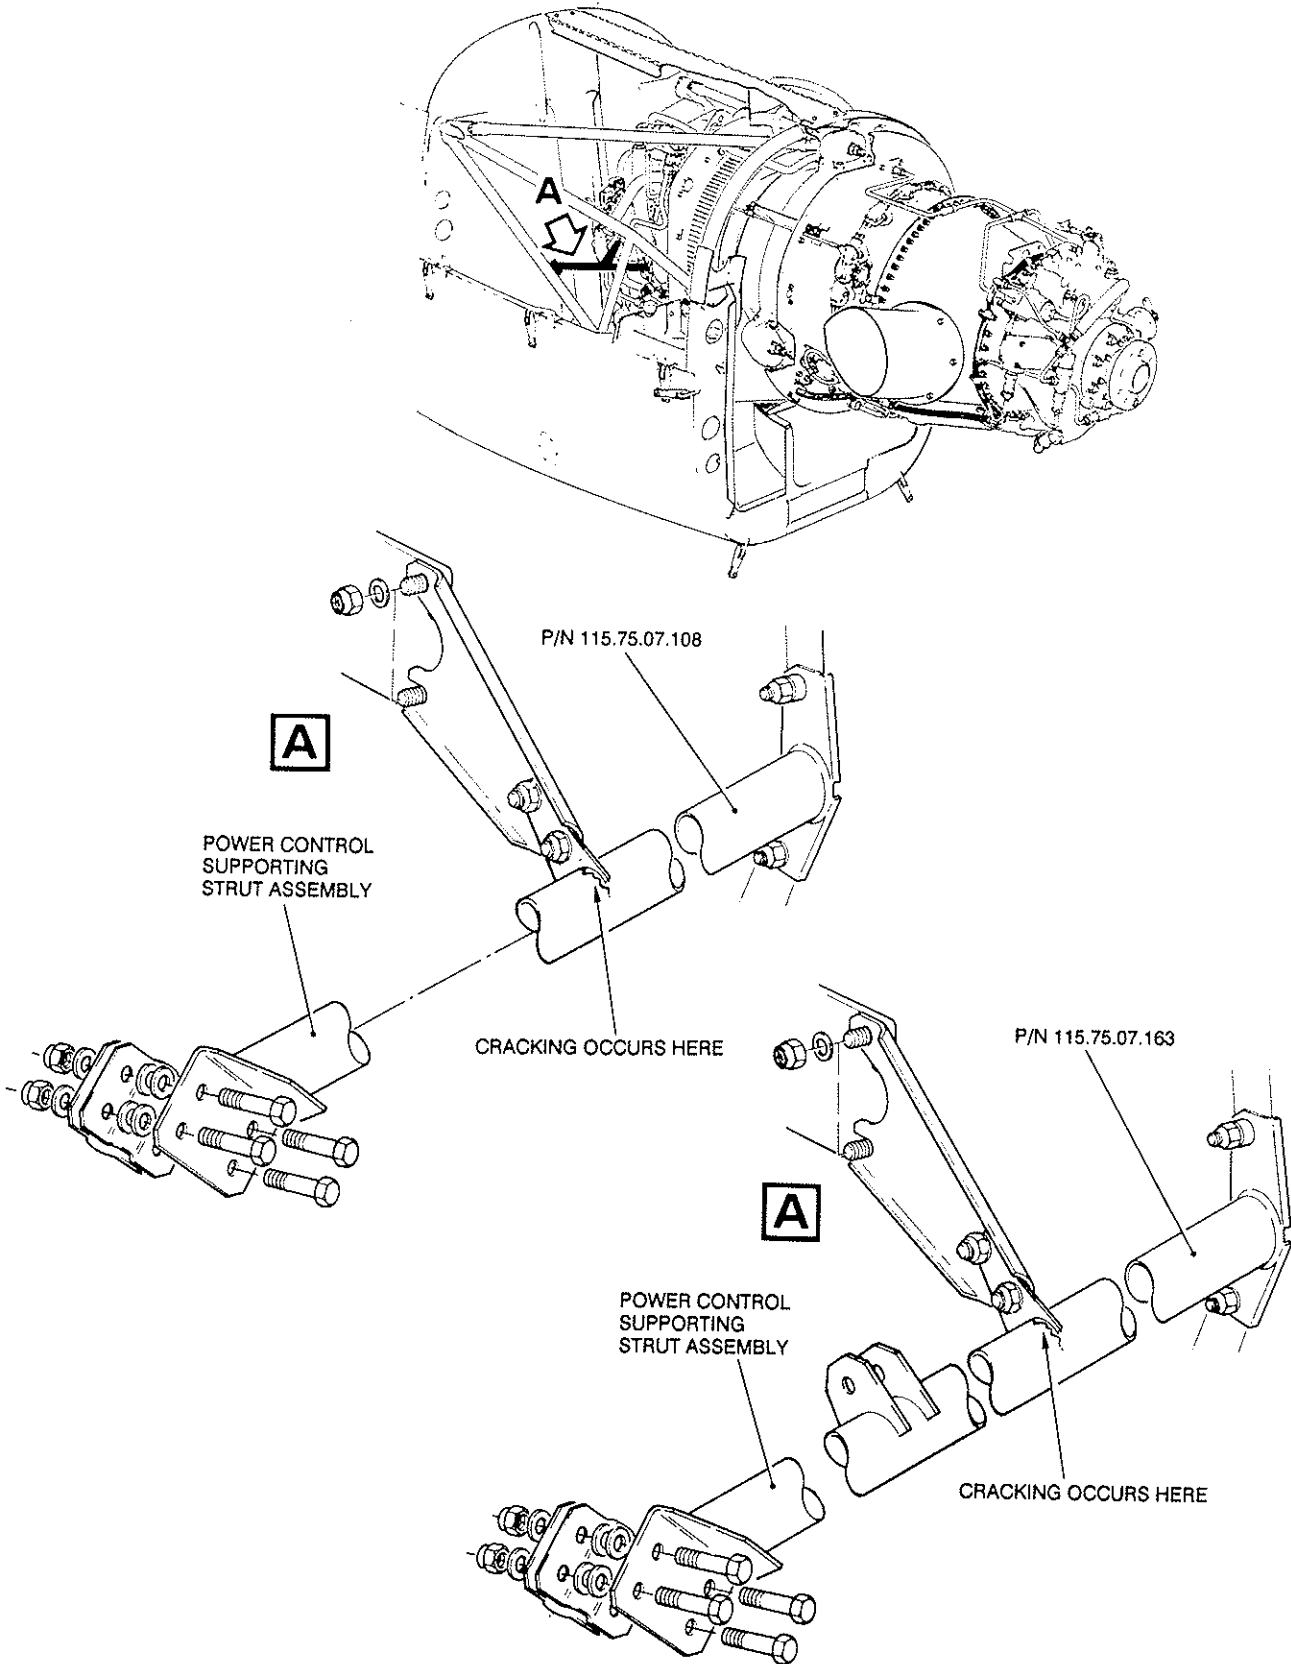
Power Control Supporting Strut - Inspection
Figure 1

Fatigue cracks have been found on some Power Control Supporting Struts. The struts were cracked at the weld on the HP fuel pump support attachment lug and radially around the strut tube.

- (1) Inspect the weld and the tube structure around the weld for cracks. Use a torch and mirror. - If cracks are found, SB 73-003 must be incorporated before the next flight.

- (i) If no cracks were found during the inspection procedure, repeat the accomplishment instructions of this SB after every 100 flying hours.
- (ii) If a crack is found during the inspection procedure the aircraft must be modified to SB 73-003 standard.
