SERVICE BULLETIN

SERVICE BULLETIN NO: 57-009

ATA CHAPTER: 57

WINGS - CENTER WING NOSE SKIN - INSPECTION FOR CRACK DAMAGE

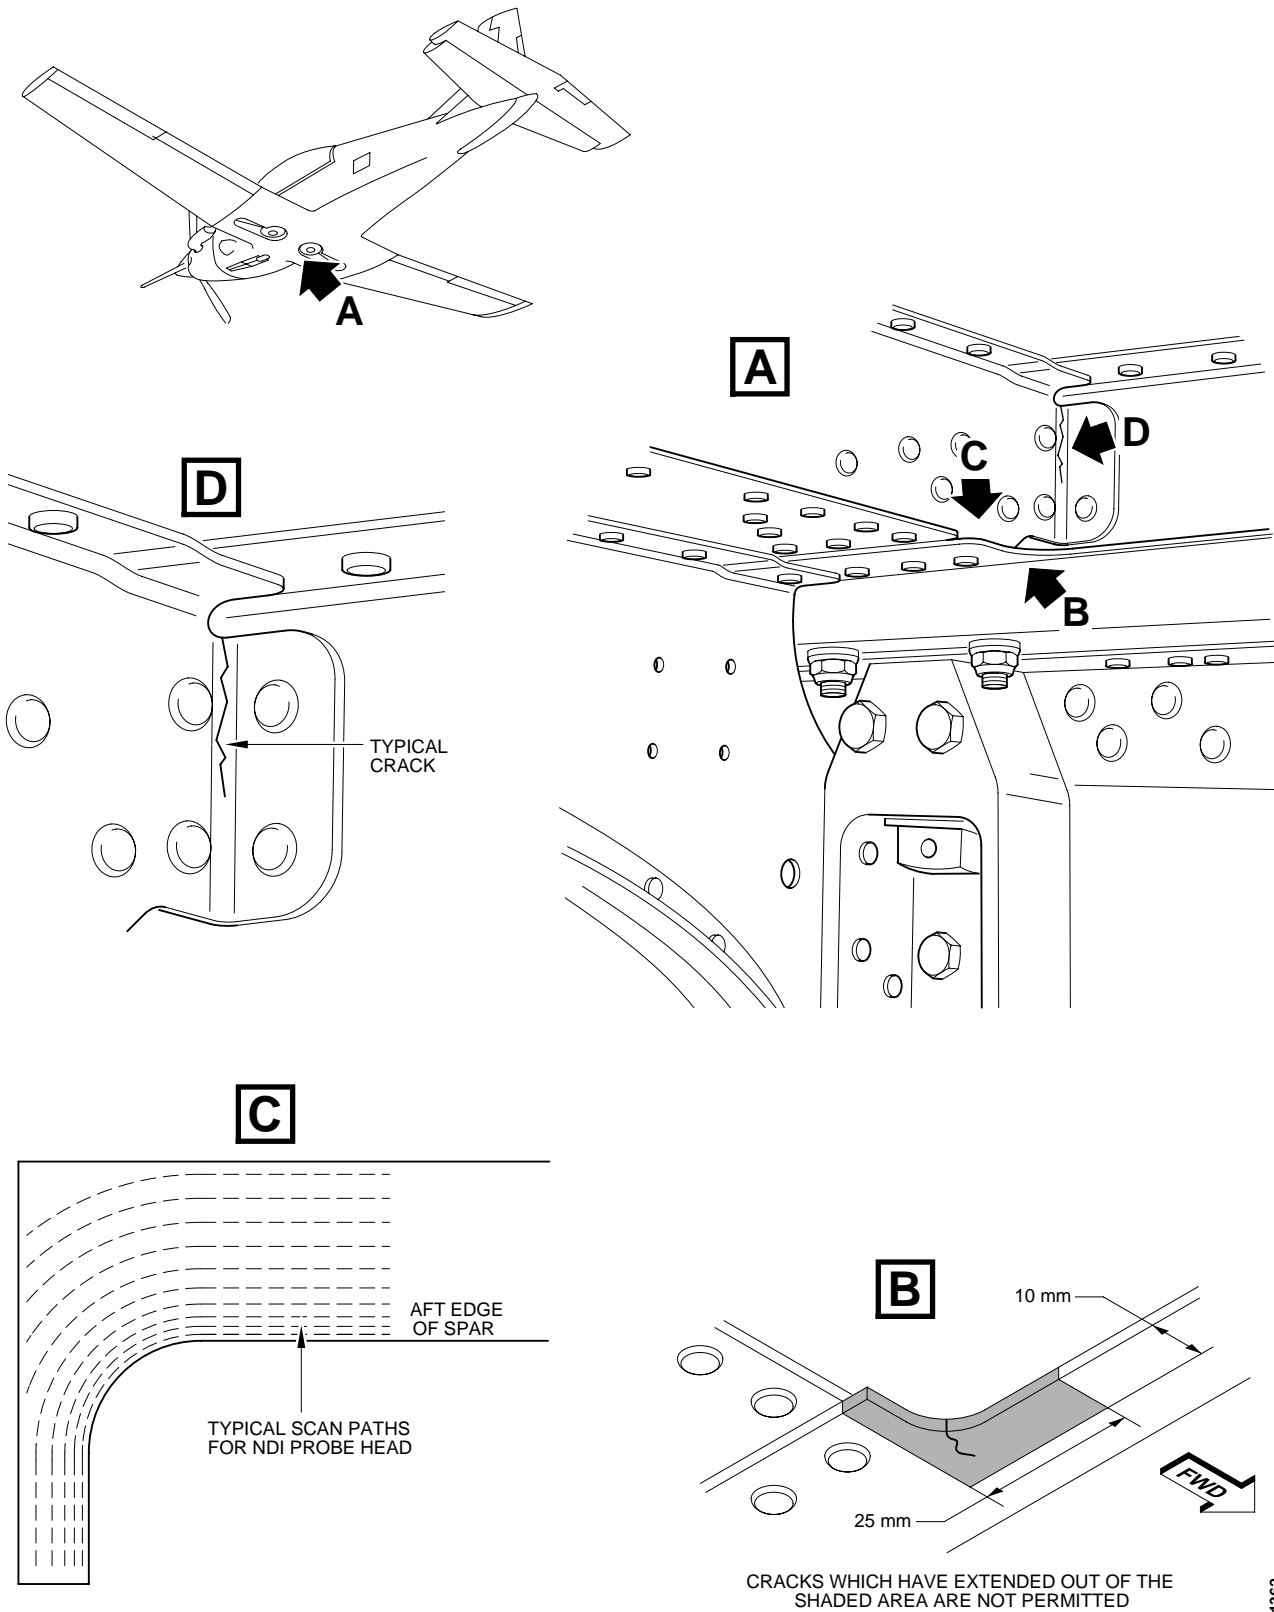
Nose Skin - Inspection
Figure 1

Crack damage can occur in the radii at the rear edge of the nose skin P/N: 111.34.07.434. The radii are adjacent to the left and right corners at the forward edge of the floor panel P/N: 111.34.07.530. Crack damage can also occur in the forward support structure of the floor panel adjacent to the skin panel.

Fatigue damage caused by stresses which occur normally during operation of the aircraft.

Cracks that have extended out of the limit areas shown are not permitted. Apply to PILATUS for instructions before the next flight if such cracks have occurred.

Do an eddy-current, non-destructive inspection (NDI) of the nose skin for crack damage and if necessary, apply to PILATUS for monitor/repair instructions.

Do an inspection for crack damage in the forward structure of the floor panel.

- (1) Use a source of bright light and a X10 magnifier and do an inspection of the forward area of the floor panel and the related structure at the locations shown (Ref. View D). Crack damage is not permitted. Apply to PILATUS for instructions if crack damage has occurred.
- (2) Do an NDI of the nose skin (Ref. Sect 4 and Views B and C). Cracks that have not extended out of the limit areas shown are permitted. Instructions to do subsequent inspections will be given in AMM, 05-10-20. The lengths of permitted cracks must also be monitored at the subsequent inspections.

- (1) Put the probe in position on the top of the skin in the inspection scan area.
- (2) Train the equipment.
- (3) Check train.
- (4) Zero the equipment.
- (5) Do a line scan on the nose skin as near to the edge as possible. Make sure you scan the full radius length (Ref. Fig. 1, Views B and C).
- (6) Do Step (5) again as many times as necessary to fully scan the inspection area shown. Make each line scan approximately 1,0 mm (0.04 in.) apart.
- (7) Do Steps (1) thru (5) again on the lower surface of the nose skin.
- (8) Do Steps (1) thru (7) again on the right inspection areas.
