**Lufttüchtigkeitsanweisung  
Consigne de navigabilité  
Prescrizione di aeronavigabilità  
Airworthiness directive**

**HB 91-144**

Main Landing Gear (MLG) - Cracks in the MLG leg housing - Inspection and repair, if necessary

## LANDING GEAR - CRACKS DETECTED IN MAIN LEG HOUSING

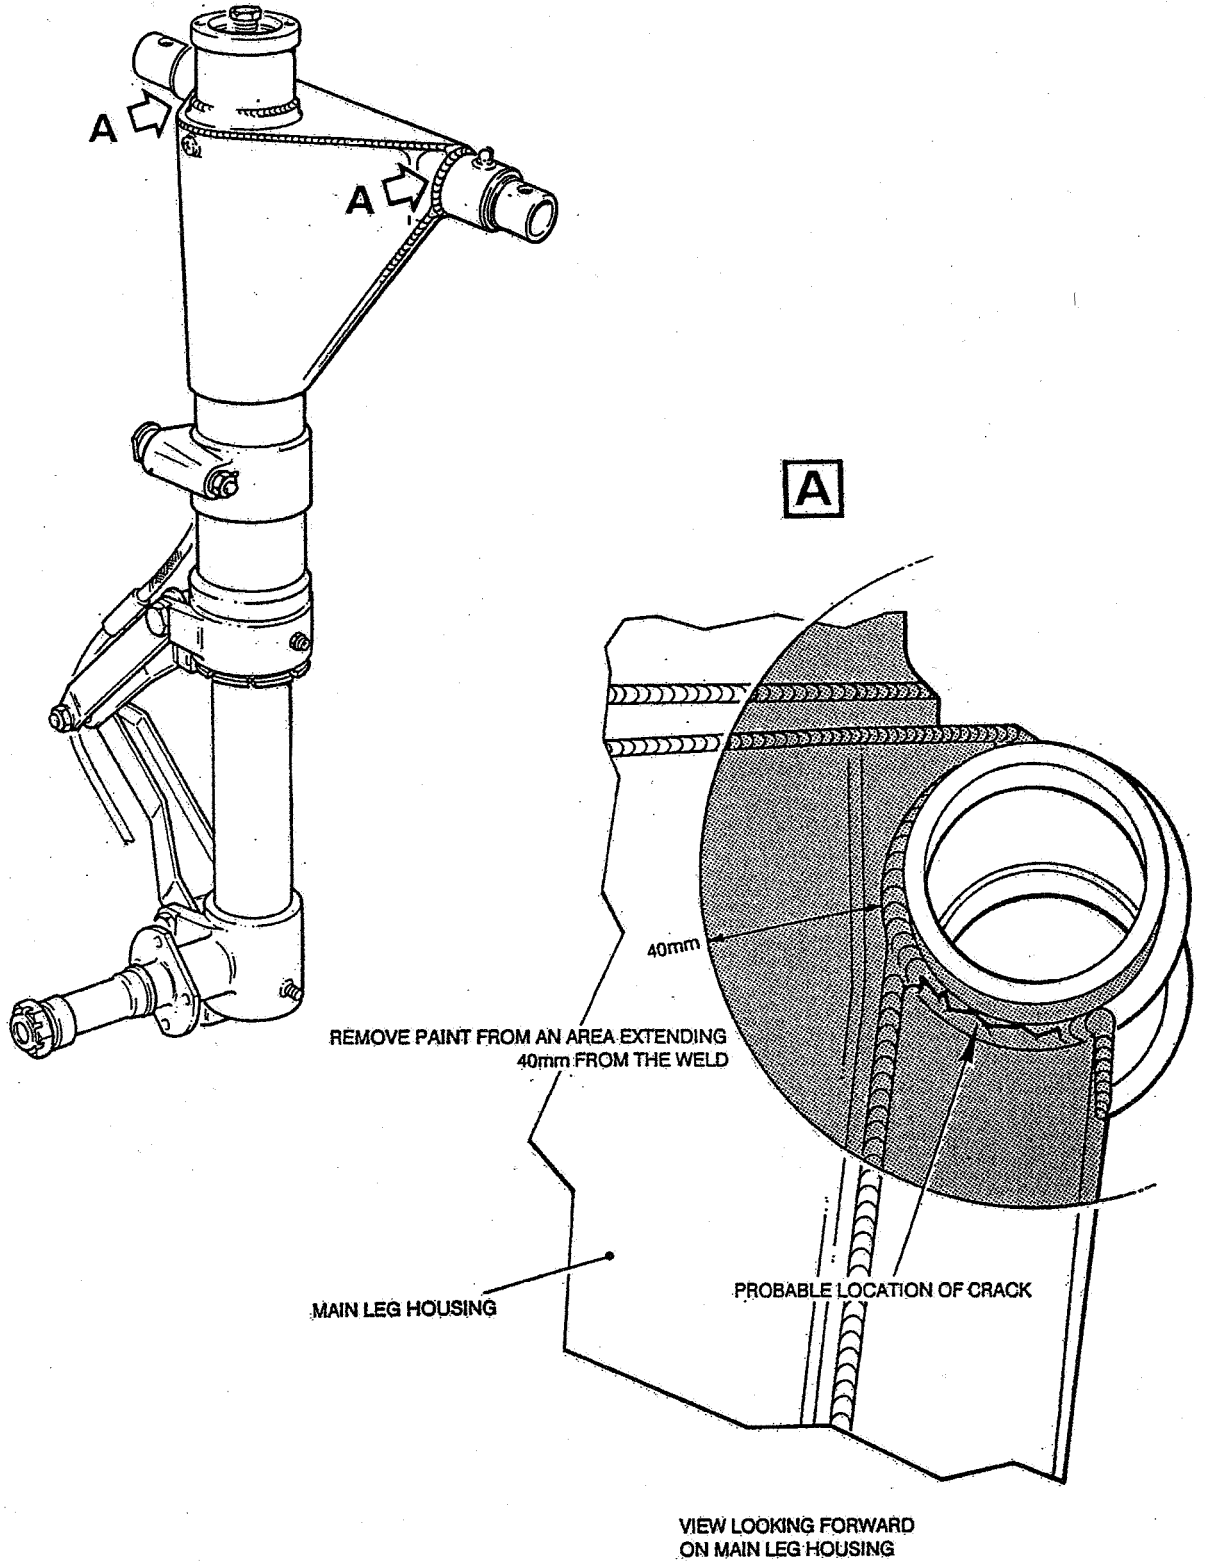
Main Landing Gear Installation - Location of Possible Cracks  
Figure 1

During a heavy landing inspection on a PC-7 aircraft, cracks were found in the leg housings of the main landing gear. The cracks were found in the fabricated part of the leg housing, in the welded seams at the upper axle attachment points (Ref. Fig. 1). Subsequent inspections of PC-7 aircraft as a result of this development, have confirmed other cases of cracks in the same location.

The main leg housings on PC-9 aircraft are of similar construction to those installed on the PC-7. Inspection of a number of PC-9 aircraft has revealed cracks in identical locations.

The cracks can be extremely difficult to detect, and it is not possible to do an "in situ" inspection with accuracy. The main legs must be removed from the aircraft and they must be inspected using magnetic flaw detection techniques.

- (1) Remove the paint from the area to be crack-tested.
- (2) Complete the applicable magnetic flaw detection test(s).
- (3) Repair any cracks which are detected using the TIG welding process.
- (4) Repair the paint finish on the main legs.

- (i) If no cracks were found during the inspection procedure, repeat the accomplishment instructions of this SB after 1000 flying hours or 2000 landings (whichever comes first).
- (ii) If a crack was found during the inspection procedure and the repair was completed by the Operator, after a further 500 landings, repeat the instructions given in para 2C (Inspection) of the Accomplishment Instructions. If no cracks are found on this inspection, proceed as in para (i) above. If cracks are found, return the defective item(s) to Pilatus for repair.
