PILATUS AIRCRAFT LTD. CH-6371 STANS, SWITZERLAND

SERVICE BULLETIN NO: 28-009

## FUEL - DISTRIBUTION FUEL BOOSTER PUMP - DAMAGE TO WIRES DURING INSTALLATION

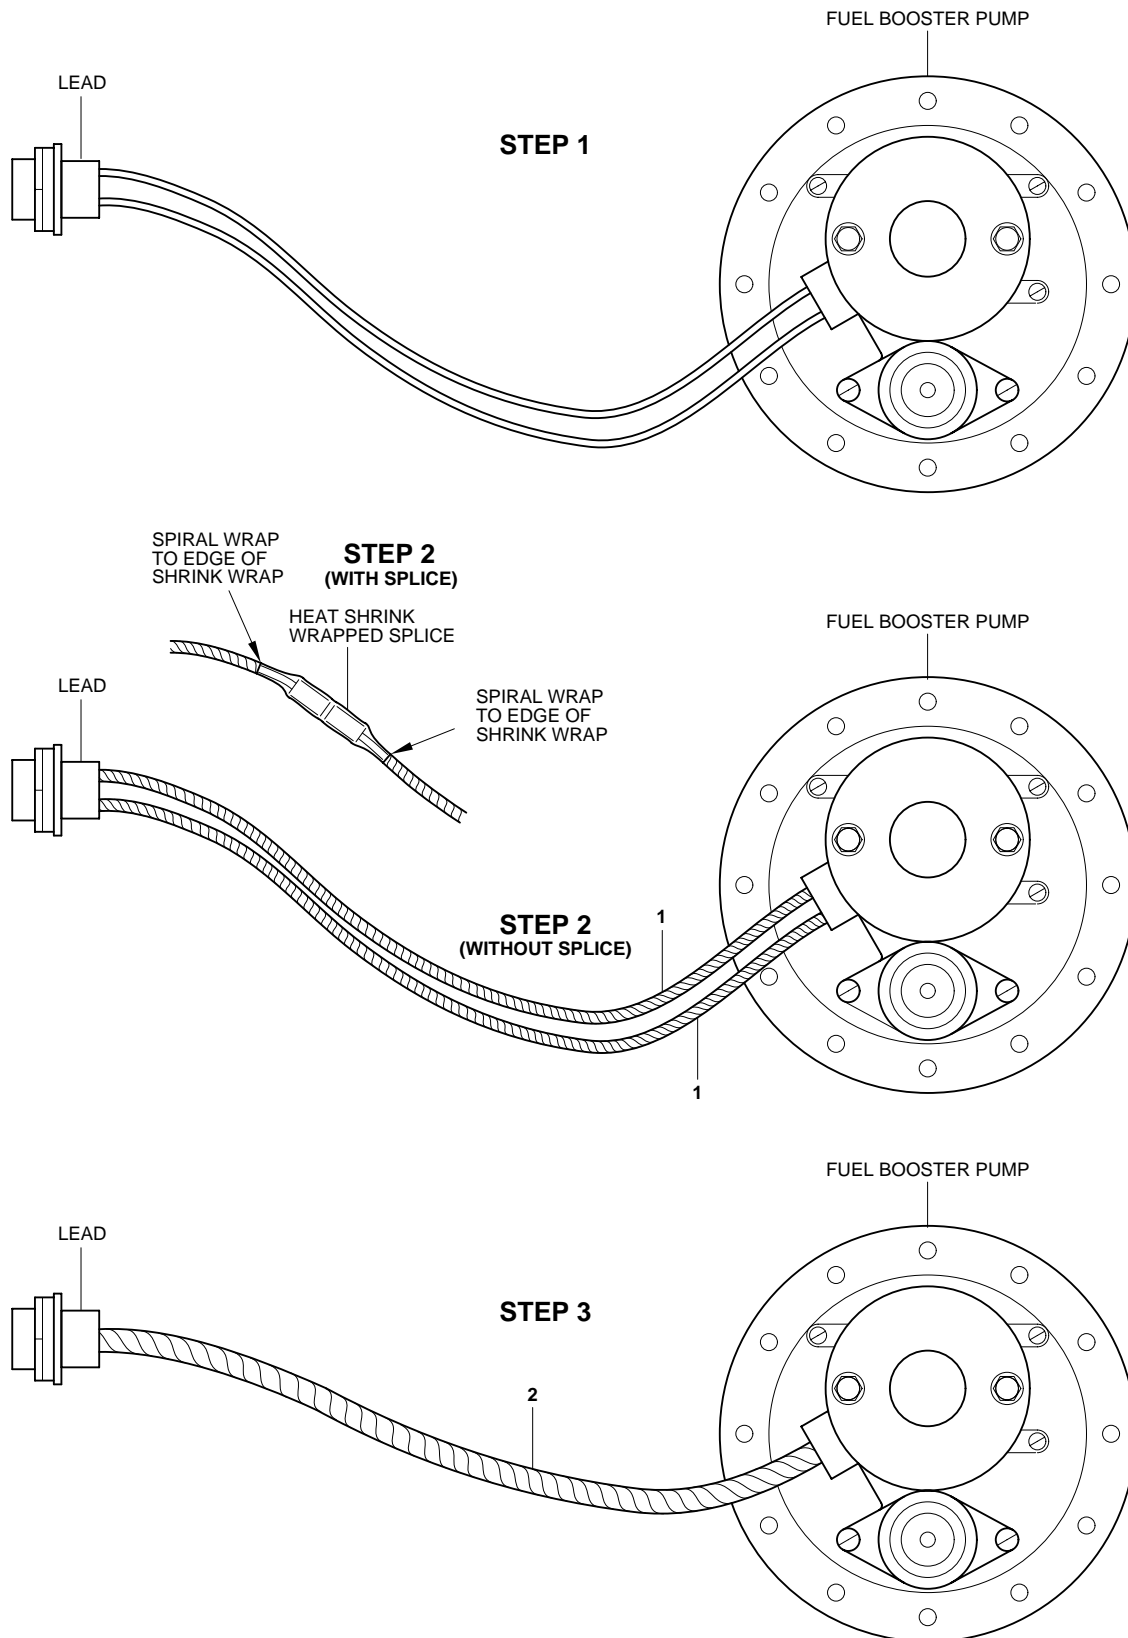
Lead Protection - Installation  
Figure 1

It is possible the electrical power wires (leads) to the left and right fuel pumps are damaged. This damage could cause an electric arc from the leads in an air/fuel mixture which can make a dangerous condition.

The damage can occur to the leads during the installation of the pump. It is also possible that the leads could rub during the operation of the aircraft.

- (2) Install the spiral wrap on each wire:
  - (a) For a wire with no splice. Wind spiral wrap (1) around the full length of the wire. Twist the spiral wrap (1) to make sure there are no gaps and cut the spiral wrap (1).
  - (b) For a wire with a splice. Wind spiral wrap (1) around the wire between the edge of the shrink wrap and the end of the wire. Twist the spiral wrap (1) to make sure there are no gaps and cut the spiral wrap (1). Do this for each side of the splice.
- (3) Release the black wire and the white wire.
- (4) Wind the spiral wrap (2) around the full length of the black wire and the white wire. Twist the spiral wrap (2) to make sure there are no gaps and cut the spiral wrap (2).

- (3) Install the spiral wrap on each wire:
- (a) For a wire with no splice. Wind spiral wrap (1) around the full length of the wire. Twist the spiral wrap (1) to make sure there are no gaps and cut the spiral wrap (1).
- (b) For a wire with a splice. Wind spiral wrap (1) around the wire between the edge of the shrink wrap and the end of the wire. Twist the spiral wrap (1) to make sure there are no gaps and cut the spiral wrap (1). Do this for each side of the splice.
- (4) Release the black wire and the white wire.

- (5) Wind the spiral wrap (2) around the full length of the black wire and the white wire. Twist the spiral wrap (2) to make sure there are no gaps and cut the spiral wrap (2).
- (6) Reidentify the fuel pump Part No. 968.84.11.401, 968.84.11.403 or 968.84.11.404 when this Service Bulletin is done. Use a stamp or vibropen to put the letter B immediately after the Serial Number on the fuel pump Identification plate.
