PILATUS AIRCRAFT LTD. CH-6371 STANS, SWITZERLAND

SERVICE BULLETIN NO: 57-002

## WING - MAIN SPAR - INSPECTION OF THE MAIN-LANDING-GEAR FRONT ATTACHMENT-BRACKETS

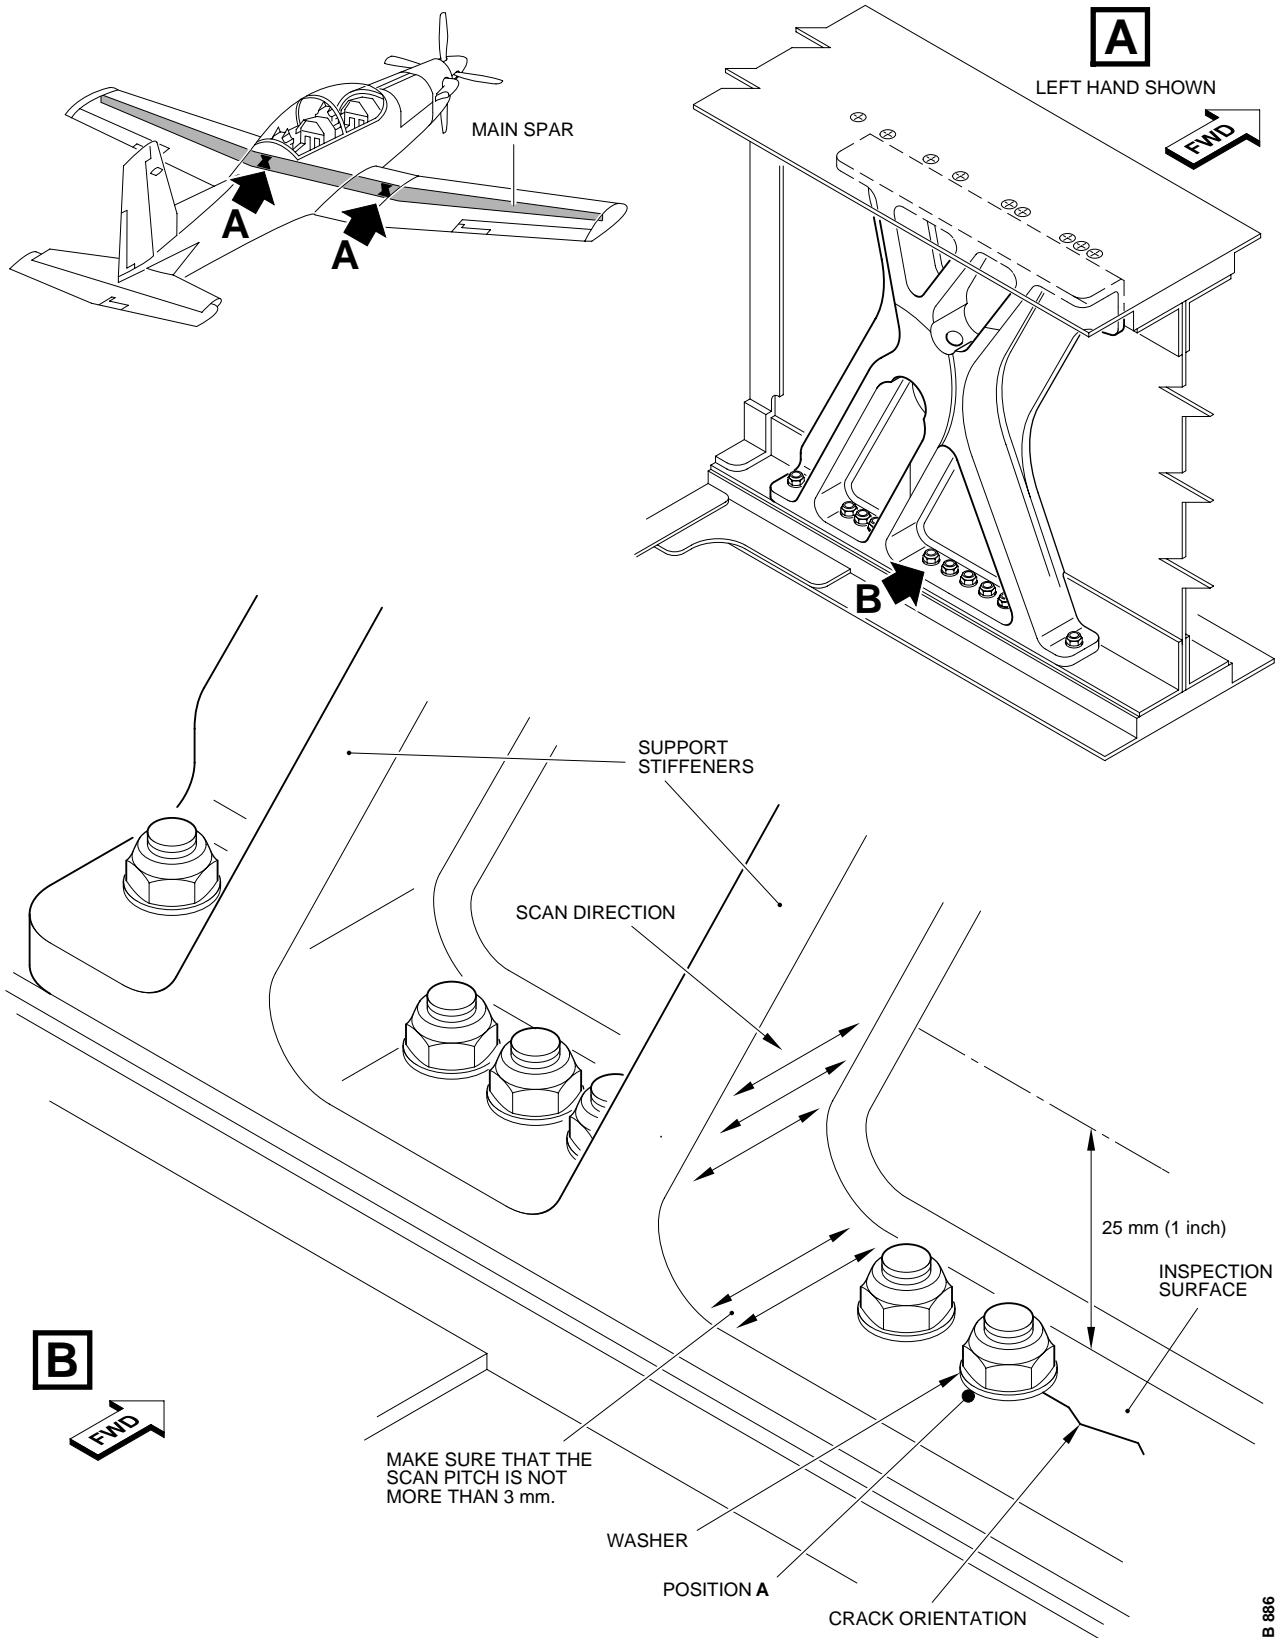
Inspection of the MLG Front Attachment Brackets - Surface and Scan Path Data  
 Figure 1

**B. Inspection of the MLG Front Attachment Brackets (Ref. Fig. 1)**

- (1) Put the probe on the inspection surface of the bottom flange of the left MLG attachment bracket so that it touches the washer of the fastener (Ref. Fig 1, Position A).
- (2) Do the balance procedure as given in the manufacturer's handbook.
- (3) From Position A, scan around the fasteners of the bottom flange. Use the washers as guides.
- (4) Scan the other accessible areas of the bottom flange. The inspection must include the radii of the support webs to a distance of 25 mm (1 inch) from the inspection surface.

**NOTE:** Edge effect and part geometry can cause a defect indication.

- (5) Scan the top flange as described for the bottom flange.
- (6) Record the results of the inspection (Ref. Para. D).
- (7) Scan the right MLG attachment bracket as described for the left MLG attachment bracket and record the results of the inspection (Ref. Para. D).

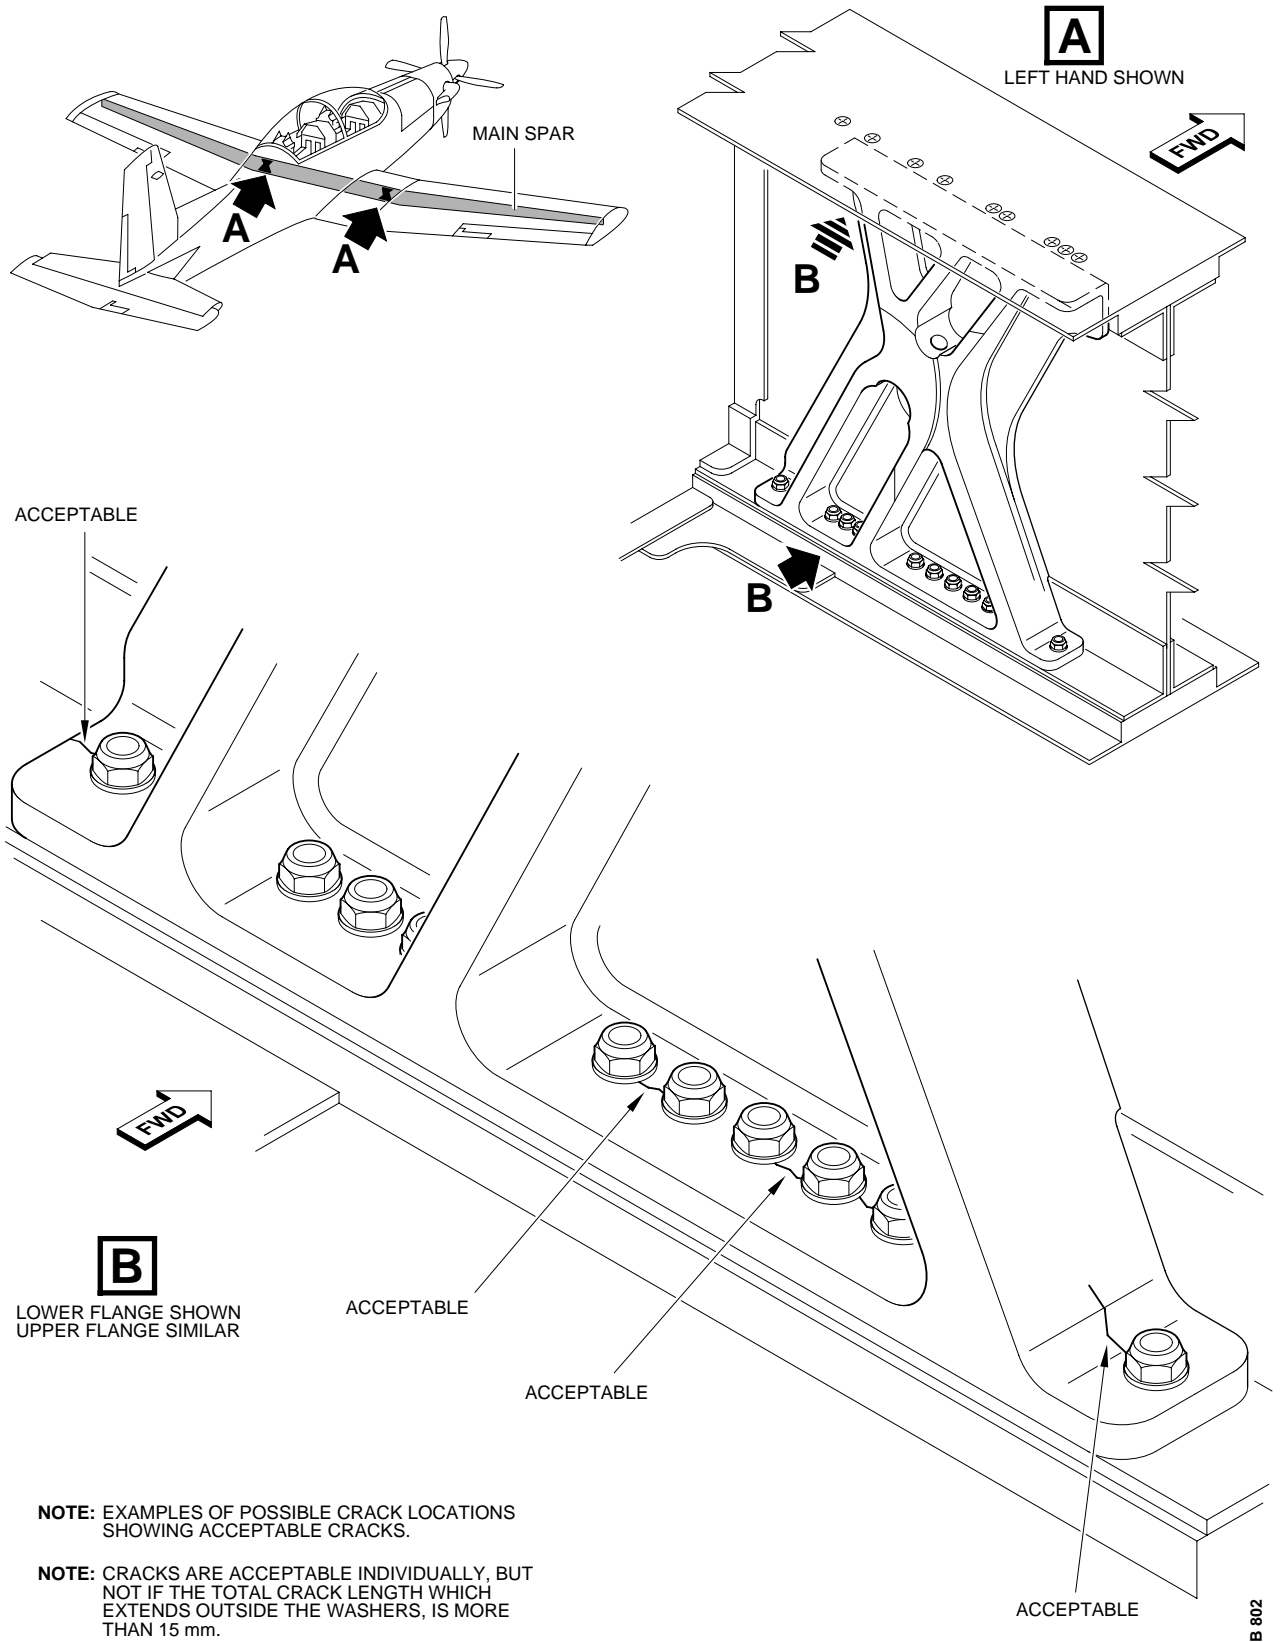
Inspection of the MLG Front Attachment Brackets - Crack Acceptance/Rejection Criteria  
Figure 2

**C. Acceptance/Rejection Criteria (Ref. Fig. 2)**

- (1) If the inspection shows more than five cracks, which extend from the edge of the washers, with a total crack length of more than 15 mm
  - Use the Inspection Report Form (Figure 4 and/or 5) to tell the result of the inspection to PILATUS.
  - Do not fly the aircraft until PILATUS have made an analysis of the the results. PILATUS will make a decision on the repair, replacement or inspection frequency necessary for each aircraft.
- (2) If the inspection shows no more than five cracks that extend along the flange and extend less than a total crack length of 15 mm from the edge of the washers, do as follows:
  - (a) Keep a record of the length and location of the crack(s) and the related aircraft details.

**NOTE:** The Aircraft Maintenance Manual (AMM) will be revised to include the inspection and inspection frequency.
- (3) Apply the Dinitrol AV 30 (Item No. P10-005C, liquid or spray) to the attachment nuts and washers and to the upper and lower flange. This will give protection against corrosion and ease regular inspection of the brackets.
