SERVICE BULLETIN

SERVICE BULLETIN NO: 57-004

WINGS - CENTER WING - INSPECTION AND MODIFICATION OF THE MAIN-SPAR DIHEDRAL FITTINGS

PILATUS
PC9
SERVICE BULLETIN

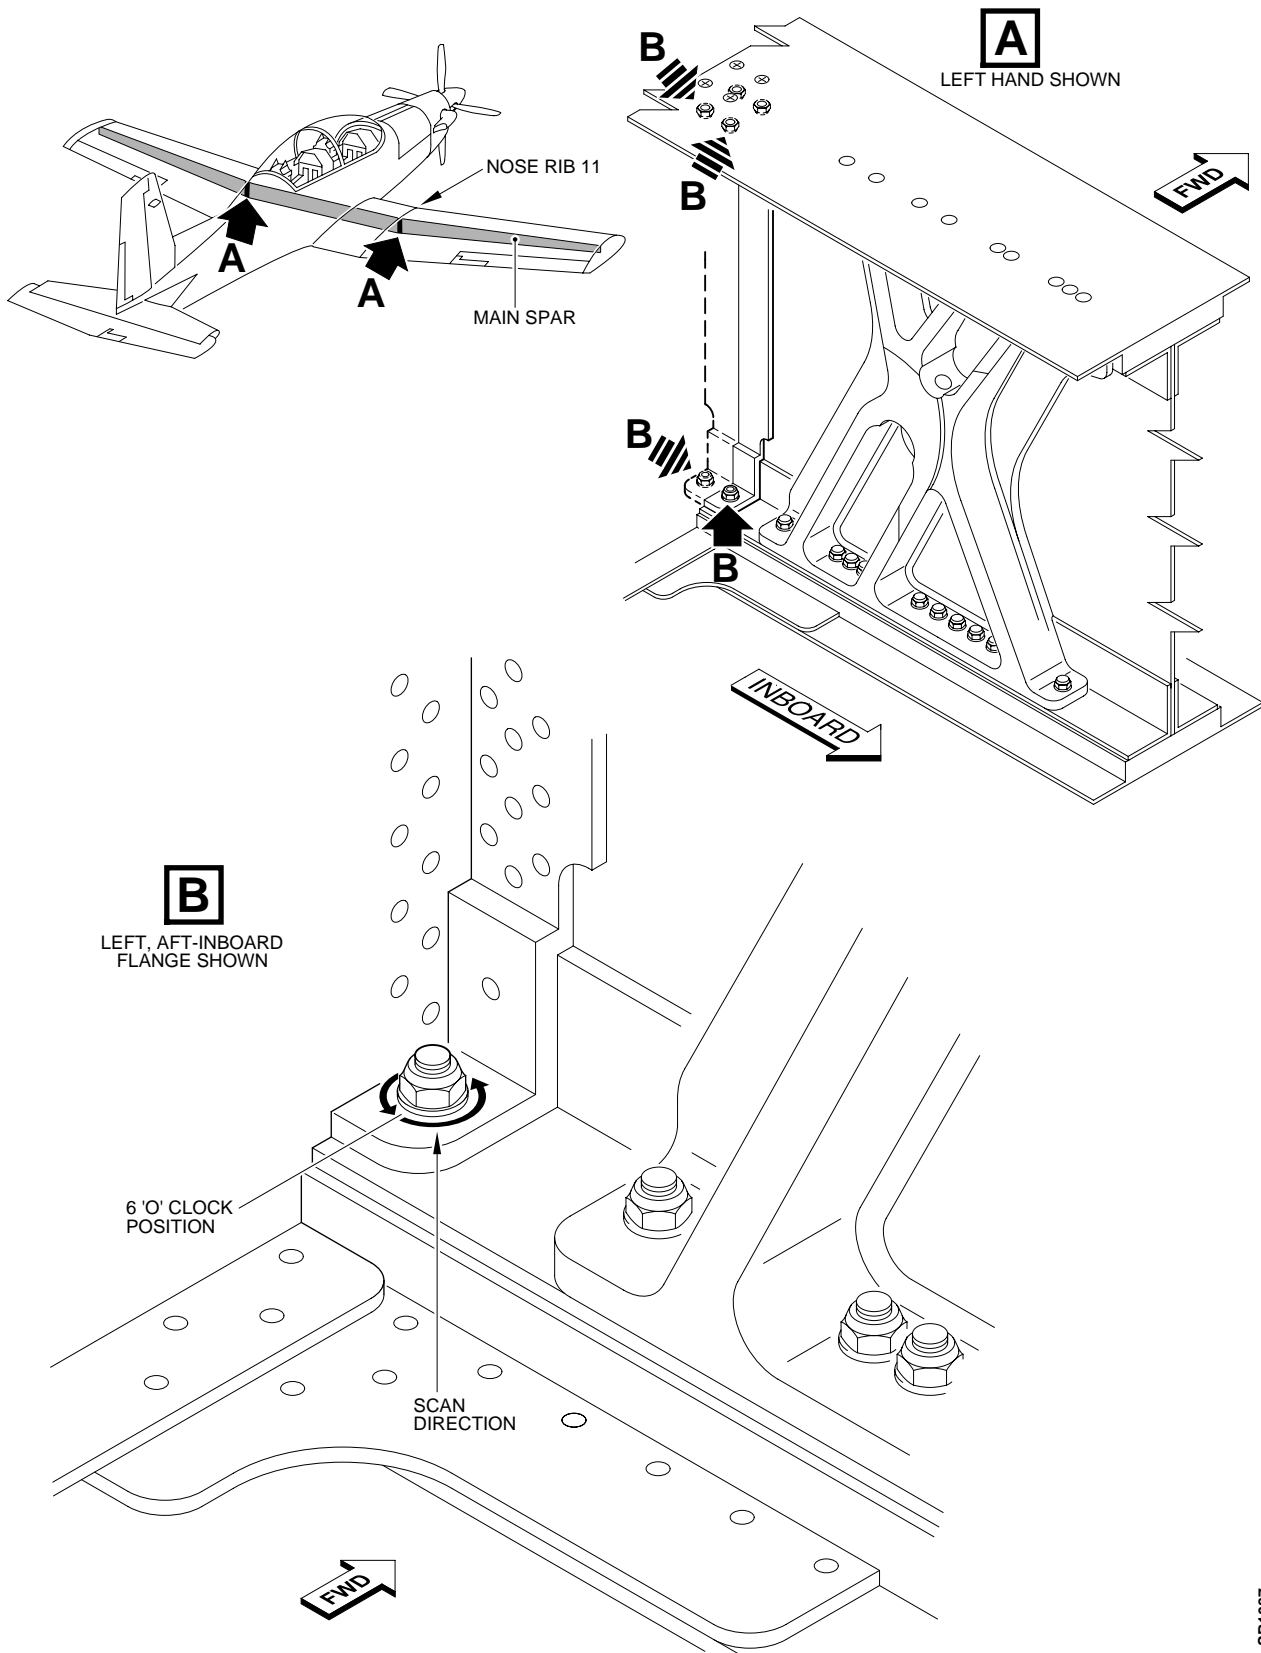
Eddy Current Inspection of the Wing Aft-Dihedral Fittings - Surface and Scan Path Data
Figure 1

B. Eddy Current Inspection of the Aft Dihedral Fitting Flanges (8 Locations) (Ref. Fig. 1)

- (1) A defect indication in a fitting that can be repeated and is not caused by edge effect or part geometry and is not in the permitted crack-damage area is not permitted.

Do not fly the aircraft until PILATUS has made an analysis of the results. PILATUS will make a decision on the repair, replacement or inspection frequency necessary for each aircraft.

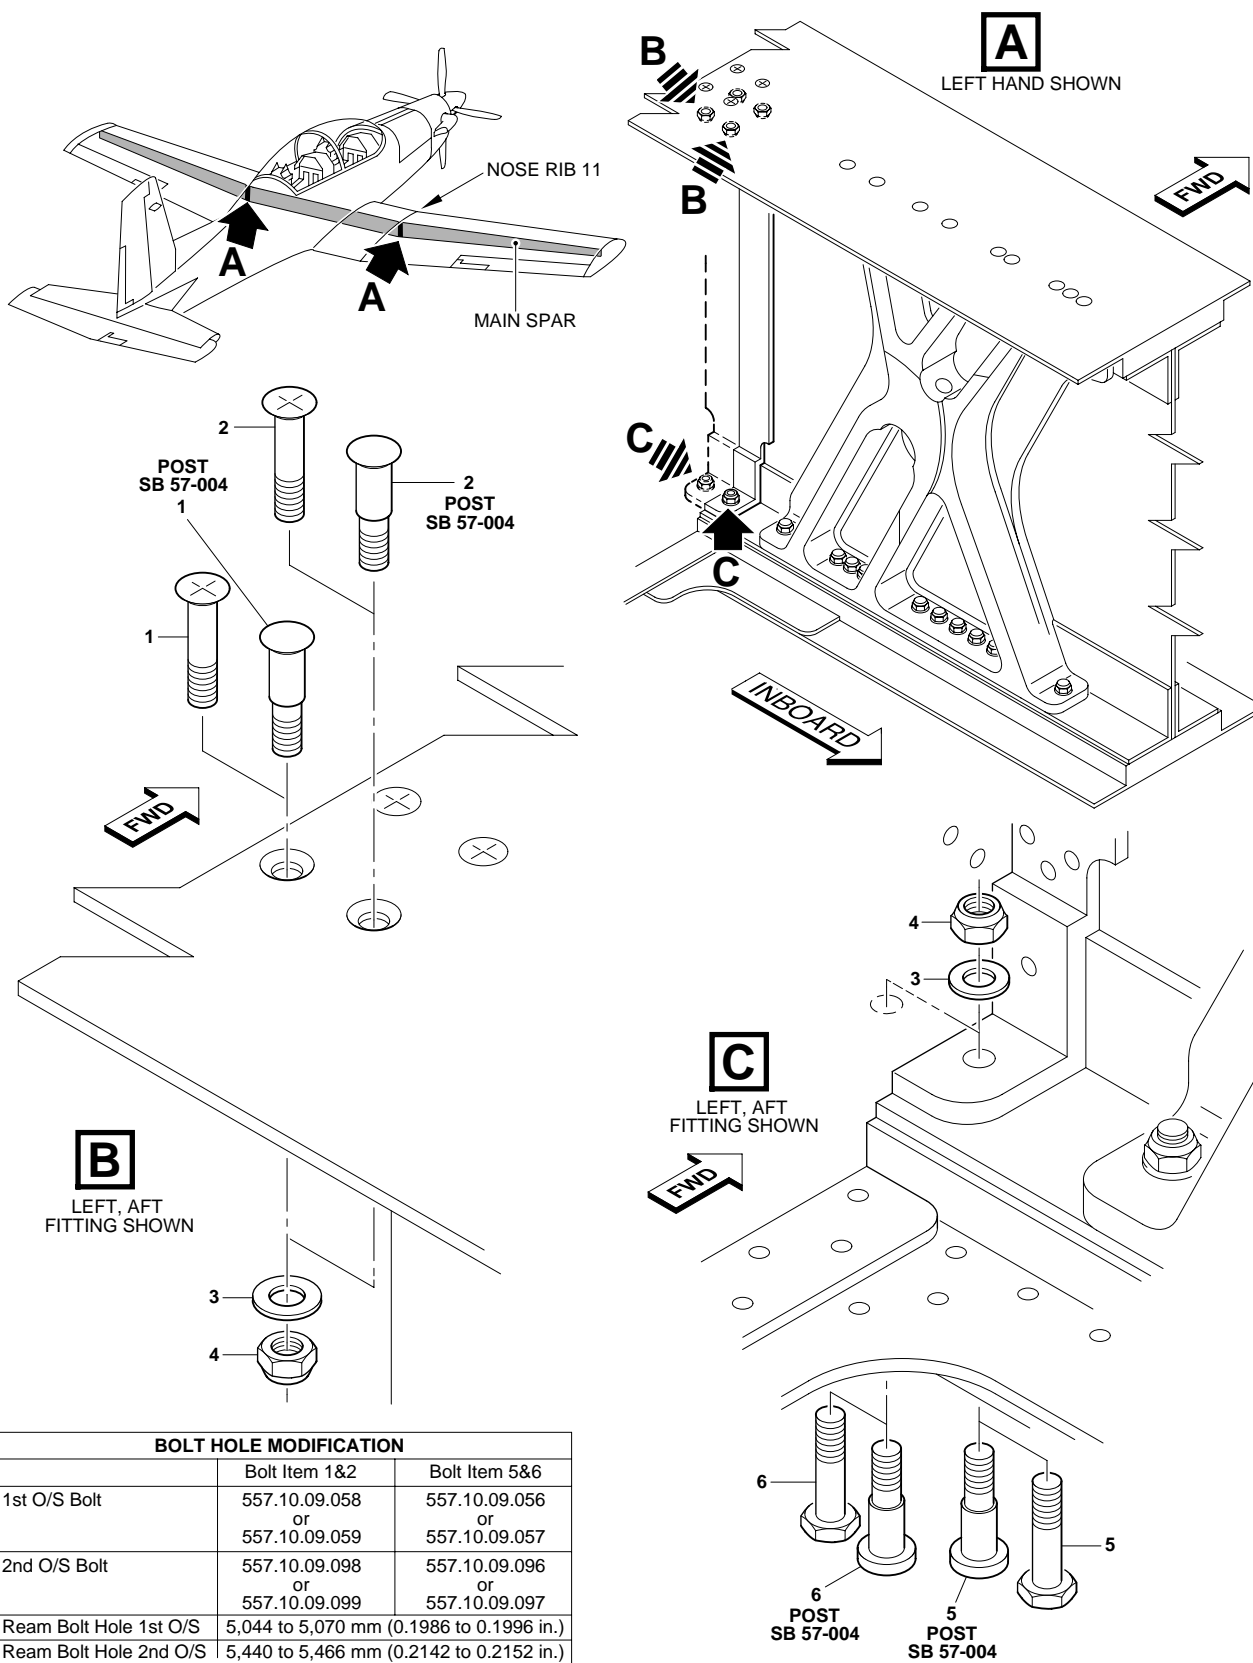
Aft Dihedral Fittings - Repair
Figure 5

Only do this modification to dihedral fittings at locations which have no cracks in the flanges. The modification removes high remaining stress from around the bolt holes so that stress corrosion will not start.

- (4) Use an applicable drift and carefully punch the bolts through the spar and the flange of the dihedral fitting.
- (5) Use the reamer (P/N: 513.57.09.086) to increase the diameter of the bolt holes to between 5,044 and 5,070 mm (0.1986 and 0.1996 in.).

- (12) Obey the manufacturer's instructions and apply corrosion preventative (Item No. P04-012) to the shanks of the new bolts (1), (2), (5) and (6).
- (13) Install the new bolts (1), (2), (5) and (6).

- (14) Install the new washers (3) and nuts (4). Torque the nuts (4) to between 4,0 and 5.0 Nm (35 to 45 lbf in.)
- (15) Clean unwanted sealant from the bolt head, nut and washer.

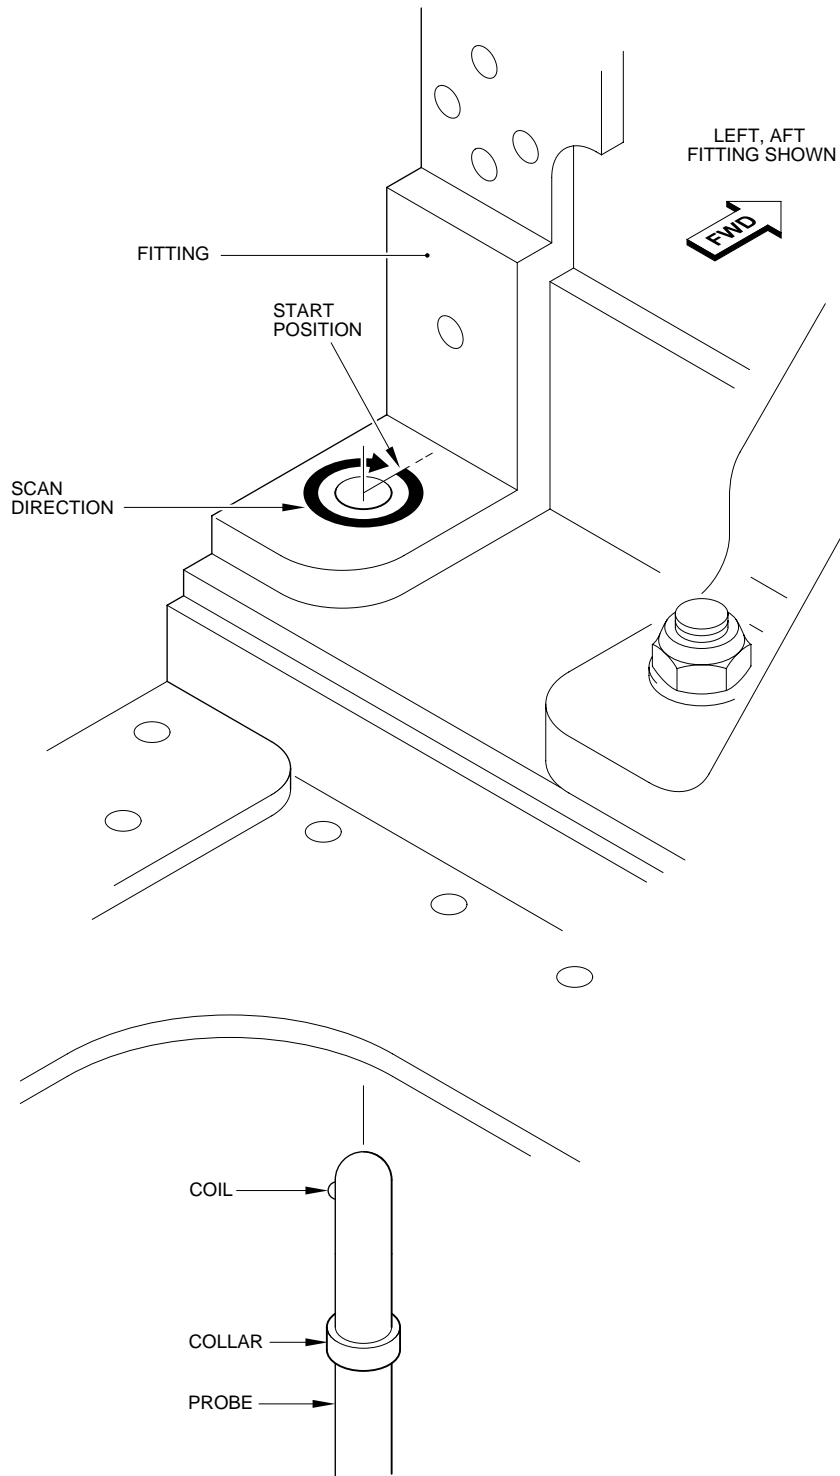
Eddy Current Inspection of the Wing Aft-Dihedral-Fitting Bolt-Holes - Surface and Scan Path Data
Figure 6

This procedure is applicable to the 4 bolt holes in each fitting, which were reamed out in Para. D.
