Service Bulletin No: 52-006

ATA Chapter: 52

**CANOPY - GENERAL
INSPECTION FOR CORRECT INSTALLATION OF THE HINGE ATTACHMENT RIVNUTS****1. Planning Information****A. Effectivity**

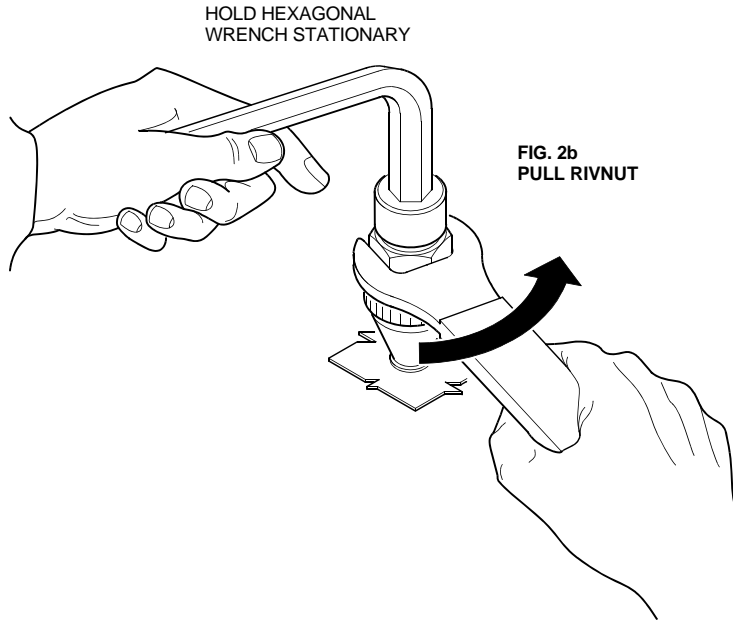
FIG. 2b
PULL RIVNUT

NOTE: 3/4 of a turn is the maximum required to completely deform the sleeve of a rivnut that is not correctly installed.

- (b) Pull the rivnut (Ref. Fig. 2b):

CAUTION: MAKE SURE YOU HOLD THE HAND TOOL PERPENDICULAR TO THE SURFACE OF THE CANOPY FRAME. YOU MUST NOT INSTALL THE RIVNUT AT AN ANGLE.

- 1 Insert the hexagonal wrench in the jackscrew of the hand tool.

- 2 Hold the hexagonal wrench stationary.

- 3 Use a wrench to turn the large hexagonal nut counter-clockwise for 3/4 of a turn.
