Service Bulletin No: 53-012

**FUSELAGE - GENERAL
INSPECTION FOR GALVANIC CORROSION ON THE UPPER LEFT LONGERON AND REPLACEMENT
OF THE CHAFING PLATES****1. Planning Information****A. Effectivity**

PC-9 aircraft MSNs 101 thru 248 and MSNs 501 thru 567.

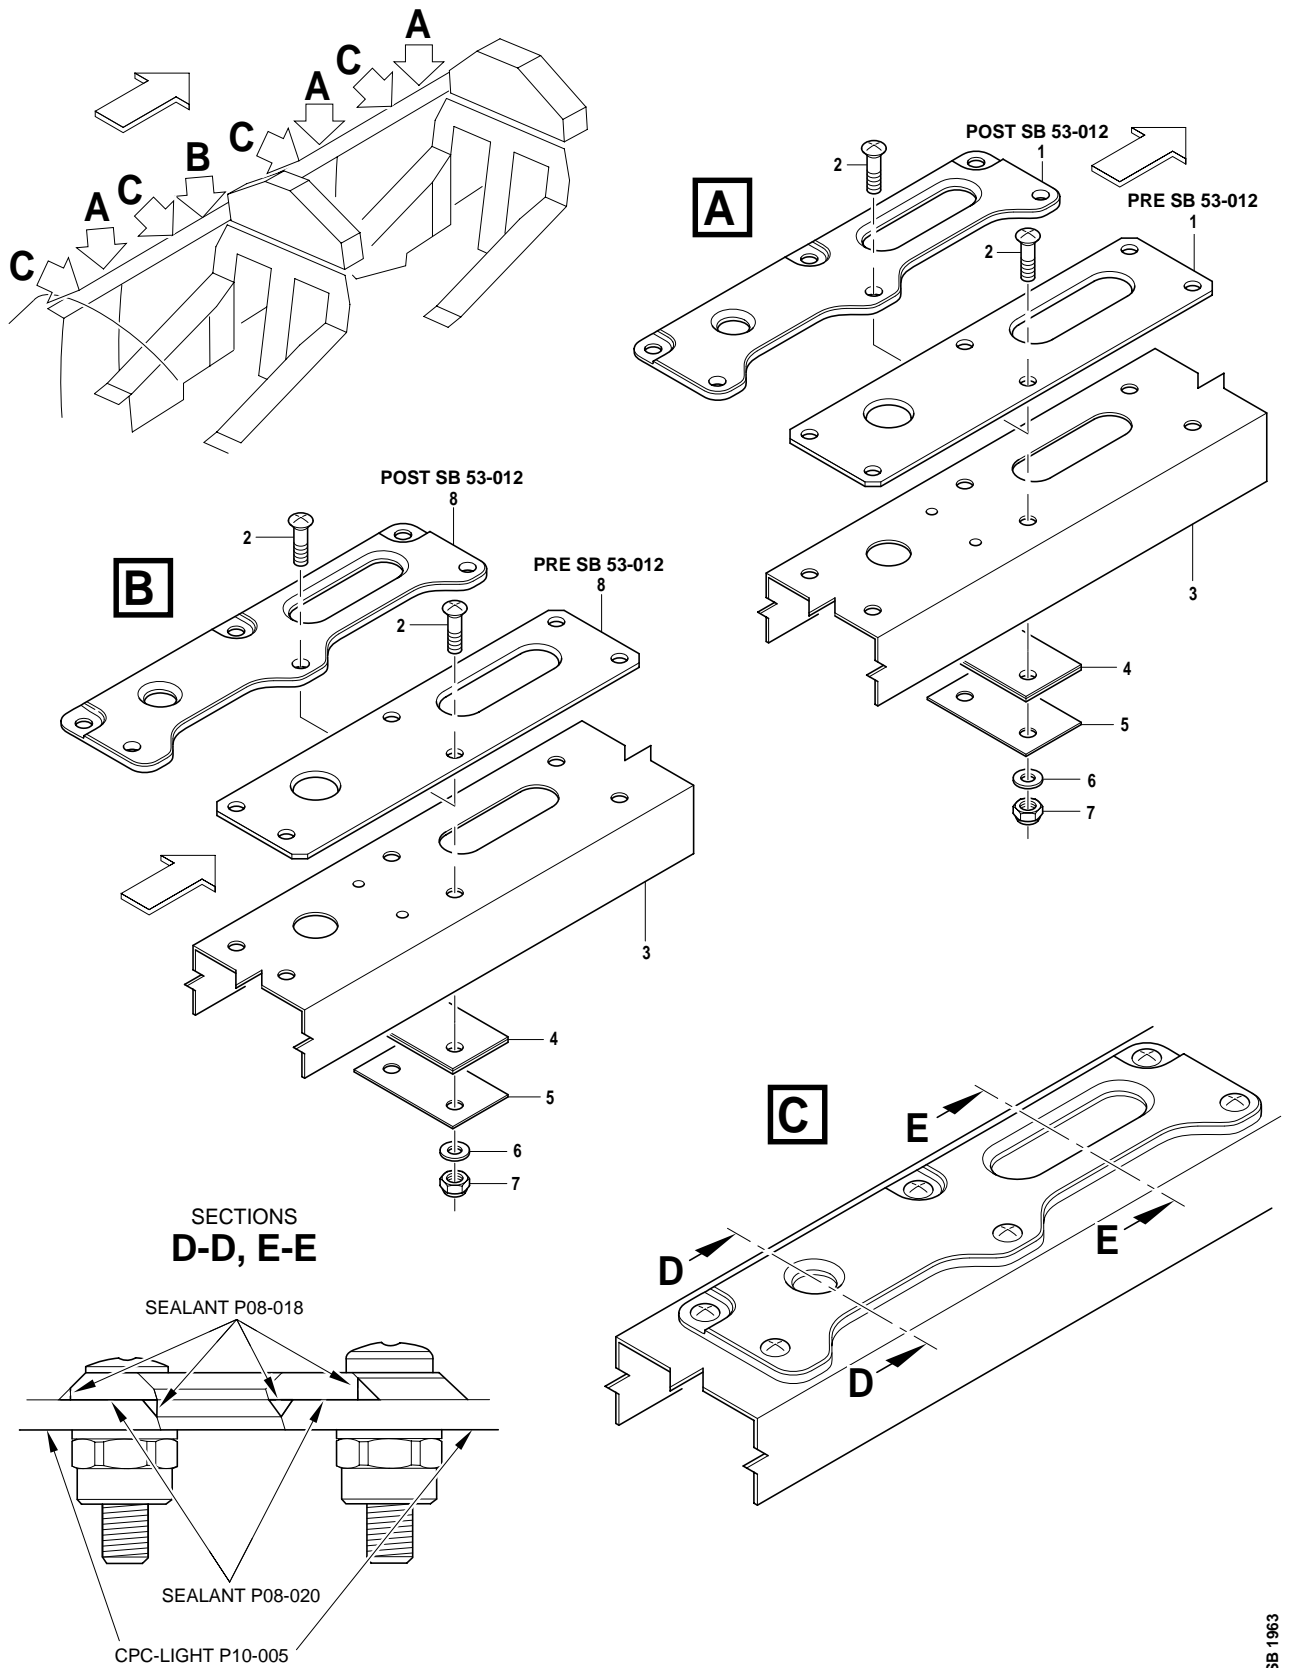
Canopy-lock Chafing Plates - Removal and Installation
Figure 1

Corrosion has been reported on the upper left longeron underneath the chafing plates for the canopy door latches.

The cause of the corrosion can be due to a number of reasons, for example:

- The use of liquid shim
- Excessive latch chafing that damages and causes removal of the sealant and nucleation of further galvanic corrosion
- Poor application of sealant or finishes such as Alodine to the blended aluminium
- The use of chemical paint stripper.

- (c) Use a X 10 magnifier and look for signs of corrosion in the areas of the chafing plates (1 and 8) on the upper and lower surfaces of the longeron (3) (Ref. SRM, 51-10-01).
- (d) If you find corrosion in Para. 3.B.(2)(c), obey the evaluation and assessment instructions (Ref. SRM, 51-10-02).
- (e) Remove the corrosion (Ref. SRM, 51-10-02) from the longeron (3).
- (f) After you have removed the corrosion in Para. 3.B.(2)(e), measure and record the thickness of the metal in the bare metal areas of the longeron (3). Make an entry in the Aircraft Logbook to record these values.

- (g) If the thickness of the remaining metal is less than:
- 1,8 mm (0.071 in.) at the FWD chafing plate (1) in the front cockpit
 - 2,3 mm (0.091 in.) at the AFT chafing plate (1) in the front cockpit
 - 2,1 mm (0.083 in.) at the FWD chafing plate (8) in the rear cockpit
 - 1,8 mm (0.071 in.) at the AFT chafing plate (1) in the rear cockpit,

Do an inspection of the longeron in the specified areas and, if necessary, remove the corrosion. Apply to Pilatus for a repair scheme if the removal of corrosion decreases the metal thickness to less than the specified limits. Install new, more robust, chafing plates.

- (k) Put the new chafing plates (1) (P/N 553.20.09.326) and (8) (P/N 553.20.09.327) in position on the longeron (3).
 - (l) Put the locking plate assemblies (5) and shim packs (4) in their recorded locations on the longeron (3) (Ref. Para 3.B.(1)).

- (m) Install the new screws (2) (P/N 935.63.11.065), the new washers (6) (P/N 938.77.11.111) and the new nuts (7) (P/N 938.07.68.303).
 - (n) Remove the unwanted sealant (Material No. P08-020).

- The chafing plates (1)
 - The chafing plate (8)
- As shown in Detail C and Section D-D and E-E.
- (q) Apply a layer of the CPC-Light (Material No. P10-005) to the lower surface of the longeron (3) in the areas of the chafing plates (1) and the chafing plate (8).
