**Service Bulletin No:** 53-013  
**Modification No:** EC-09-0734

**FUSELAGE - GENERAL  
INSPECTION OF THE FORWARD ELECTRICAL BONDING POINTS**

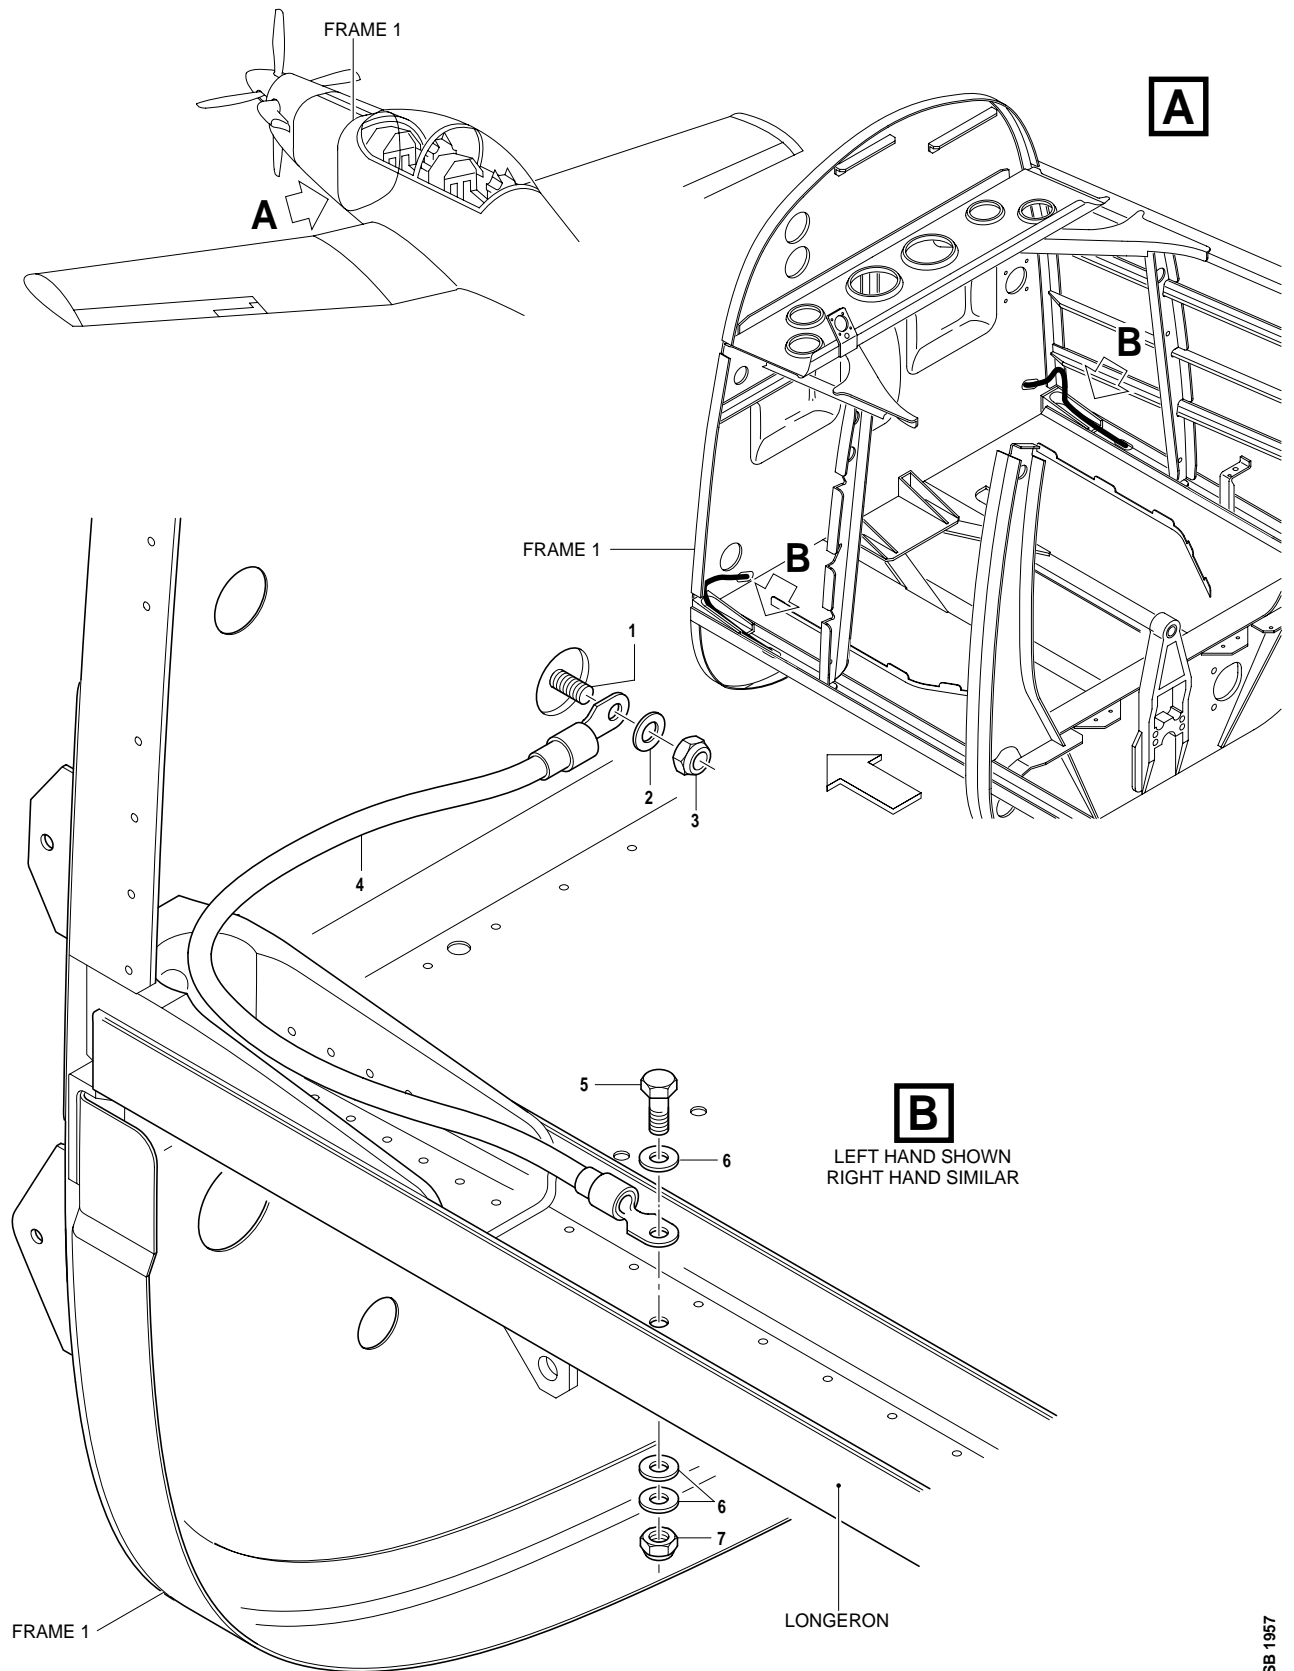
Bonding Strap - Removal/Installation  
Figure 1

Corrosion has been reported at the bonding strap connections on the left and right lower longerons between fuselage frames 1 and 1A.

The contact faces of the longeron and bonding strap are susceptible to corrosion. The possibility of corrosion is increased because of the high electrical current flow between the tinned copper terminal lug of the bonding strap and the aluminum longeron.

- (1) If the bonding connection is oversealed, use a non-metallic scraper and solvent (Material No. P01-008) to remove the sealant.
- (2) Remove the nut (7) and the washers (6).

- (3) Remove the bolt (5) and washer (6) to disconnect the terminal lug of the bonding strap (4) from the longeron.

- (a) Use absorbent paper (Material No. P02-031) and solvent (Material No. P01-008) to clean:
  - the bore of the bolt hole
  - the top surface of the longeron around the bolt hole
- (b) Do a visual inspection for corrosion in the bore of the bolt hole and the area around the bolt hole. If necessary, use a borescope to do this.
- (c) If you find corrosion, do the Repair (Ref. Para. D.).

- (a) Use absorbent paper (Material No. P02-031) and solvent (Material No. P01-008) to clean the terminal lug of the bonding strap (4).
- (b) Examine the terminal lug for corrosion.
- (c) Remove all corrosion with Scotch-Brite (Material No. P02-016).
- (d) Examine the terminal lug again to make sure the protective tin coating is serviceable. If you can see the copper metal of the terminal lug, remove the bonding strap (4) as follows:

1 Connect the bonding strap (4) to the longeron with the bolt (5) the washers (6) and the nut (7).

(e) Torque tighten the nut (7) to the measured run-down torque plus between 11 and 16 Nm (100 and 140 lb in.).

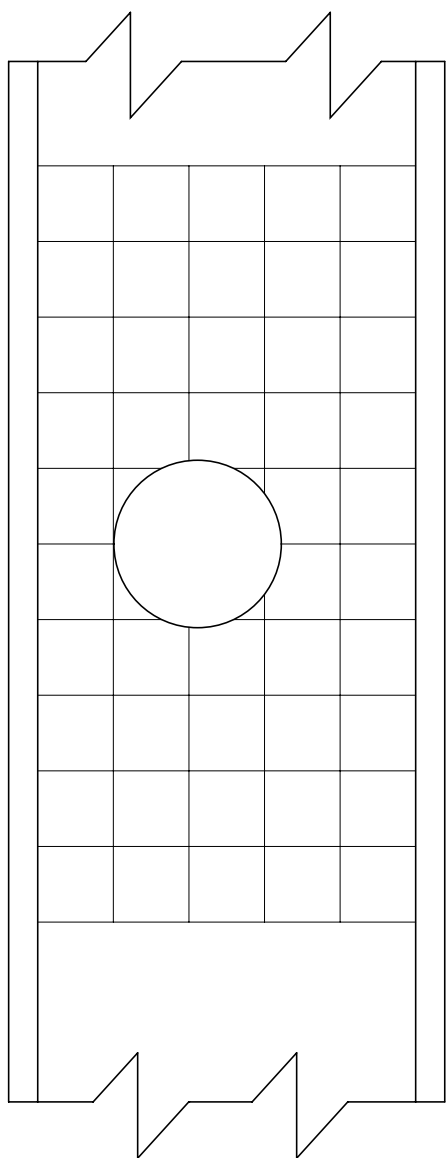
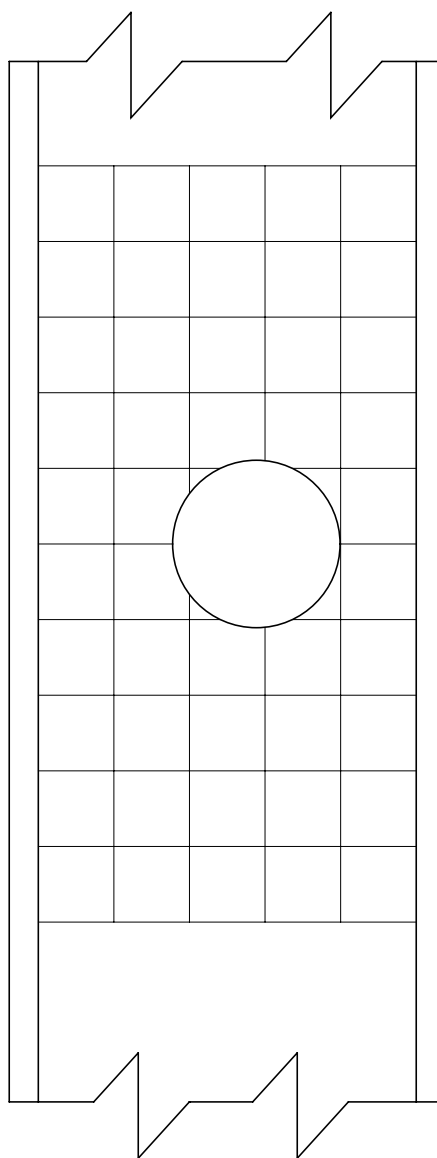
Report Form  
Figure 2

- (9) Measure (with the ultrasonic thickness gage) and record this data on a copy of the Report Form (Fig. 2):
  - The minimum thickness of the metal in the repaired area(s). Use the grid on the Report Form to record the position of the measurement(s)

- The shape and area(s) where you removed corrosion
- (10) If the thickness of the longeron at any position is less than 1,9 mm, stop the procedure and contact Pilatus for more repair information:
