**Service Bulletin No: 53-014**  
**Modification No: INSPECTION**

**Ref No: 121**  
**ATA Chapter: 53**

**FUSELAGE - GENERAL**  
**INSPECTION FOR CORROSION ON THE UPPER LEFT AND RIGHT LONGERONS ADJACENT TO FRAME 4**

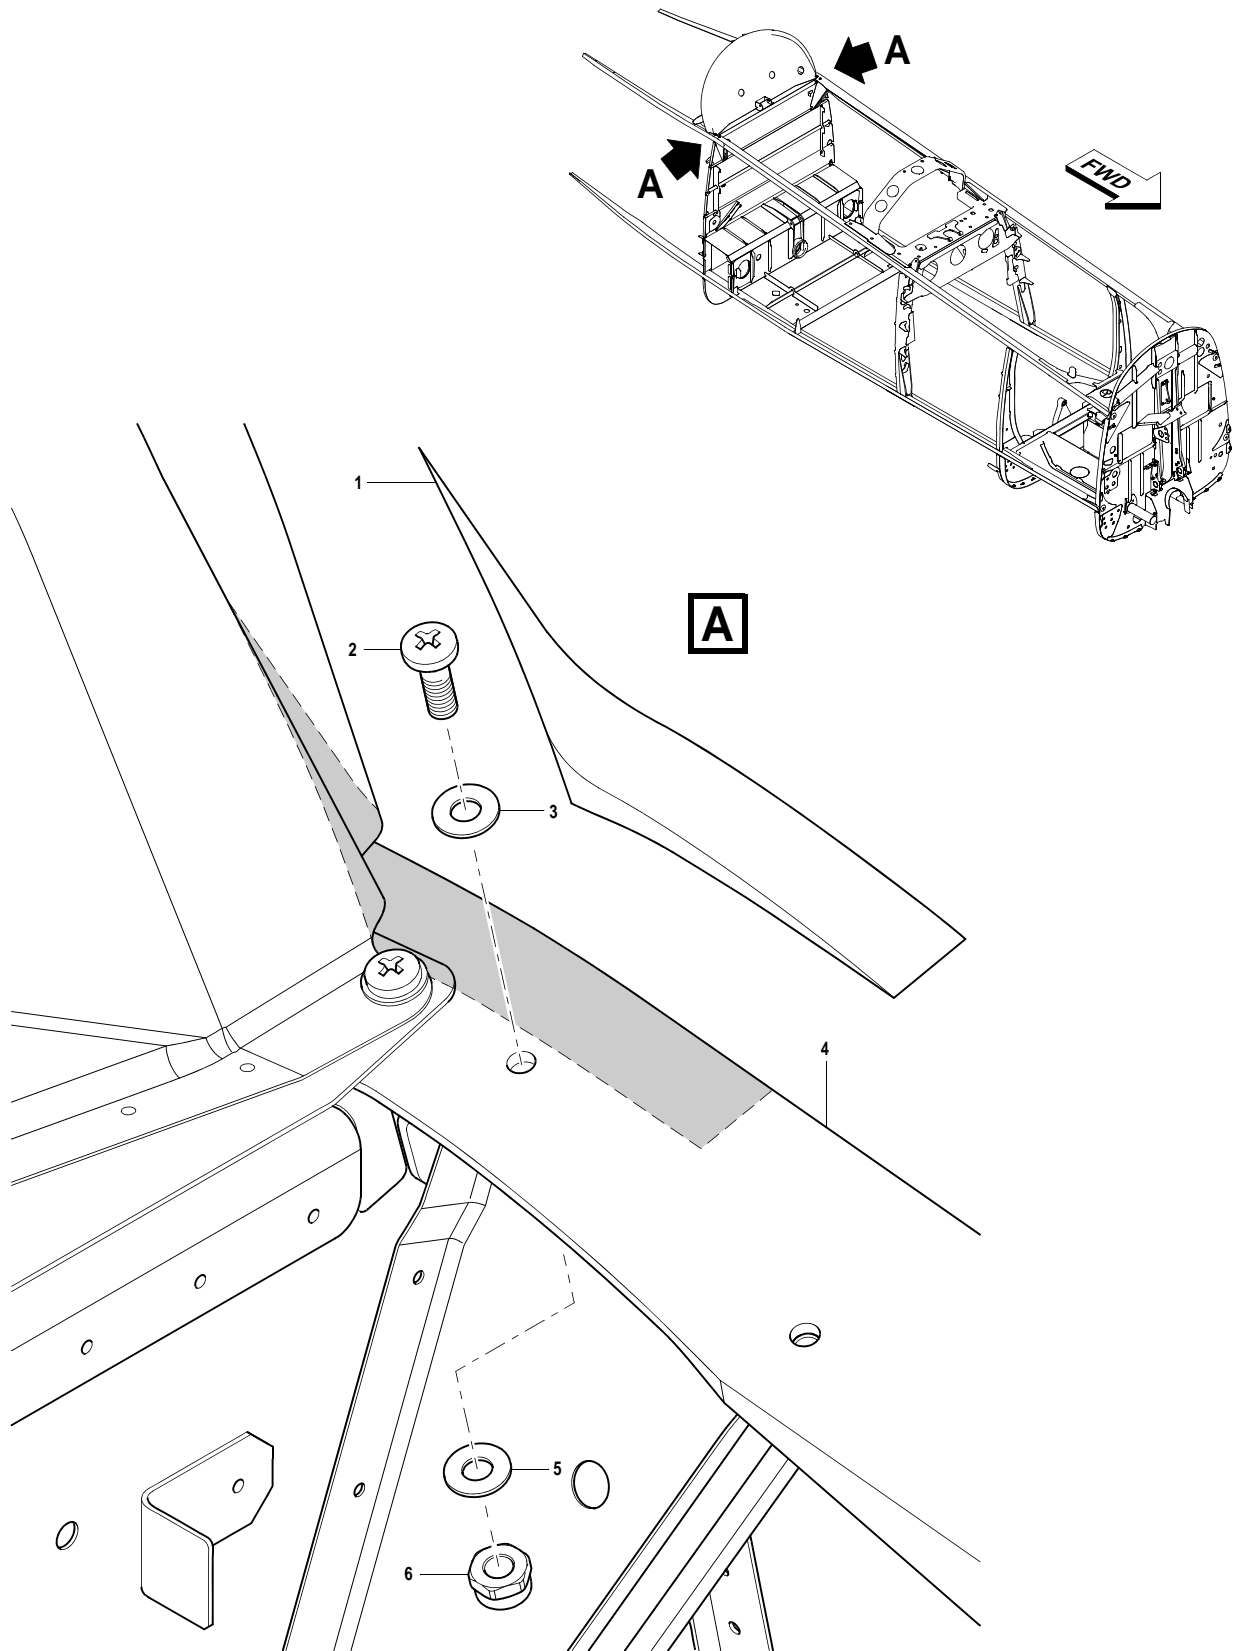
Wedge Ends - Removal and Installation  
Figure 1

Corrosion has been reported on the upper left and right longerons underneath the wedges installed at the joint with FR4.

The cause of the corrosion is most probably due to water ingress through the sides of the fiberglass where the adhesive (used to bond the wedge to the longeron) was not sufficiently watertight.

Do an inspection of the longeron in the specified areas and, if necessary, remove the corrosion. Install a new wedge and seal the area with sealant.

- (b) Remove the nut (6), the washers (3 and 5) and the screws (2).
- (c) Carefully remove the fibre glass wedge (1) from the longeron (4) with the round nose metal spatula or scraper (or equivalent tool).

- (b) Use a X 10 magnifier and look for signs of corrosion in the areas of the left and right wedge ends on the upper surface of the longeron (4) (Ref. SRM, 51-10-01).

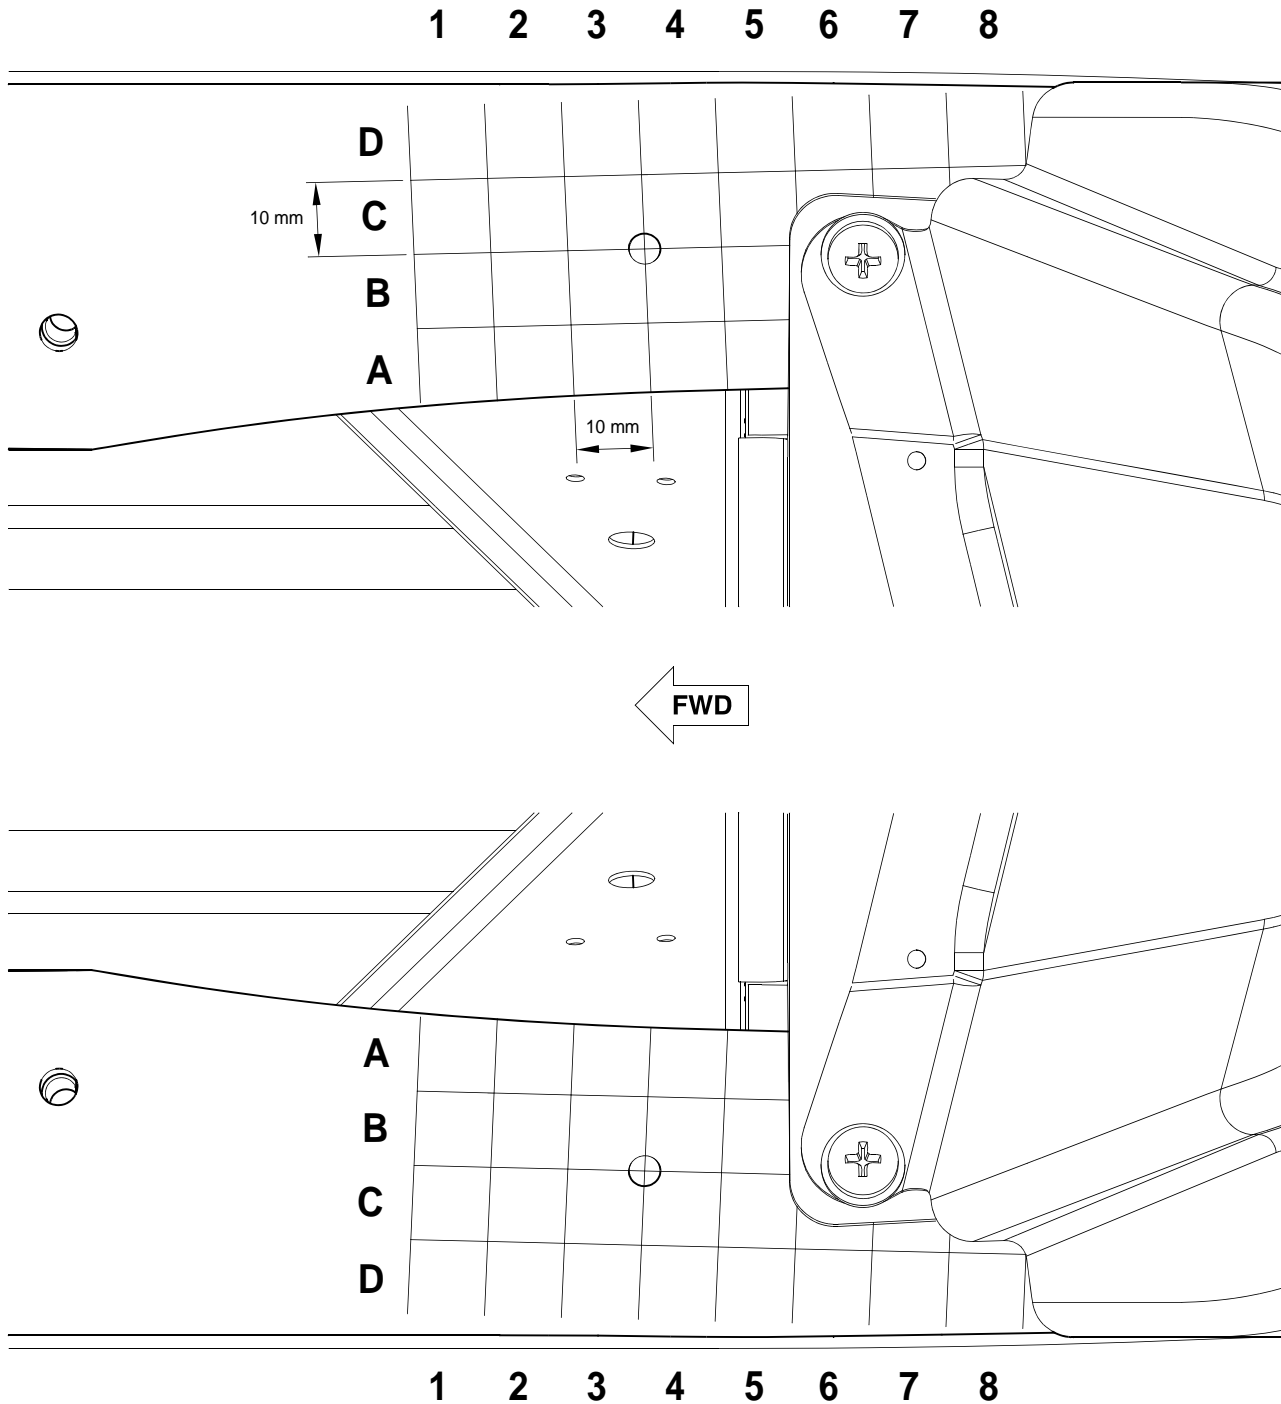
Feedback Form (Rear Cockpit)  
Figure 2

- (f) If you do not find corrosion in Para. 3.B.(2)(b), measure and record the thickness of the metal in the bare metal areas of the longeron (4). Metal thickness which is less than 2.5 mm (0.098 in.) shows that a blend repair has been done in the area. Make an entry in the Aircraft Logbook to record the thickness if you find that a blend repair has been done.

**NOTE:** The nominal thickness of the metal is  $2.7 \pm 0.2$  mm ( $0.106 \pm 0.008$  in.). You can use the feedback form (Ref. Fig. 2) to record the values.

**NOTE 1:** You can use the feedback form (Ref. Fig. 2) to record the values. Align the holes in the longeron (4) with the holes drawn in the Figure.

- (g) If the recorded metal thickness in Para. 3.B.(2)(e) is less than 1.4 mm (0.055 in.), use the feedback form (Ref. Fig. 2) to record the values and apply to Pilatus for a repair scheme. The address is:
