PILATUS AIRCRAFT LTD. CH-6371 STANS, SWITZERLAND

SERVICE BULLETIN NO: 57-015

WINGS - INNER WING INSPECTION FOR DAMAGE TO THE WING BOTTOM SKIN BETWEEN RIBS 5 AND 11

PC-9 aircraft up to and including MSN 188 and MSN 501 thru 567.

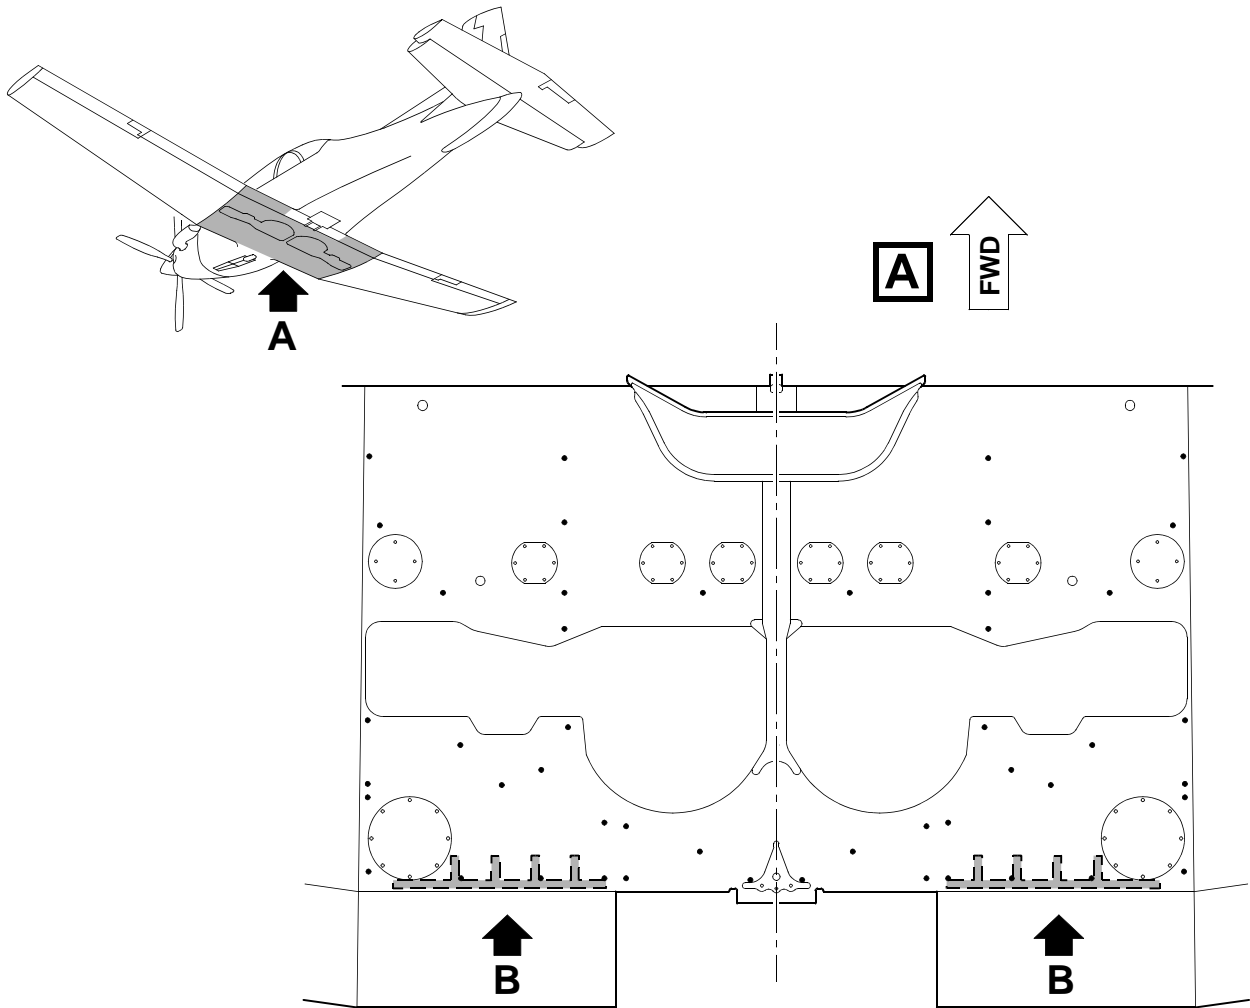
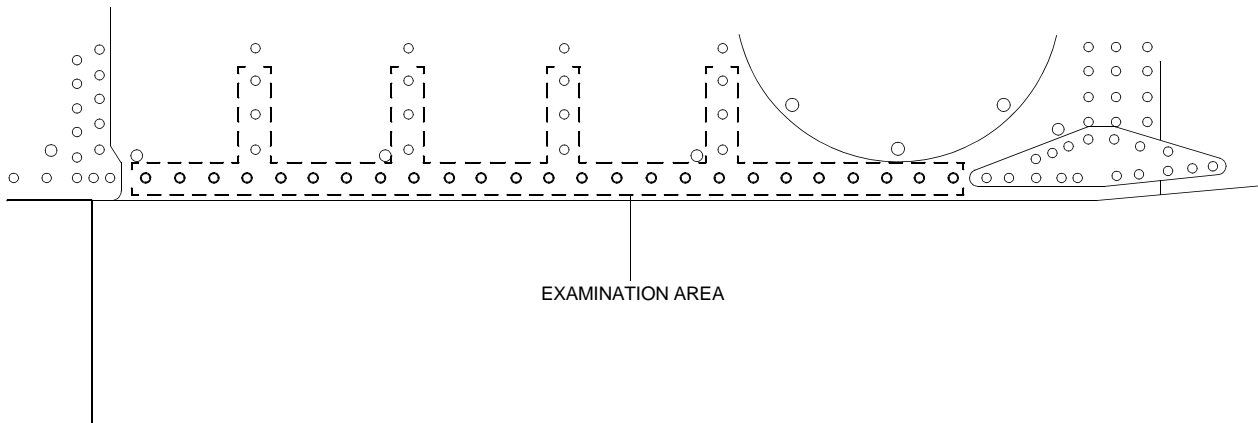
Examination Areas
 Figure 1

The countersunk rivets which attach the bottom skin of the inner wing to the rear-spar between ribs 5 and 11 can become loose and damage the skin panel.

Flexing of the wing skin can cause the countersunk rivets to work loose and pull through the skin panel.

- (1) Examine the rivets which attach the wing bottom skin to the rear-spar, and end ribs, in the areas shown on Fig. 1.
- (2) If dome head rivets are installed, no further action is necessary.

- (b) Use a bright light source and examine the areas for:
 - Rivet heads pulled through the skin panel
 - Cracks
 - Loose or 'working' rivets
 - (c) If you find no damage:

- Write 'No Damage Found' on the Report Form (Fig. 3) and send to Pilatus Customer Support
 - Do the Repair No. 1 (Ref. Para. B.) at, or before, the next scheduled 300 hrs/ annual inspection.

- (d) If you find rivet heads pulled through the skin panel:
 - Do the Repair No. 2 (Ref. Para. C) before the next flight
 - Use the Report Form (Fig. 3) to send the data of the damage found to Pilatus Customer Support

- (e) If you find loose or 'working' rivets:
 - Do the Repair No. 2 (Ref. Para. C) at, or before, the next scheduled 150 hrs inspection
 - Use the Report Form (Fig. 3) to send the data of the damage found to Pilatus Customer Support

- (f) If you find cracks that start from pulled, loose or 'working' rivets:
 - Do not permit the aircraft to fly
 - Contact Pilatus Customer Support for repair instructions. Use a copy of the Report Form (Fig. 3) to give the data of the damage found
