PILATUS AIRCRAFT LTD. CH-6371 STANS, SWITZERLAND

SERVICE BULLETIN NO: 57-007

WINGS - CENTER WING NOSE SKIN - INSPECTION FOR CRACK DAMAGE

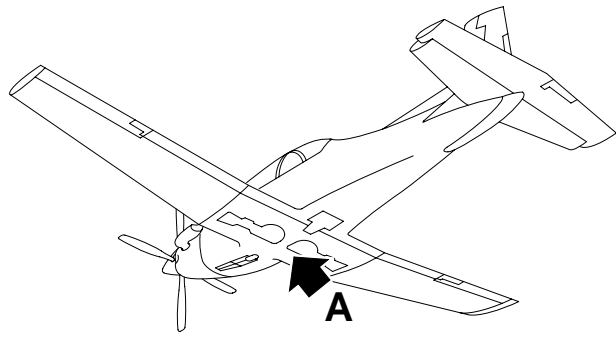
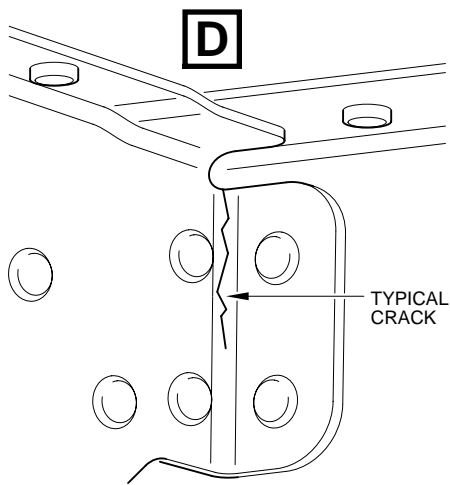
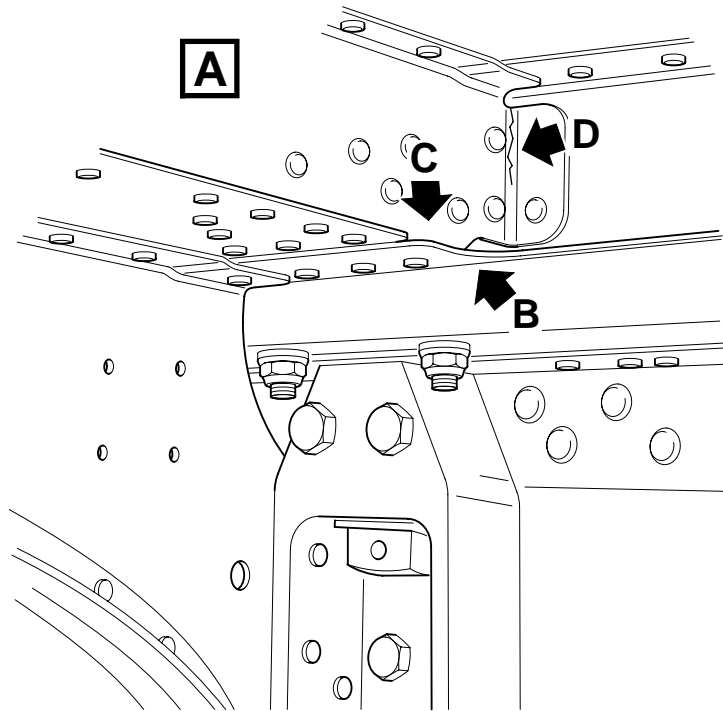
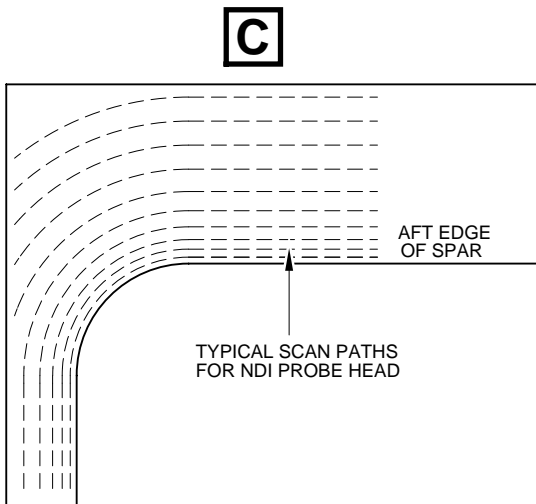
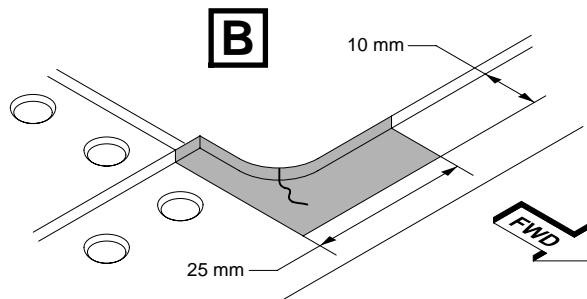
Nose Skin - Inspection
 Figure 1

Crack damage can occur in the radii at the rear edge of the nose skin P/N: 557.31.09.120. The radii are adjacent to the left and right corners at the forward edge of the floor panel P/N: 557.31.09.027. Crack damage can also occur in the forward support structure of the floor panel.

Fatigue damage caused by stresses which occur normally during operation of the aircraft.

- (1) Use a source of bright light and a X10 magnifier and do an inspection of the forward area of the floor panel and the related structure at the locations shown (Ref. View D). Crack damage is not permitted. Apply to PILATUS for instructions if crack damage has occurred.
- (2) Do an NDI of the nose skin (Ref. Sect 4 and Views B and C). Cracks that have not extended out of the limit areas shown are permitted. Instructions to do subsequent inspections will be given in AMM, 05-10-20. The lengths of permitted cracks must also be monitored at the subsequent inspections.

Cracks that have extended out of the limit areas shown are not permitted. Apply to PILATUS for instructions before the next flight if such cracks have occurred.

Do an eddy-current, non-destructive inspection (NDI) of the nose skin for crack damage and if necessary, apply to PILATUS for monitor/repair instructions.

Do an inspection for crack damage in the forward structure of the floor panel.

- (1) Put the probe in position on the top of the skin in the inspection scan area.
- (2) Train the equipment.
- (3) Check train.
- (4) Zero the equipment.
- (5) Do a line scan on the nose skin as near to the edge as possible. Make sure you scan the full radius length (Ref. Fig. 1, Views B and C).
- (6) Do Step (5) again as many times as necessary to fully scan the inspection area shown. Make each line scan approximately 1,0 mm (0.04 in.) apart.
- (7) Do Steps (1) thru (5) again on the lower surface of the nose skin.
- (8) Do Steps (1) thru (7) again on the right inspection areas.
