# The last slice of the Swiss cheese

SASCON 2011

Patrick Fauchère  
Flight Safety Manager  
Air Glaciers SA

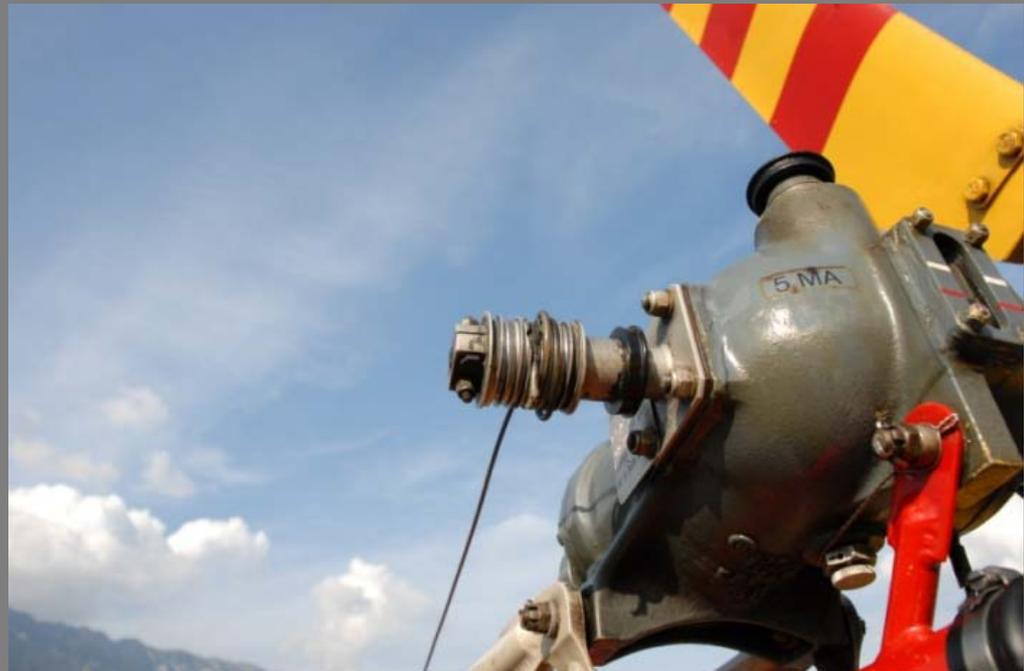
- The first analysis showed a broken control wire at about 1 cm after the connector on the winder drum of the tail boom.

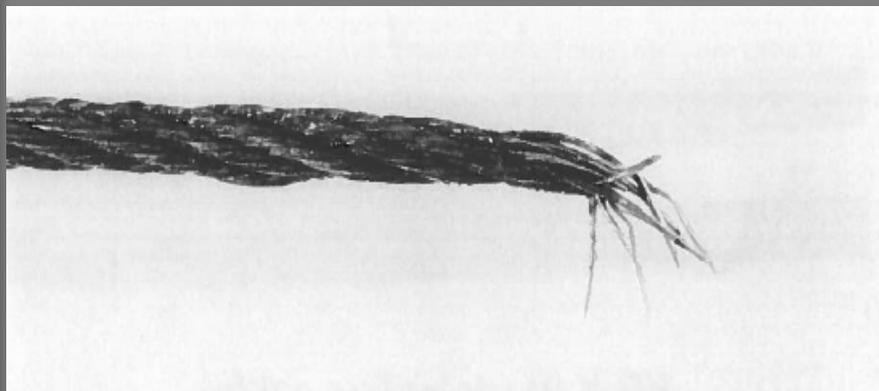
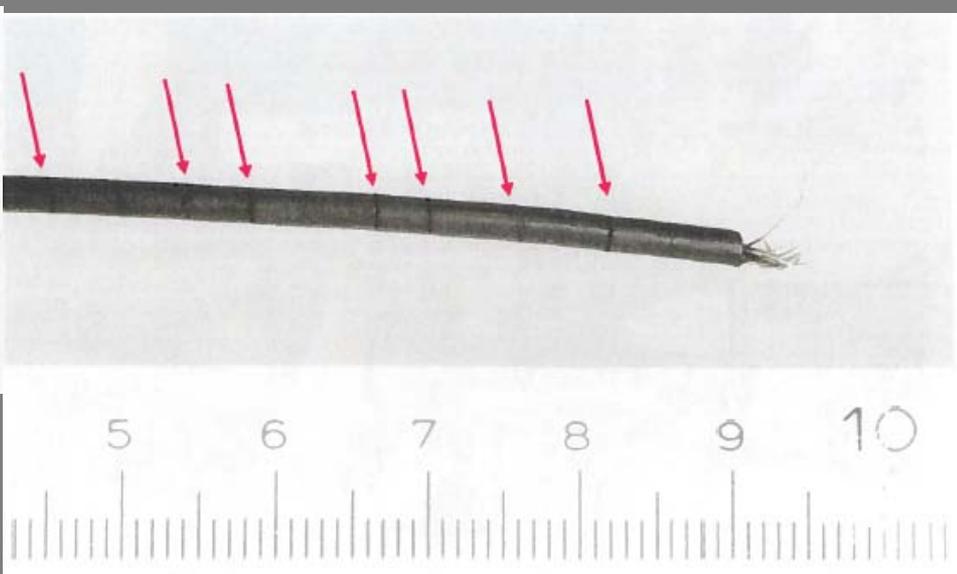
- **2.2 Fractographic investigation**
- For the fractographic investigation of the initial rupture, a 55 mm long segment has been cut off and the polymer sleeve has been removed.

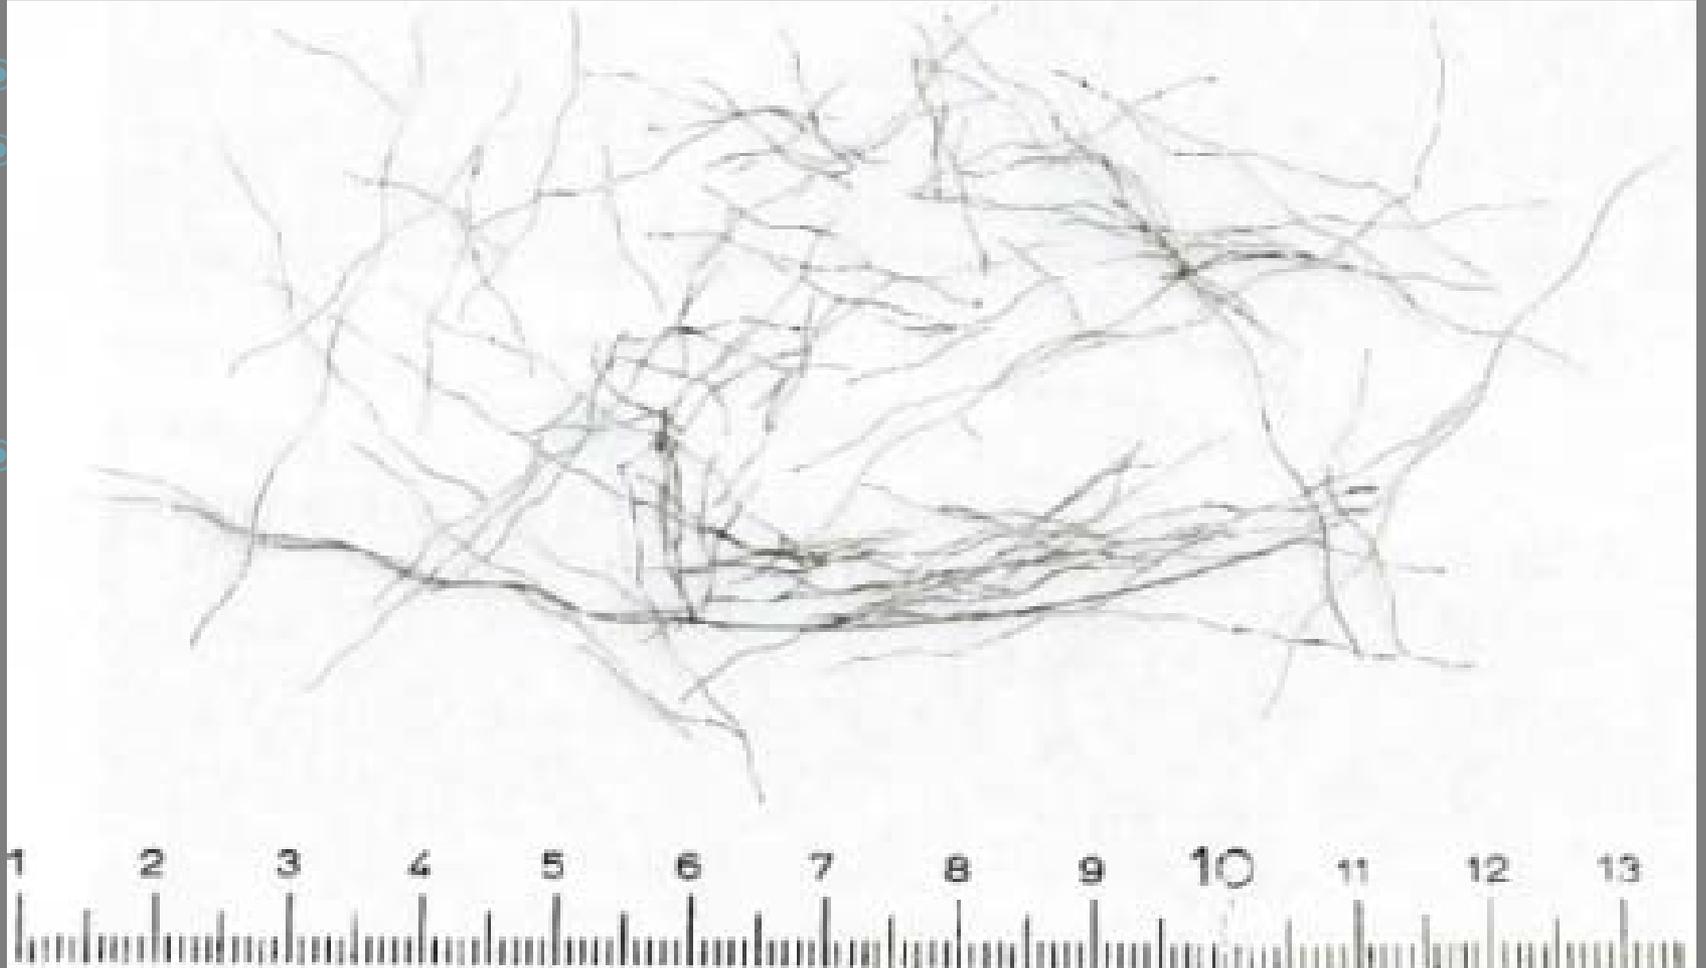
- The investigation of the fracture surfaces revealed, that the wires are thinned by wear and then fail by simple overload.
- **2.2.2 Segment with missing polymer sleeve**
- The segment which was located on the same pulley as the rupture (opposite side) has been investigated to compare the condition of the wires with the rupture area.
- Compared with the ruptured area, the wear effects are less extensive in this area.

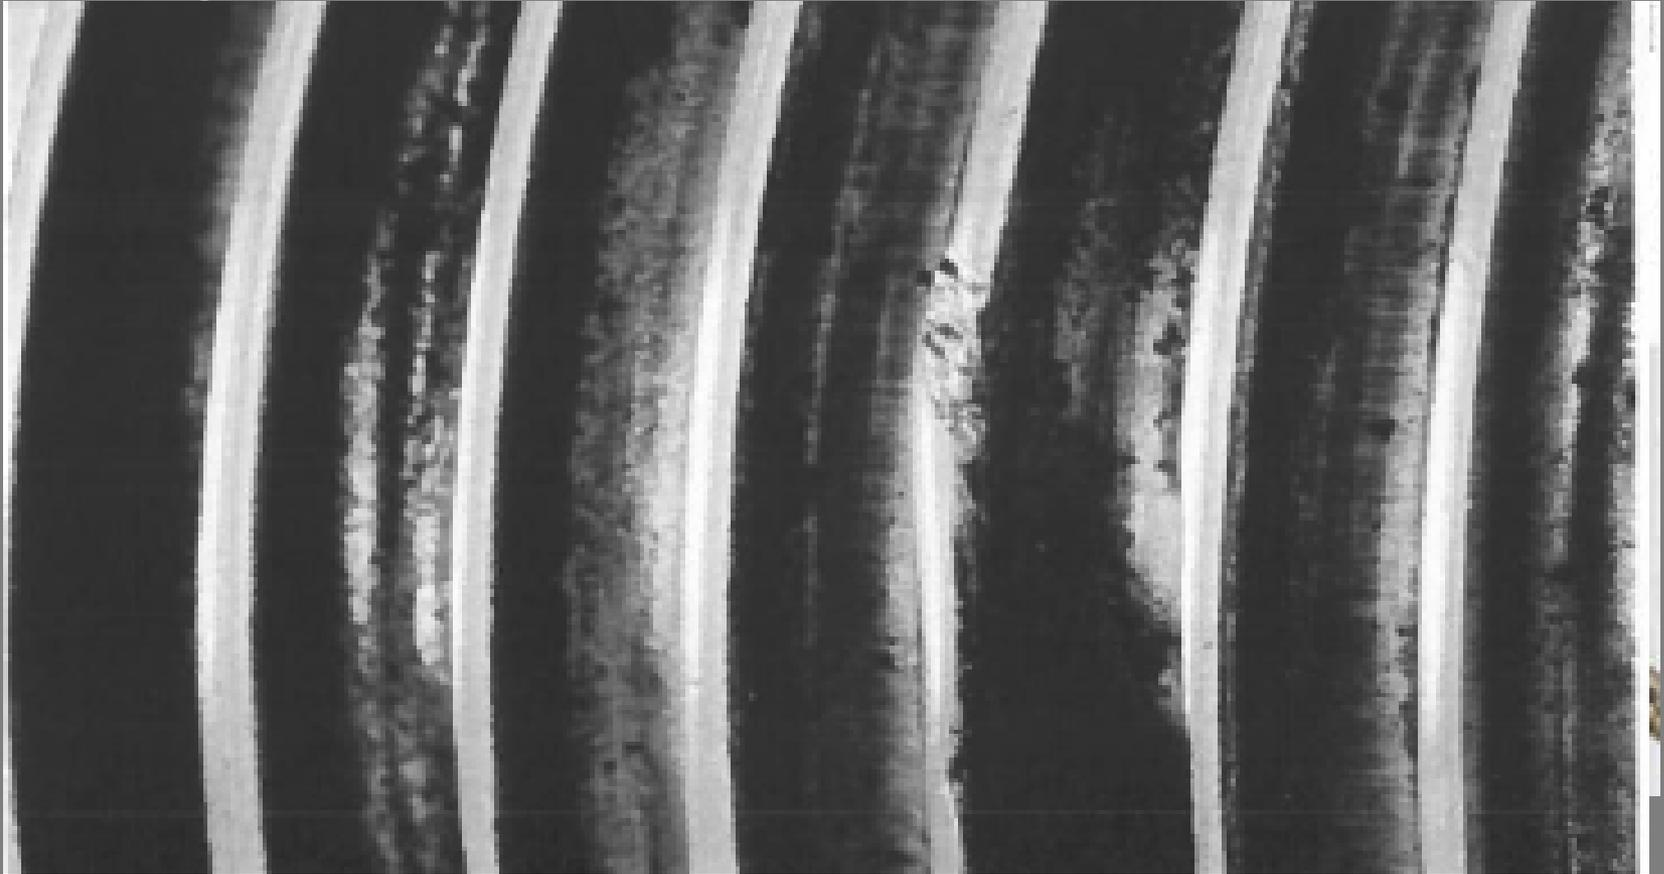
- The investigation showed that the initial rupture of the tail rotor control cable has been a result of excessive wear between the wires themselves.
- Wear within steel cables is the result of movement between the individual wires. The observed wear occurs underneath the polymer sleeve and is therefore not directly visible by the performed inspections (only by secondary indication as discoloration of the sleeve).

- The different amount of wear of the failed cable on the same pulley indicates the following :
- In the rupture area either atypical torsion momentum was present or some kind of « relaxing effect » due to the altered polymer sleeve allowed excessive movement between the wires (or a combination of both).

- **4 Conclusions**
- Several (daily and scheduled) checks must have been performed while the cable was already in an unserviceable condition.
- A more restrictive compliance to the OEM recommendations in exchanging such cables should diminish the risk of such an incident greatly.
