Service Bulletin No: 57-015
Modification No: INSPECTION

Ref No: 136
ATA Chapter: 57

**WING - AILERON INSTALLATION
INSPECTION OF THE AILERON OUTBOARD-BEARING SUPPORT**

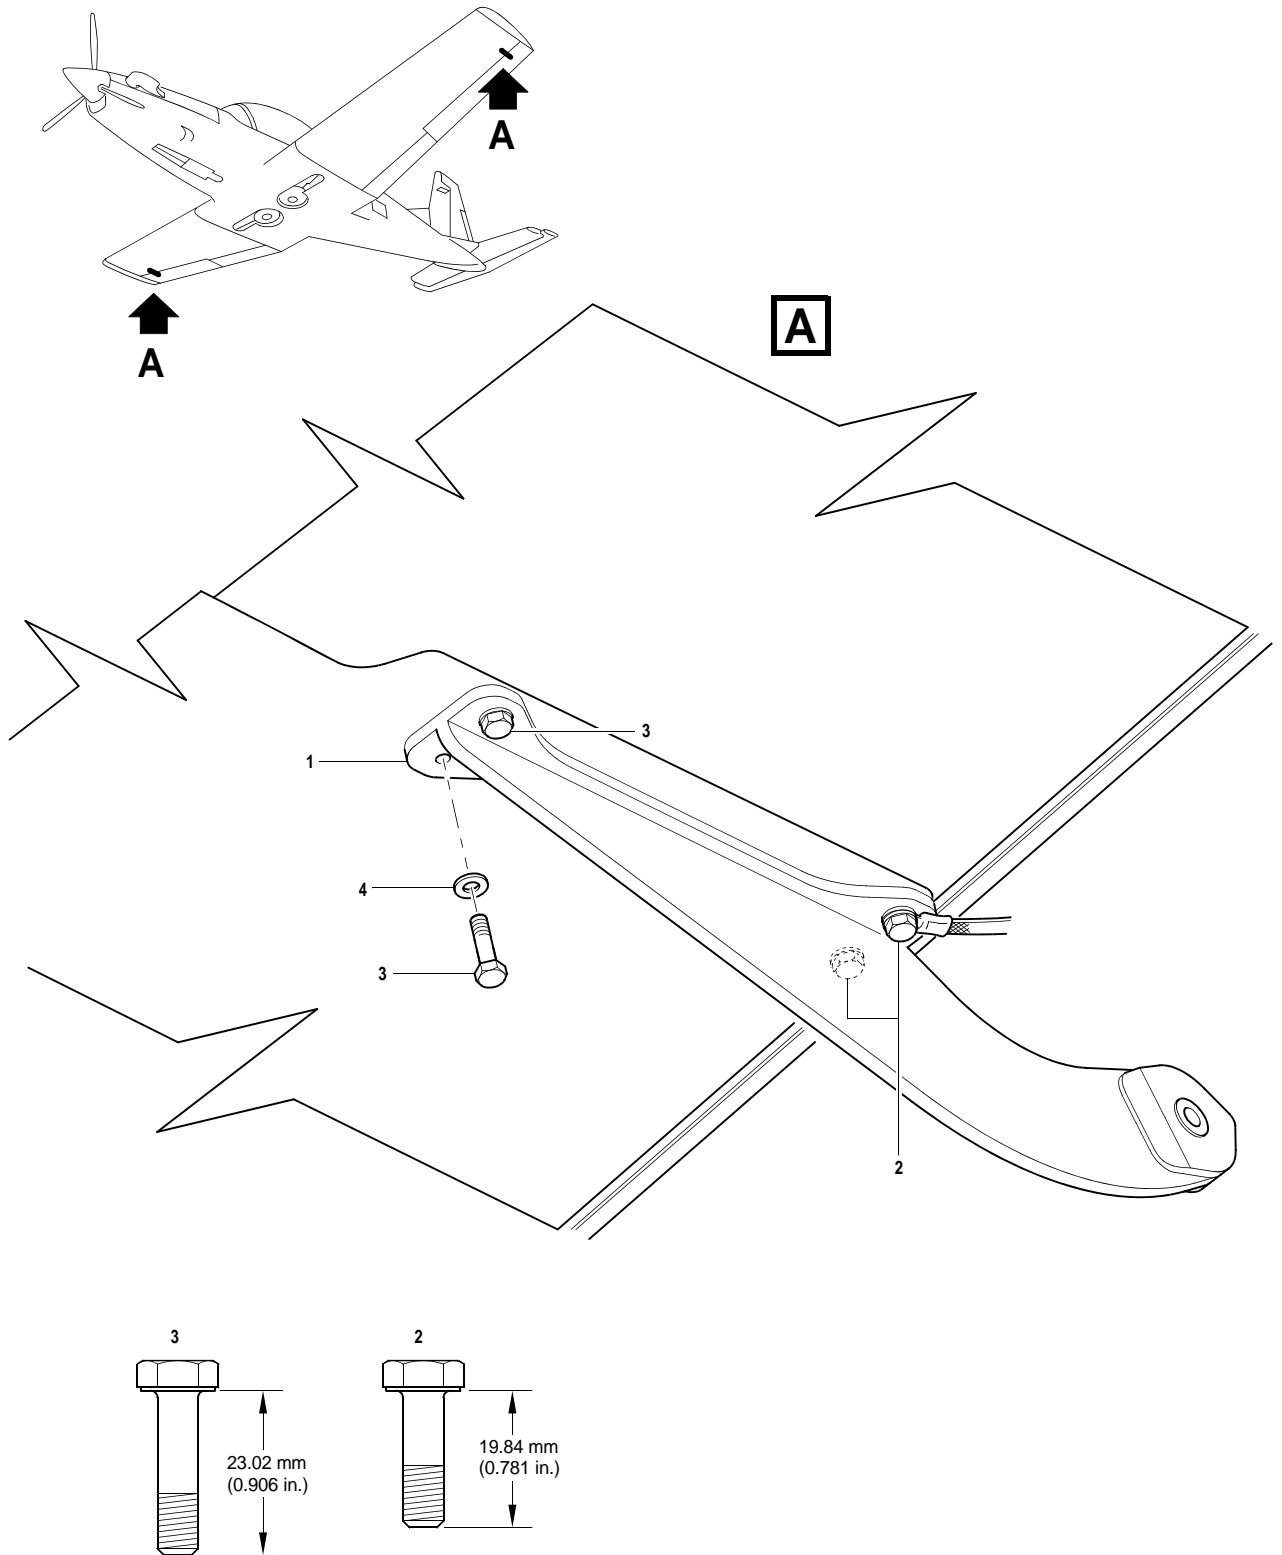
Inspection of the Attachment Bolts and Anchor Nuts
Figure 1

The aileron outboard-bearing supports are attached with two forward attachment bolts and two aft attachment bolts. The forward attachment bolts are approximately 3.2 mm (0.125 in.) longer than the aft attachment bolts.

In the case of the reported incident, the longer bolts were installed in the rear attachment points. This, most probably, damaged the threads in the rear attachment anchor nuts. If the bolts are removed and installed again and again, this can also cause damage to the threads of the nuts.

WARNING: IF A BOLT (2 OR 3) IS **NOT** THE CORRECT LENGTH AND/OR THE THREAD OF THE ANCHOR NUT IS **NOT** IN A GOOD CONDITION, ALL THE ATTACHMENT BOLTS AND ANCHOR NUTS MUST BE REPLACED (REF. PARA. 3.C. OF THIS SERVICE BULLETIN) BEFORE THE NEXT FLIGHT.

- (a) Remove the bolt (3) and the washer (4) from the forward inboard attachment point of the aileron outboard-bearing support (1).
- (b) Clean the bolt (3) with the absorbent paper (Material No. P02-031) made moist with the solvent (Material No. P01-010).
- (c) Measure the length of the bolt (3). If the bolt (3) is installed in the correct position, the length will be 23,02 mm (0.906 in.) (Ref Detail on Fig. 1).

- 2 Put the bolt (3) into the hole and turn the bolt (3) with your fingers until you can feel some resistance as it engages the thread of the nut. If you do not feel the normal self locking resistance, continue with this Service Bulletin from Para. 3.C.

- (m) If no damage is found to the two bolts (3), do Para. 3.B.(1)(a) thru (k) again for the aft attachment bolts (2) of the aileron outboard-bearing support (1).
NOTE: If the bolt (2) is installed in the correct position, the length of the bolt will be 19,84 mm (0.781 in.) (Ref Detail on Fig. 1).
