Service Bulletin No: 53-018

ATA Chapter: 53

**FUSELAGE - MAIN FRAMES****DO A CHECK OF THE MATERIAL SPECIFICATION OF THE FRAME 11 FITTINGS AND, IF NECESSARY, DO A CHECK FOR CRACKS****1. Planning Information****A. Effectivity**

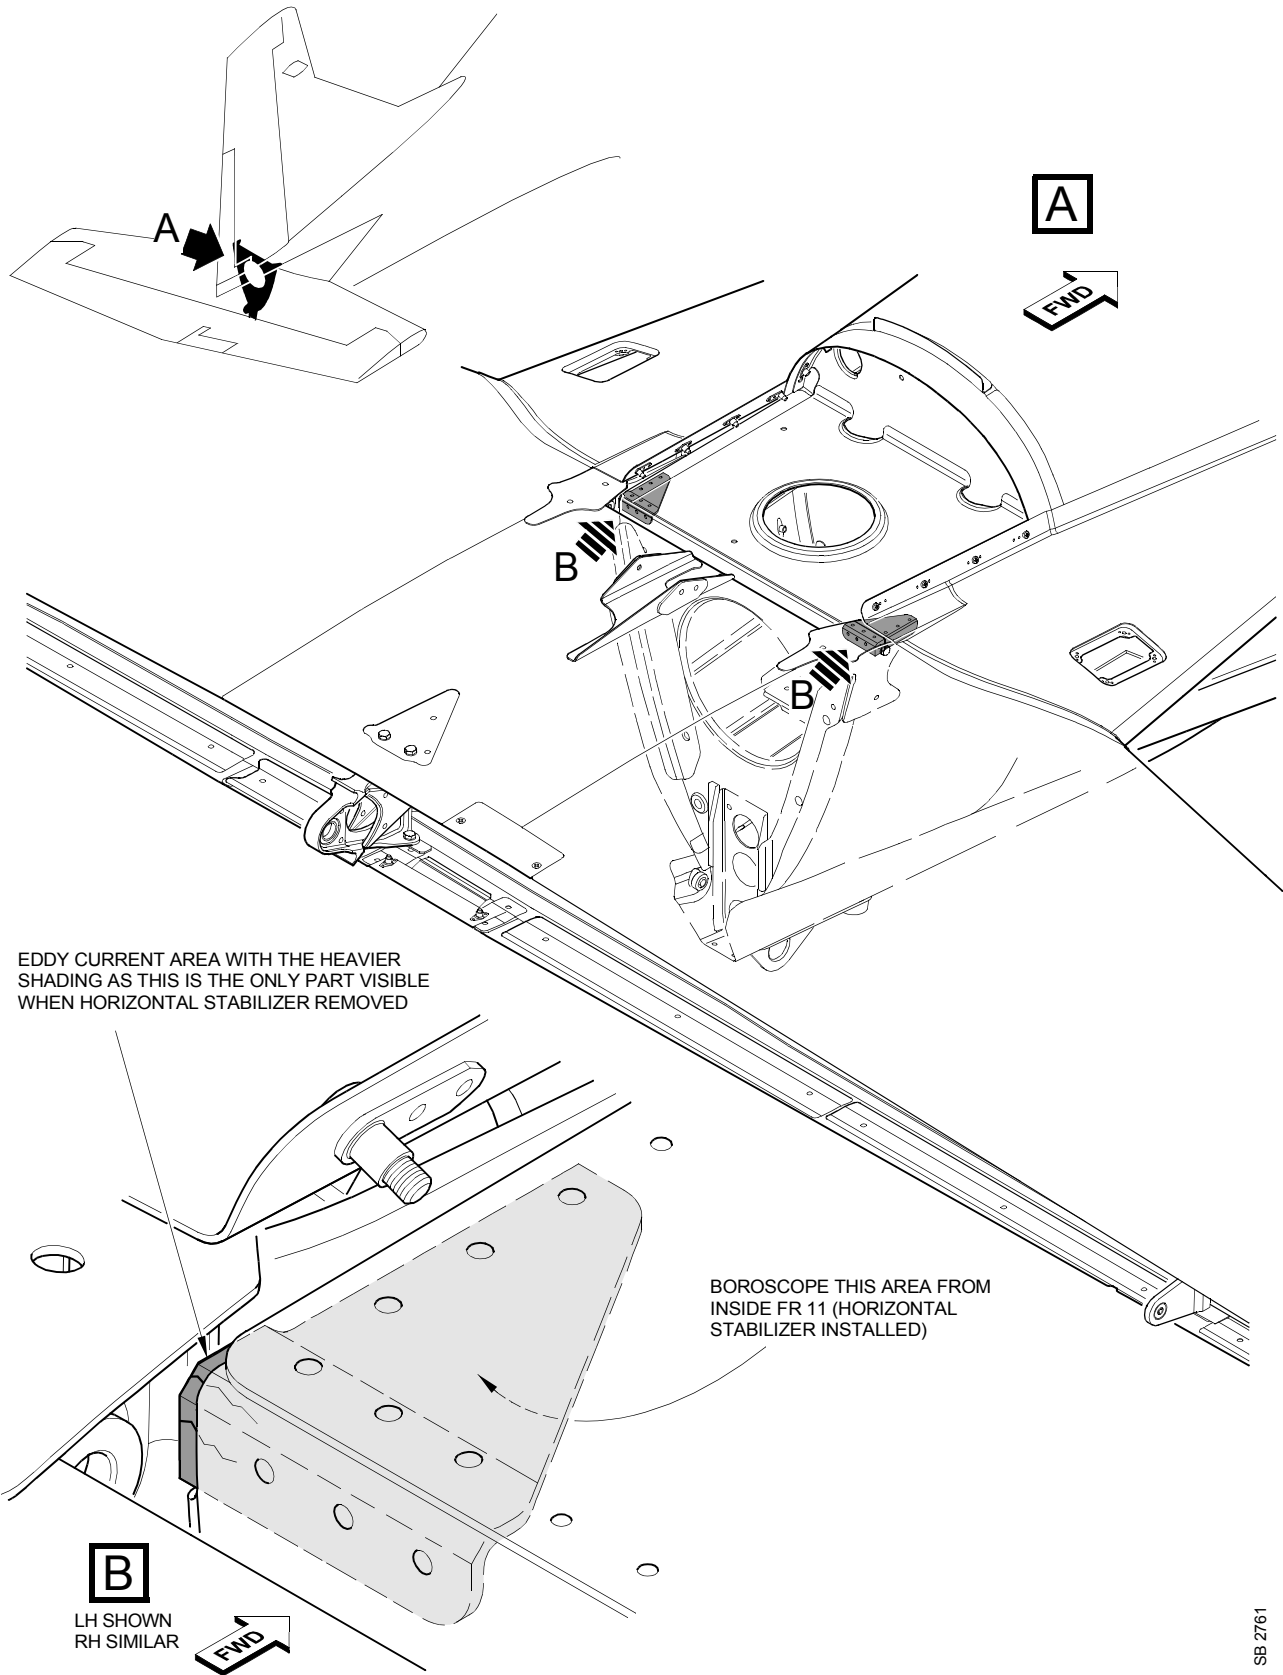
Fittings - Crack Inspection (If Necessary)  
Figure 3

An operator reported Stress Corrosion Cracking (SCC) on the FR 11 left fitting P/N 112.35.07.489 and right fitting P/N 112.35.07.490 (known hereafter as "fittings").

Initially the material specification of the parts was AA2024-T351.

**C. Do an Inspection to Find Cracks with the Borescope and / or Eddy Current (Ref. Fig. 3)**

**NOTE:** If you find cracks, you must replace the fitting before the next flight (Ref. Service Bulletin 53-019).

(1) Obey the manufacturer's instructions and use a borescope to examine the fitting from inside FR11 (looking AFT) for cracks (Ref. Fig. 3).

**NOTE:** Make sure you examine all the visible faces of the fittings.

- (2) If you find cracks, you must replace the fitting before the next flight (Ref. Service Bulletin 53-019). Make a copy of the Inspection Report Form (Ref. Fig. 4).
- (3) If you do not find cracks in the area examined in Step 3.C.(1):
  - (a) Remove the horizontal stabilizer (Ref. AMM, 55-10-00, Page Block 401).
