## **SPECIAL INFORMATION LEAFLET No. 948 PRODUCT SAFETY NOTICE**

### **A. ONE-TIME CHECK OF BTRU SEAR AND CORRECT ASSEMBLY OF RESTRICTOR CLAMPS ON STORED ENERGY FIRING UNITS DURING FUNCTION & LEAK TESTING OF EJECTION SEATS**

**All Mk. 16 ejection seat types <sup>\*(1)</sup>**

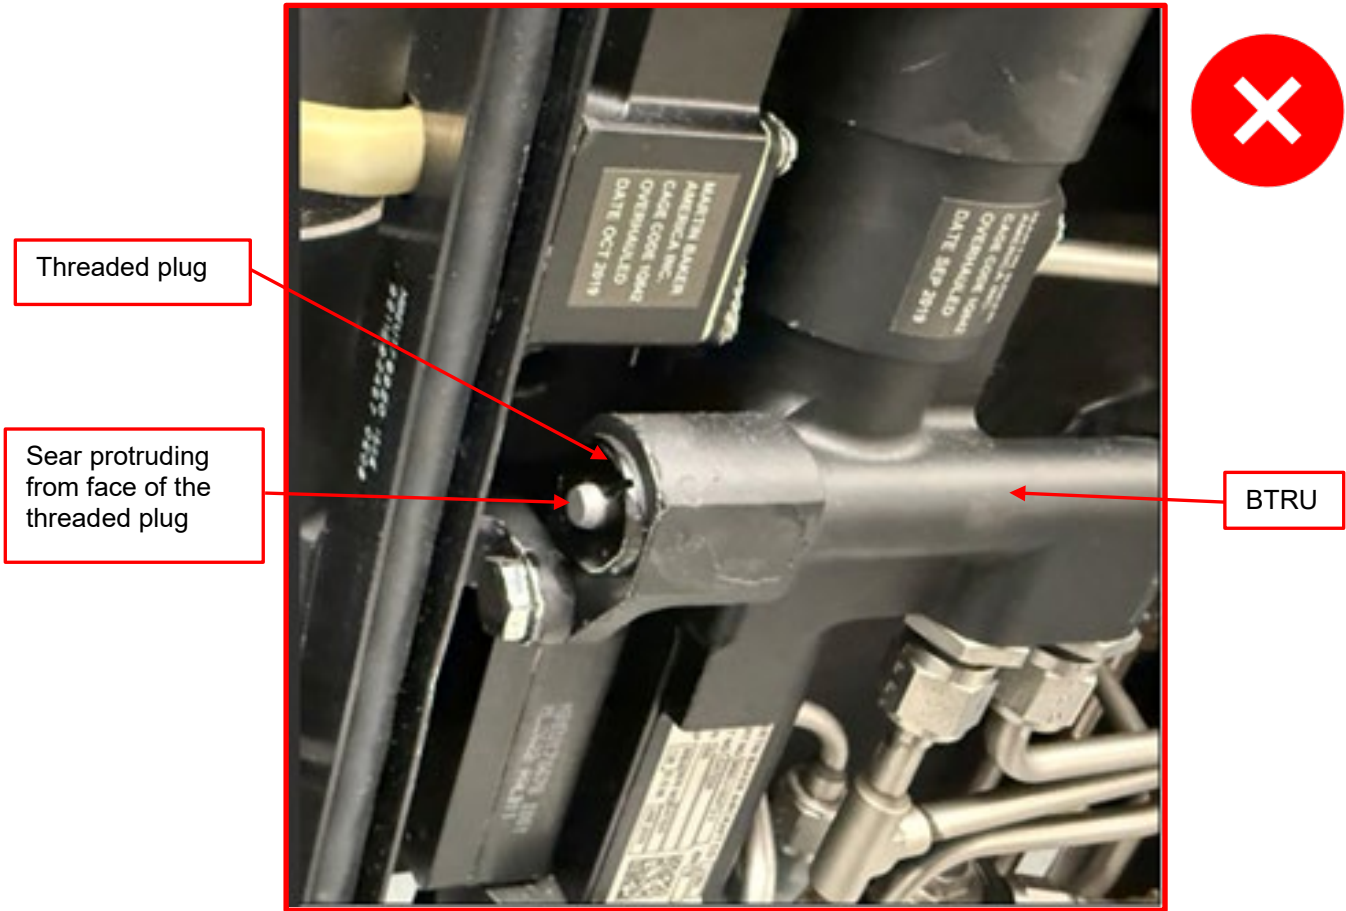
Figure 1 – Incorrectly Cocked Sear – BTRU (Typical)

**C.2** Martin-Baker have been made aware by an Operator of an issue whereby a Barostatic Time-Release Unit (BTRU) was found partially cocked during seat arming. The sear retaining the spring-loaded firing pin was found to be protruding past the face of the threaded plug – see Figure 1 for a typical example of an incorrectly cocked sear. When correctly cocked, the face of BTRU the sear should not protrude past the face of threaded plug – see Figure 2 for typical example of a correctly cocked sear.

D.1.1.4.2 Using finger pressure or a non-metallic tool, push the sear flush with the face of the threaded plug.

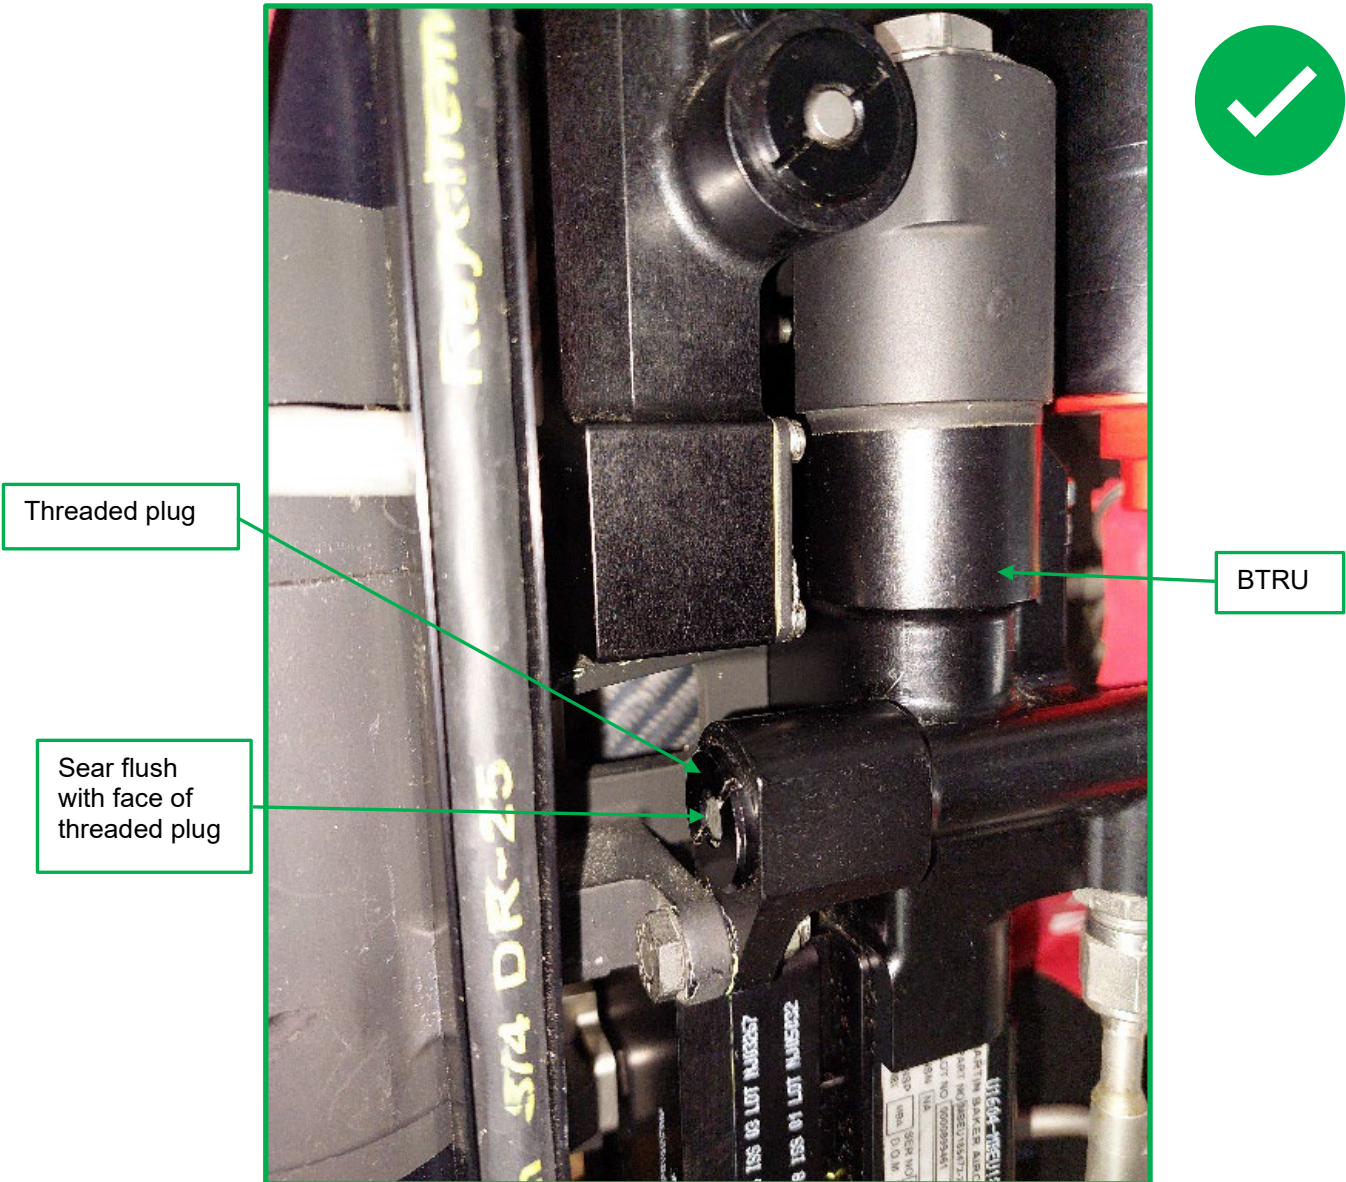
Figure 2 – Correctly Cocked Sear – BTRU (Typical)

D.1.1.2.1 The BTRU sear is cocked when the end of the sear is level with the surface of the threaded plug (no protrusion). See Figure 2 for details.

- NOTES:**
- 1) The BTRU sear is cocked when the end of the sear is level with the surface of the threaded plug.
  - 2) By design, it is permissible for the BTRU sear to be sub-flush when fully cocked.

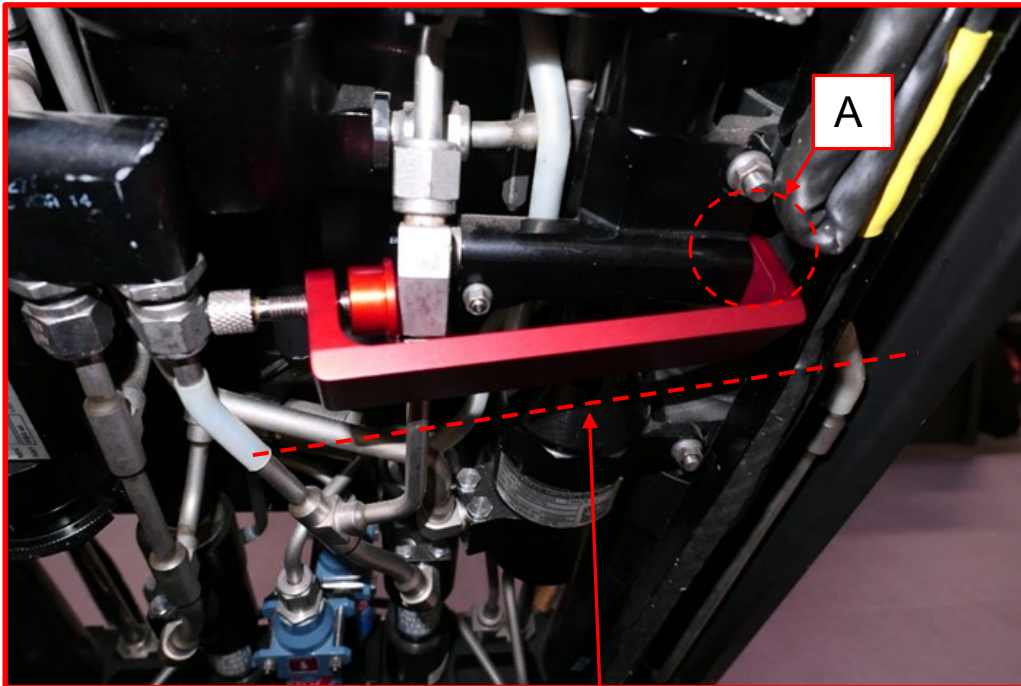
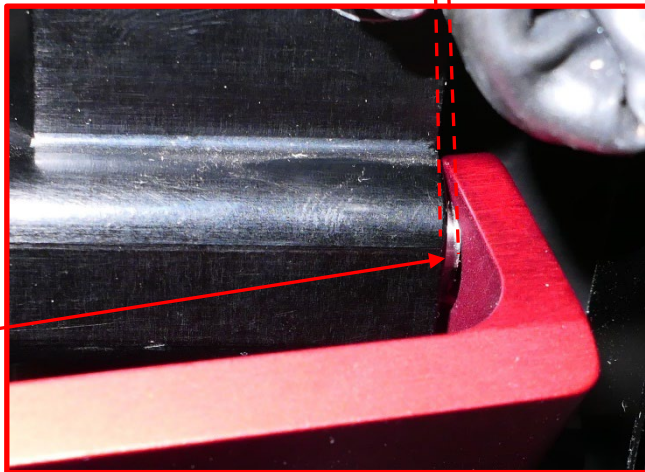
Figure 3 – Incorrect Installation of the Restrictor Clamp (Typical)

- C.3 Investigations conducted by Martin-Baker found that, during ejection seat function & leak test as part of scheduled maintenance, it was possible to move the sear to a partially cocked condition under gas pressure when using an incorrectly installed BTRU sear restrictor clamp, the face of the sear coming to rest against the inner face of the restrictor clamp. See Figure 3 and 4 for examples of incorrectly installed restrictor clamp allowing sear protrusion post function & leak test.

Restrictor clamp loosely assembled and/or at an angle, offset to the stored energy firing unit, allowing sear extraction – i.e. restrictor clamp **not** in correct alignment with the sear.

Gap between inner face of the restrictor clamp and face of sear allowing sear extraction.

**Sear protrusion.**  
Sear abutting inner face of restrictor clamp on application of gas pressure.

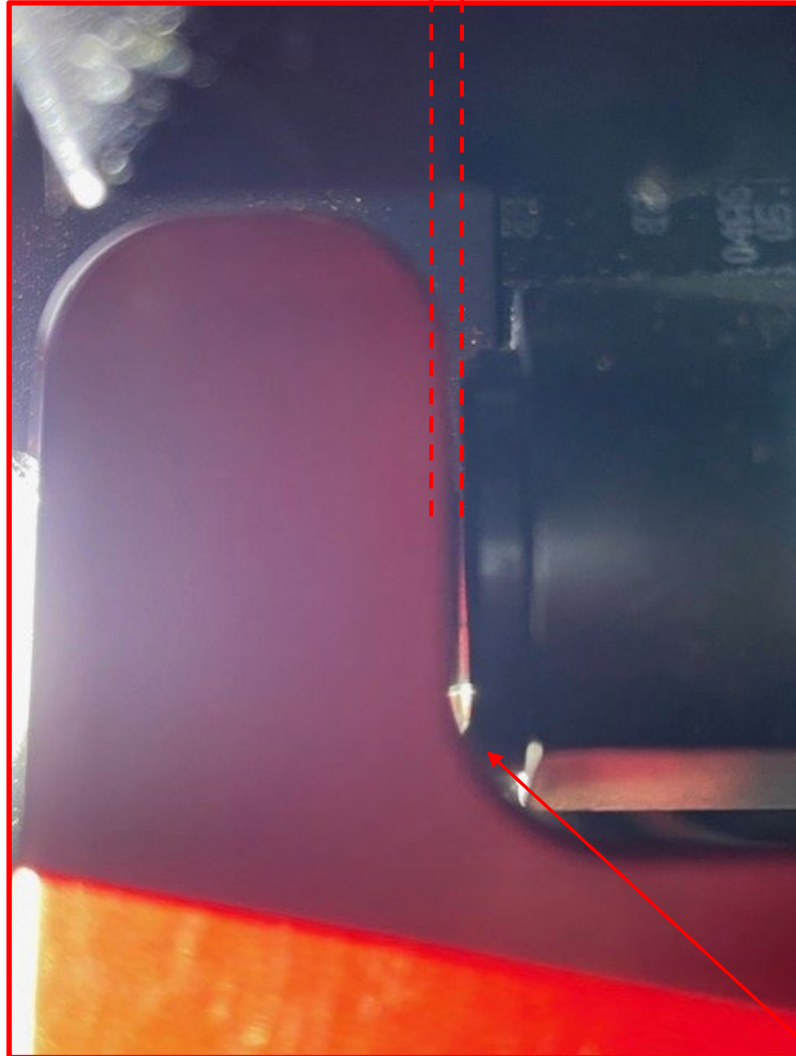
Figure 4 – Incorrect Installation of the Restrictor Clamp (Typical)

Off-set created due to device under test resting on inner radius of restrictor clamp.  
**False indication of correct installation of restrictor clamp.**

Restrictor clamp installed on stored energy firing unit.  
**Inner radius of clamp point contact between device and clamp.**

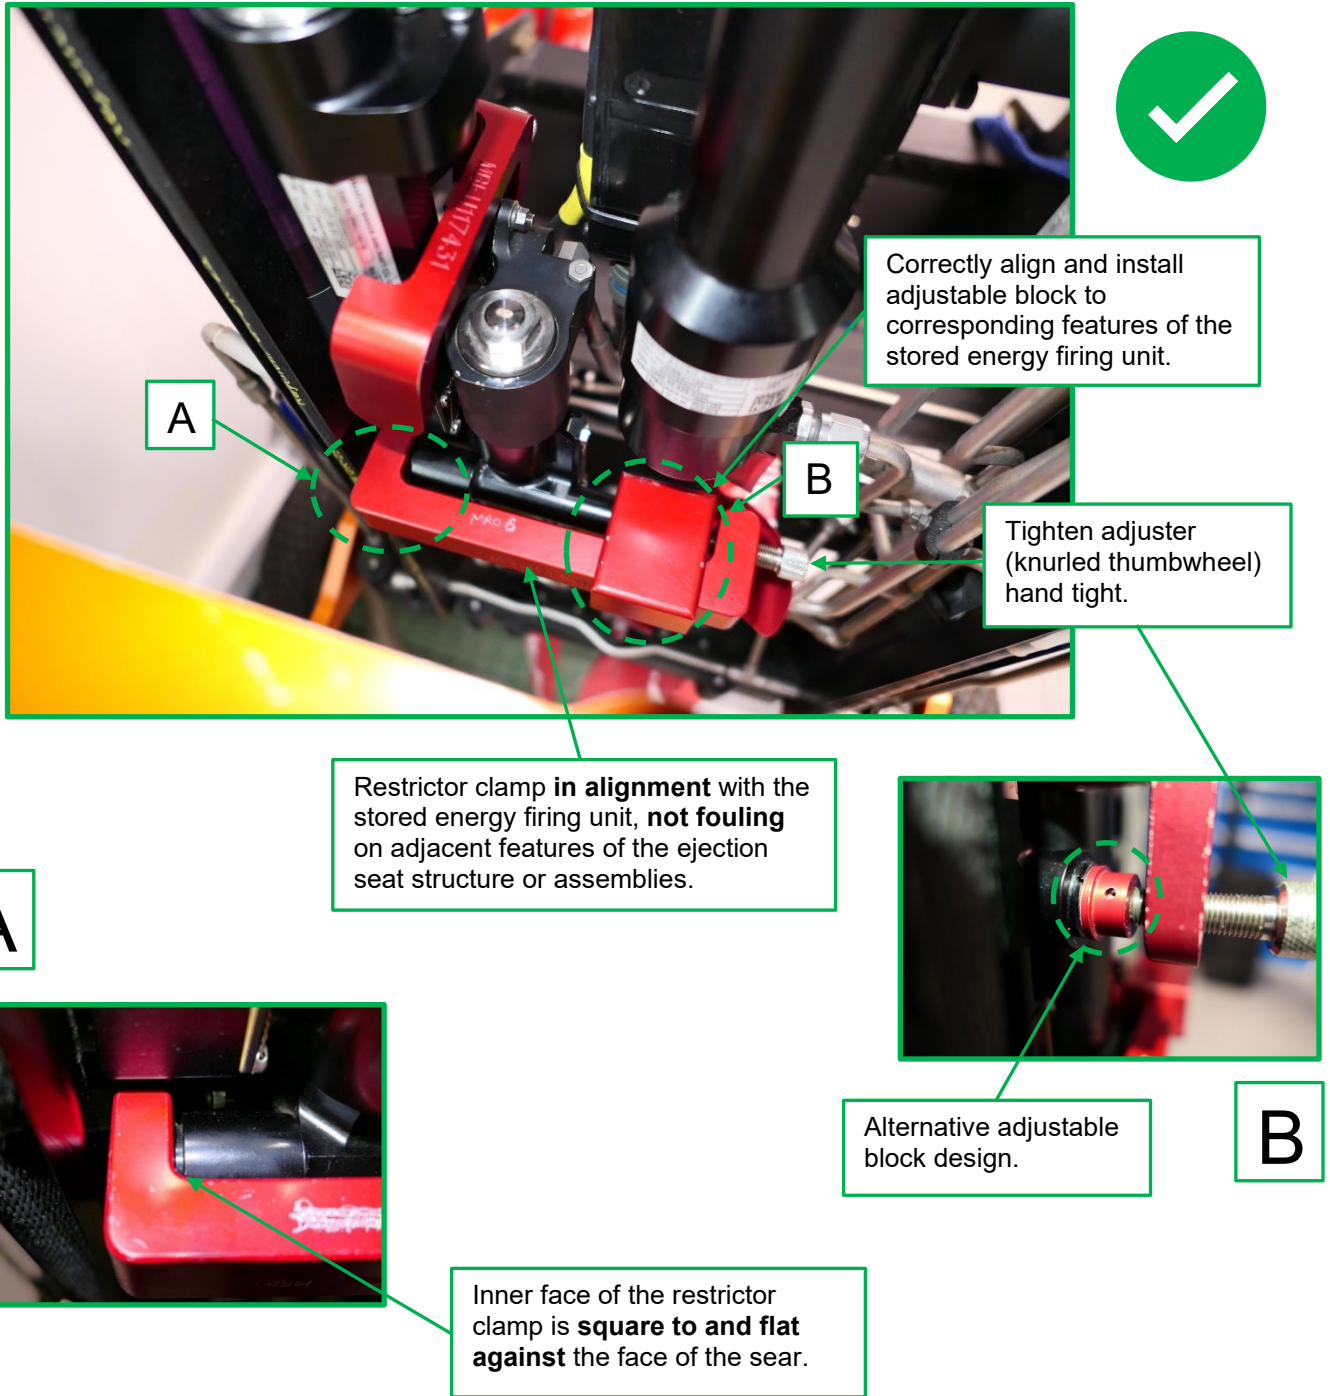
Figure 5 – Correct Installation of the Restrictor Clamp (Typical)

- C.4 Figure 5 provides guidance on correct installation of restrictor clamps, typical to ABU, BTRU and TDU assemblies.
- C.5 The consequence of an incorrectly cocked stored energy firing unit, as reported in a recent mishap event, is a potential un-commanded initiation of the parachute deployment and automatic harness release systems.

D.1.4.1.2 Align the restrictor clamp with the stored energy firing unit. Install with the inner face of the restrictor clamp square to and flat against the face of the sear.

D.1.4.1.3 Correctly align and install the restrictor clamp adjustable block to the stored energy firing unit body.

D.1.4.1.4 Tighten the adjuster hand tight.

D.1.4.1.5 Check the restrictor clamp for looseness and misalignment with the face of the sear prior to function & leak test (step D.1.4.1.2 above and Figure 5 below).
