Flight Director Lateral Offset

Temporary Revision

Temporary Revision No. 02371-075
To PC-24 Airplane Flight Manual
Report No. 02371

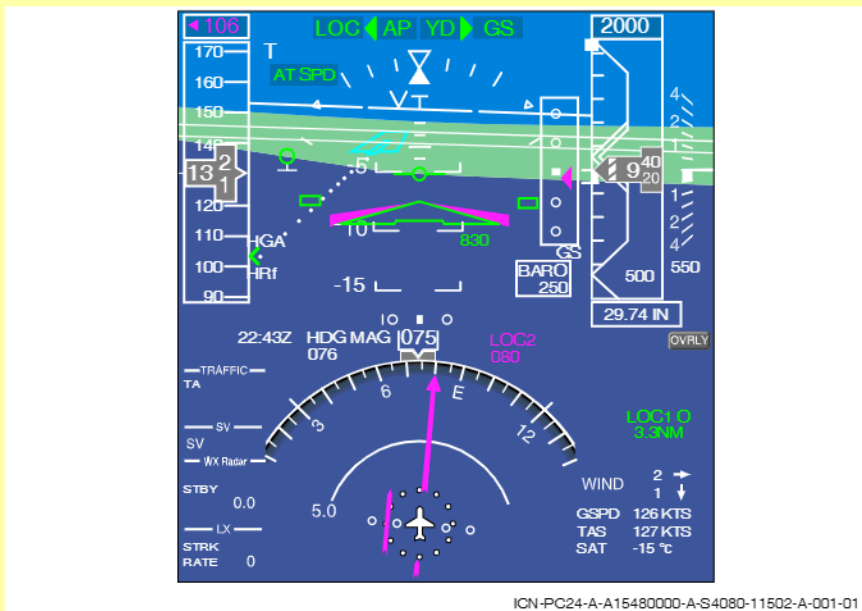
Figure 3A-NAA-1: Flight Director Lateral Offset

Possibility of inaccurate approaches in High Latitude and / or areas of High Magnetic Variation with APEX Build 5.3 and below.

Ensuing flight director calculations can result in lateral offsets to the desired approach course when flying ILS, LOC, VOR, LP or LPV approaches. In these instances, the FD maintains the lateral offset and does not provide course corrections to center the CDI.

Splits in heading between the pilot and co-pilot may sometimes occur either due to low magnetic field strength, magnetic anomalies or AHRS / IRS system failures. These heading splits can cause errors in the flight director calculation resulting in lateral offsets to the desired approach course when flying ILS, LOC, VOR, LP or LPV approaches. In these instances, the FD maintains the lateral offset and does not provide course corrections to center the CDI. For illustration purposes, an example manifestation of this issue is provided below for reference:

1. CDI / ADI..... Monitor FD guidance and Course Deviation Indicator to assess if FD provides course corrections appropriate to the displayed lateral deviation.
IF a lateral offset in the Flight Director Guidance is detected:
2. FD / AP..... Disengage FD / AP
3. Aircraft..... Initiate appropriate course correction to center the Course Deviation Indicator
Continue approach manually with raw data provided by the Course Deviation Indicator and Vertical Deviation Indicator
OR
Perform Missed Approach procedure.

4. MFD..... Select MFD 1/6 window, AHRS Sensor Page
Check DG Src is set to IRS Heading
Set AHRS Mode to Directional Gyro (DG)
Select Send DG.

5. FD / AP..... Re-engage FD / AP
6. Aircraft..... Fly Approach normally
