Service Bulletin No: 57-016
Modification No: INSPECTION

**WINGS - CENTER WING
INSPECTION OF THE LOWER WING SKIN UNDER THE LOWER WING FAIRING**

PC-21 Aircraft MSN 101 thru MSN 337.

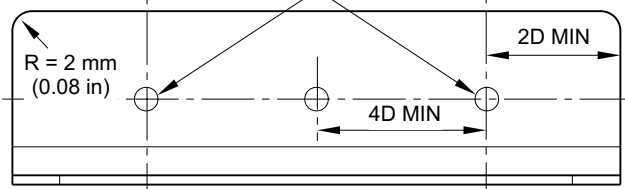
Inspection of Lower Wing Skin
Figure 1 (Sheet 6 of 8)

HOLE POSITIONS FROM LOWER WING FAIRING

CUT OUT DIMENSION MINUS BETWEEN 0,5 mm (0.02 in) AND 1 mm (0.04 in)

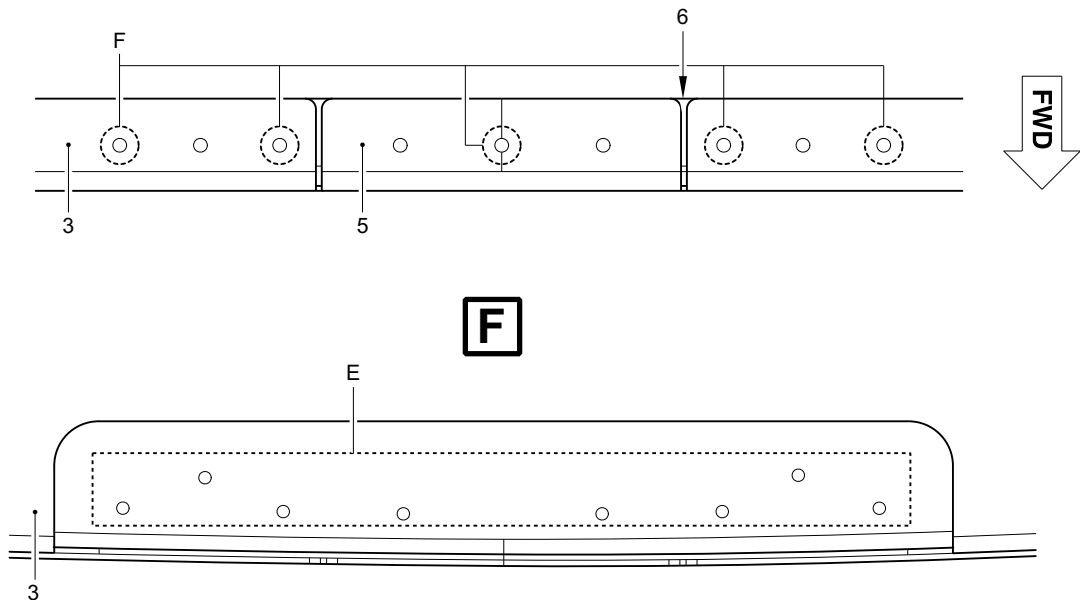
Inspection of Lower Wing Skin
Figure 1 (Sheet 7 of 8)

E SHOWN WITH DOUBLER (6) AND INFILL (5) ASSEMBLED ON SUPPORT PANEL (3)

- (d) Use sealant (Material No. P08-056) and apply a fillet seal around the edges of the infill (5) and the doubler (6).
- (e) Apply topcoat, snow white (Material No. P07-031) to these repair items:
- The support angle (3)
 - The infill (5)
 - The doubler (6).
- (f) Let the topcoat dry.
- (8) Repair the lower wing fairing (1) (Ref. Sheet 8).
