Service Bulletin No: 53-013

ATA Chapter: 53

FUSELAGE - MAIN FRAMES**DO A CHECK OF THE MATERIAL SPECIFICATION OF THE FRAME 11 FITTINGS AND, IF NECESSARY, DO A CHECK FOR CRACKS****1. Planning Information****A. Effectivity**

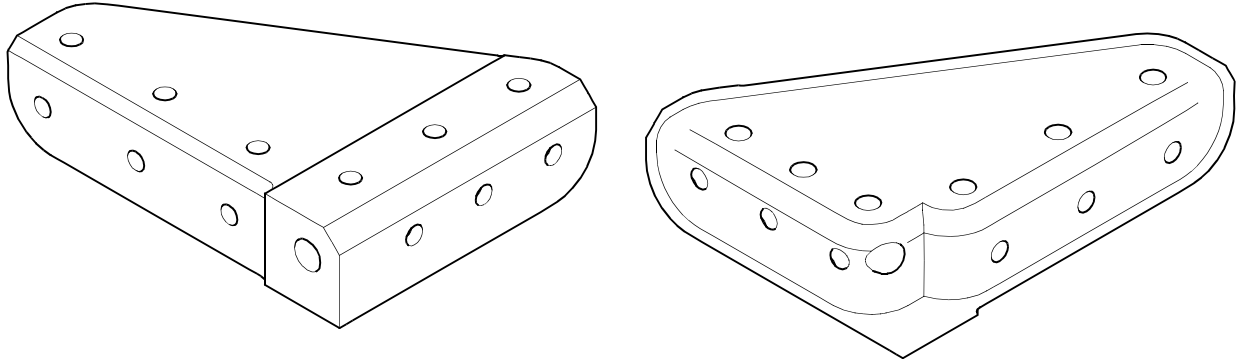
FRAME 11 LEFT FITTING

An operator reported Stress Corrosion Cracking (SCC) on the FR 11 left fitting P/N 112.35.07.489 and right fitting P/N 112.35.07.490 (known hereafter as "fittings").

- (1) Obey the manufacturer's instructions and use a borescope to examine the fitting from inside FR11 (looking AFT) for cracks (Ref. Fig. 2).

- (c) Examine the area shown in Fig. 2 with the eddy current equipment.

- (2) If you find cracks, you must replace the fitting before the next flight (Ref. Service Bulletin 53-014). Make a copy of the Inspection Report Form (Ref. Fig. 3).
