**Service Bulletin No: 57-017****Ref No: 183****Modification No: Inspection****ATA Chapter: 57**

**WINGS - WING STRUCTURE****DO AN INSPECTION FOR CORROSION OF THE ANGLE BRACKETS INSTALLED ON THE LH AND RH WING MIDDLE RIB 23****1. Planning Information****A. Effectivity**

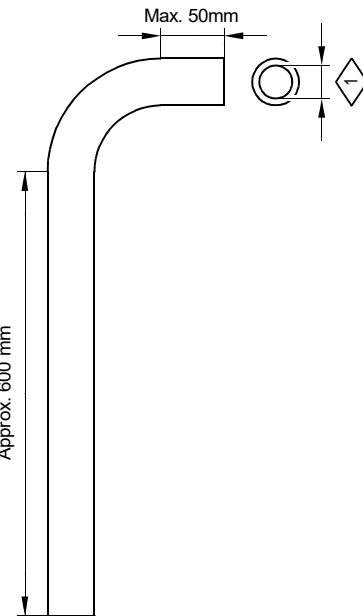
**E**  
LH SHOWN  
RH SIMILAR  
TOP WING SKIN NOT SHOWN FOR CLARITY

- (1) Do a borescope inspection to find corrosion and to identify the type of anchor nuts on the brackets on the LH and RH middle ribs 23 (Ref. Fig. 1).

**NOTE:** If you find corrosion, you must replace the brackets (Ref. Service Bulletin 57-018).
