Service Bulletin No: 53-012

**FUSELAGE - GENERAL
INSPECTION FOR GALVANIC CORROSION ON THE UPPER LEFT LONGERON AND REPLACEMENT
OF THE CHAFING PLATES****1. Planning Information****A. Effectivity**

PC-9 aircraft MSNs 101 thru 248 and MSNs 501 thru 567.

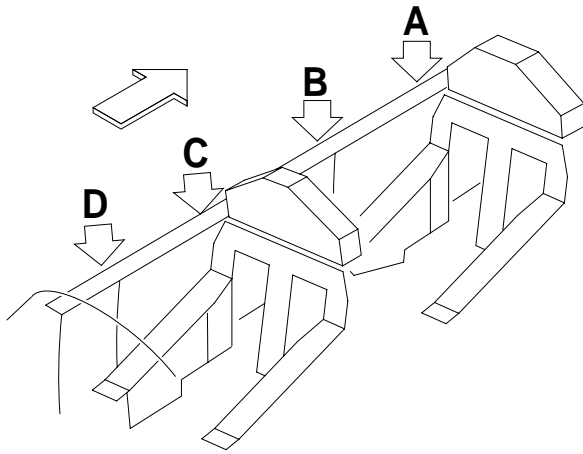
Canopy-lock Chafing Plates - Removal and Installation
Figure 1

Corrosion has been reported on the upper left longeron underneath the chafing plates for the canopy door latches.

- The use of liquid shim
- Excessive latch chafing that damages and causes removal of the sealant and nucleation of further galvanic corrosion
- Poor application of sealant or finishes such as Alodine to the blended aluminium
- The use of chemical paint stripper.

Do an inspection of the longeron in the specified areas and, if necessary, remove the corrosion. Apply to Pilatus for a repair scheme if the removal of corrosion decreases the metal thickness to less than the specified limits. Install new, more robust, chafing plates.

- (1) Do this test to make sure the canopy closes correctly (Ref. Fig. 1):
 - (a) Make sure that all four hooks engage on the lugs in the fuselage.
 - (b) Make sure when the internal handle is released, the hooks stay engaged.
 - (c) If a hook does not stay engaged:
 - 1 Remove the screws (2), the washers (6) and the nuts (7), then remove the locking plate assembly (5) and the shim (4).
 - 2 Adjust the number of shims (4).
 - 3 Put the locking plate assembly (5) and the shims (4) in the correct position and install the screws (2), the washers (6) and the nuts (7).
 - (d) Do Para. 3.C.(1) (a) thru (c) again until all the hooks stay engaged on the lugs in the fuselage.
- (2) Check the operation of the canopy lock microswitch (Ref. 52-10-00, Page Block 501).
- (3) Remove all tools and materials and make sure the work area is clean.
