# The last slice of the Swiss cheese

SASCON 2011

Patrick Fauchère  
Flight Safety Manager  
Air Glaciers SA

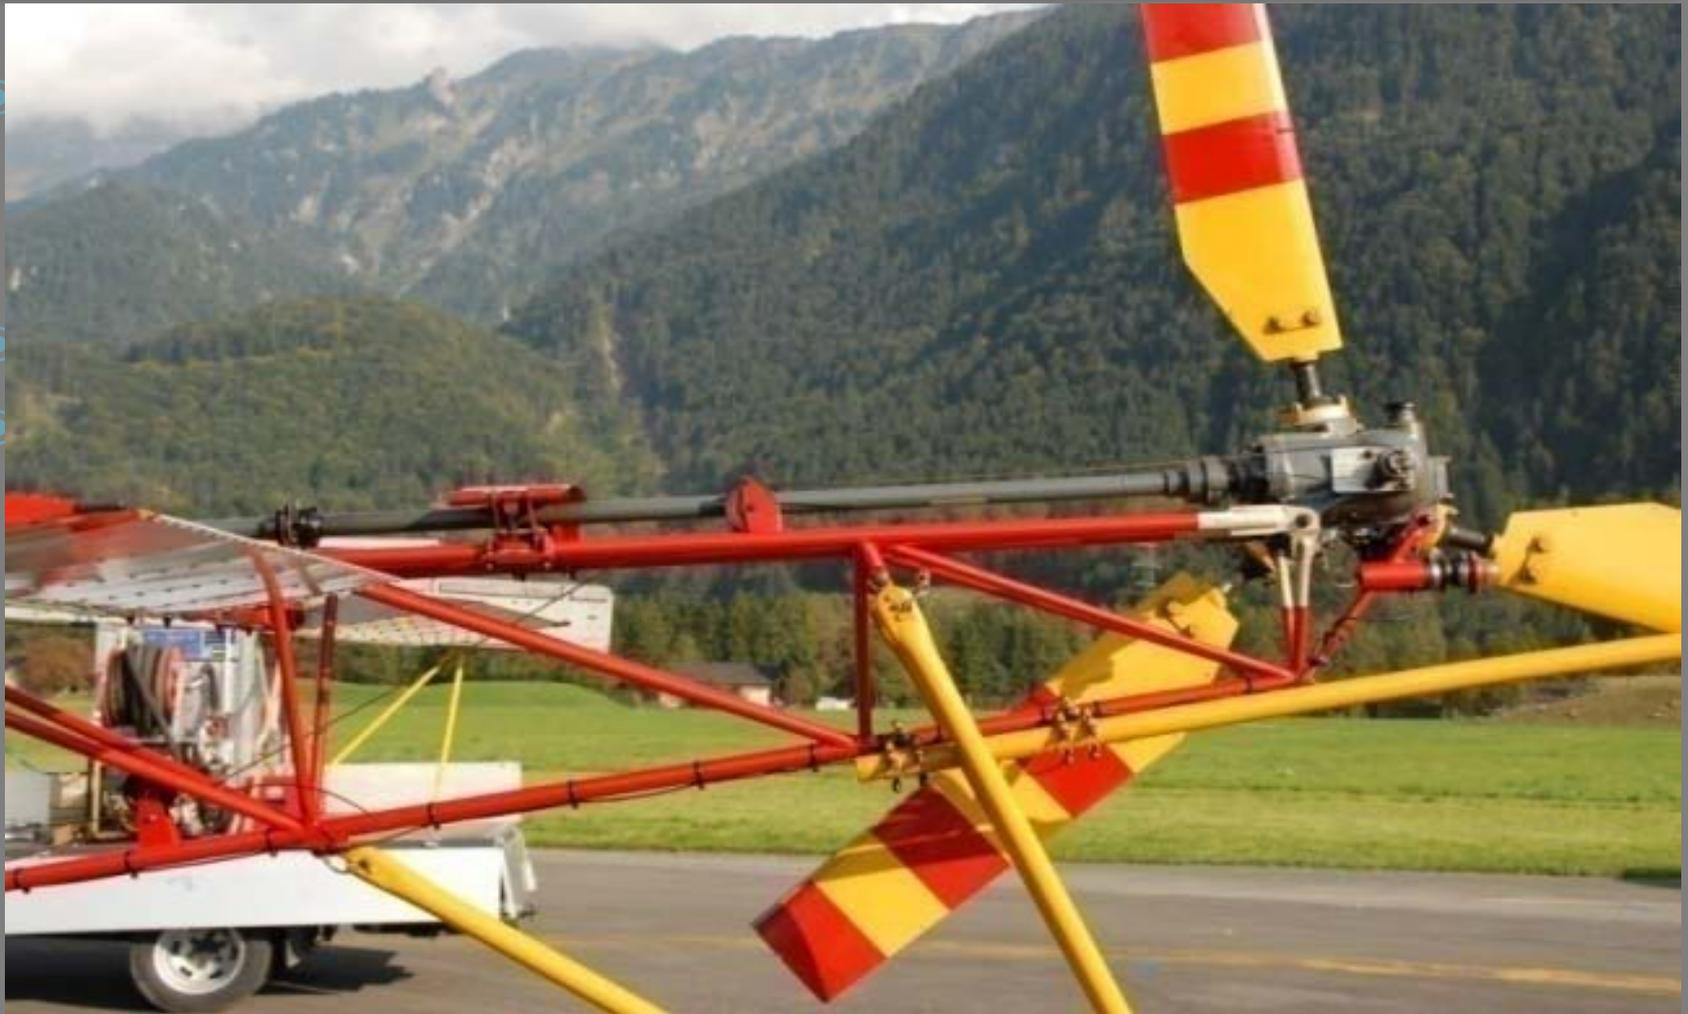
- The first analysis showed a broken control wire at about 1 cm after the connector on the winder drum of the tail boom.
