Service Bulletin No: 53-018

ATA Chapter: 53

**FUSELAGE - MAIN FRAMES****DO A CHECK OF THE MATERIAL SPECIFICATION OF THE FRAME 11 FITTINGS AND, IF NECESSARY, DO A CHECK FOR CRACKS****1. Planning Information****A. Effectivity**

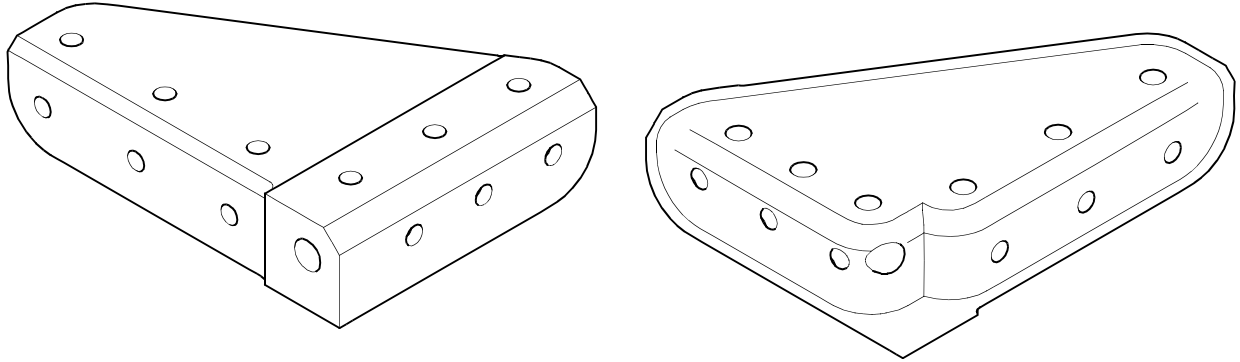
Fittings - Crack Inspection (If Necessary)  
Figure 3

An operator reported Stress Corrosion Cracking (SCC) on the FR 11 left fitting P/N 112.35.07.489 and right fitting P/N 112.35.07.490 (known hereafter as "fittings").

(1) Obey the manufacturer's instructions and use a borescope to examine the fitting from inside FR11 (looking AFT) for cracks (Ref. Fig. 3).

- (2) If you find cracks, you must replace the fitting before the next flight (Ref. Service Bulletin 53-019). Make a copy of the Inspection Report Form (Ref. Fig. 4).
- (3) If you do not find cracks in the area examined in Step 3.C.(1):
  - (a) Remove the horizontal stabilizer (Ref. AMM, 55-10-00, Page Block 401).
